**AGENDA**  
**LANDMARK COMMISSION**  
**REGULAR MEETING**  
**4:00 p.m. Monday, January 6, 2020**  
**City Council Chambers, 2<sup>nd</sup> Floor of City Hall**  
**823 Rosenberg, Galveston, Texas**

- A. 19LC-074 (1001 Postoffice/Avenue E) Request For A Certificate Of Appropriateness For Alterations To The Structure Including The Installation Of A New Garage And Curb Cut Under The Main Structure And Rear Porch Addition. Property Is Legally Described As Part Of Lots 7, Block 430, In The City And County Of Galveston, Texas. Applicant: Alex Gonzalez Property Owner: SAKM Investments

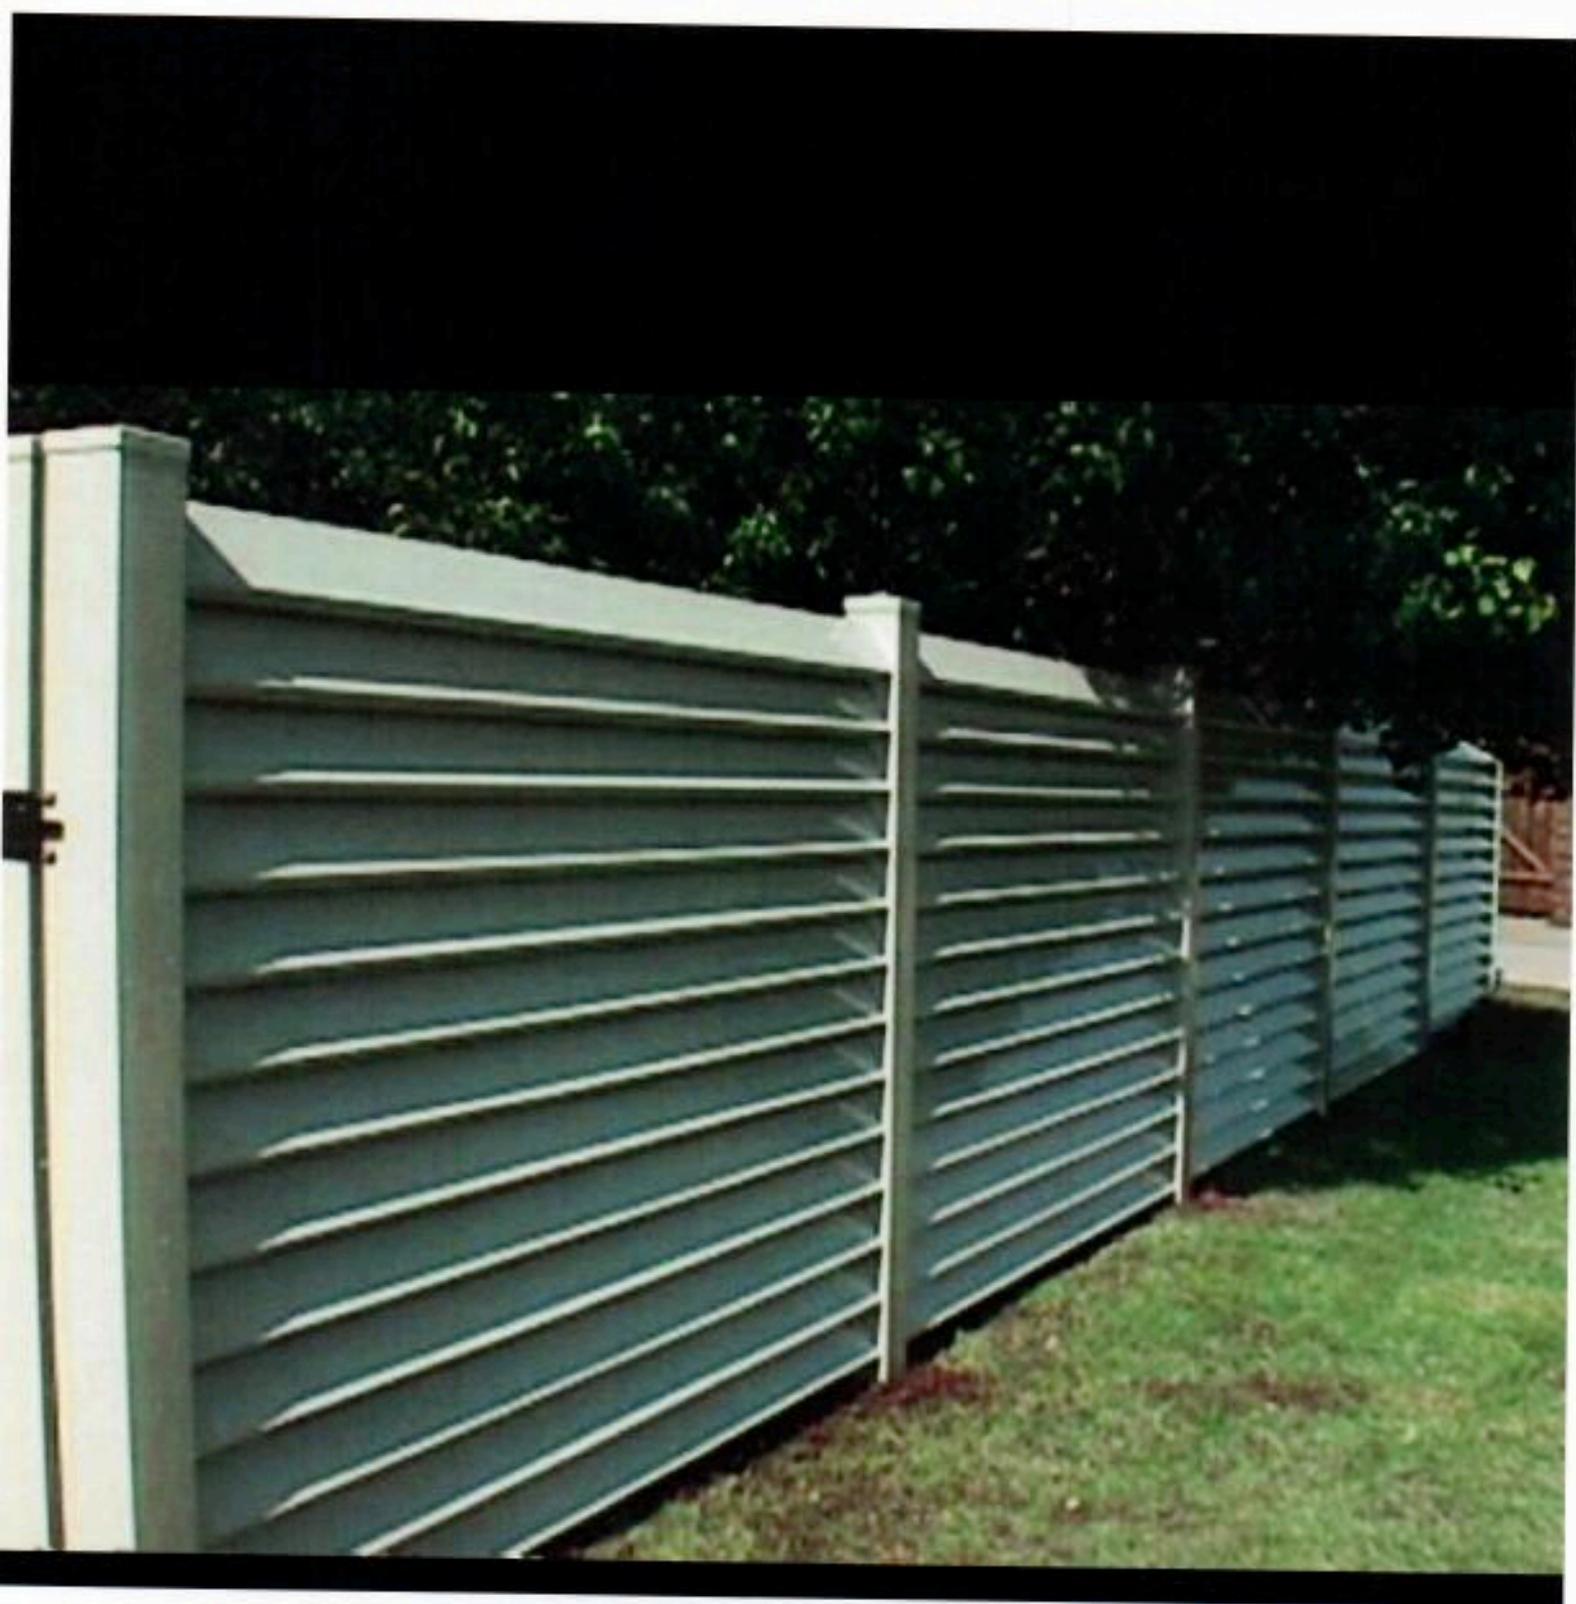
FENCE  
Request

6x6 POST 5/4" X 6" TREATED SLATS

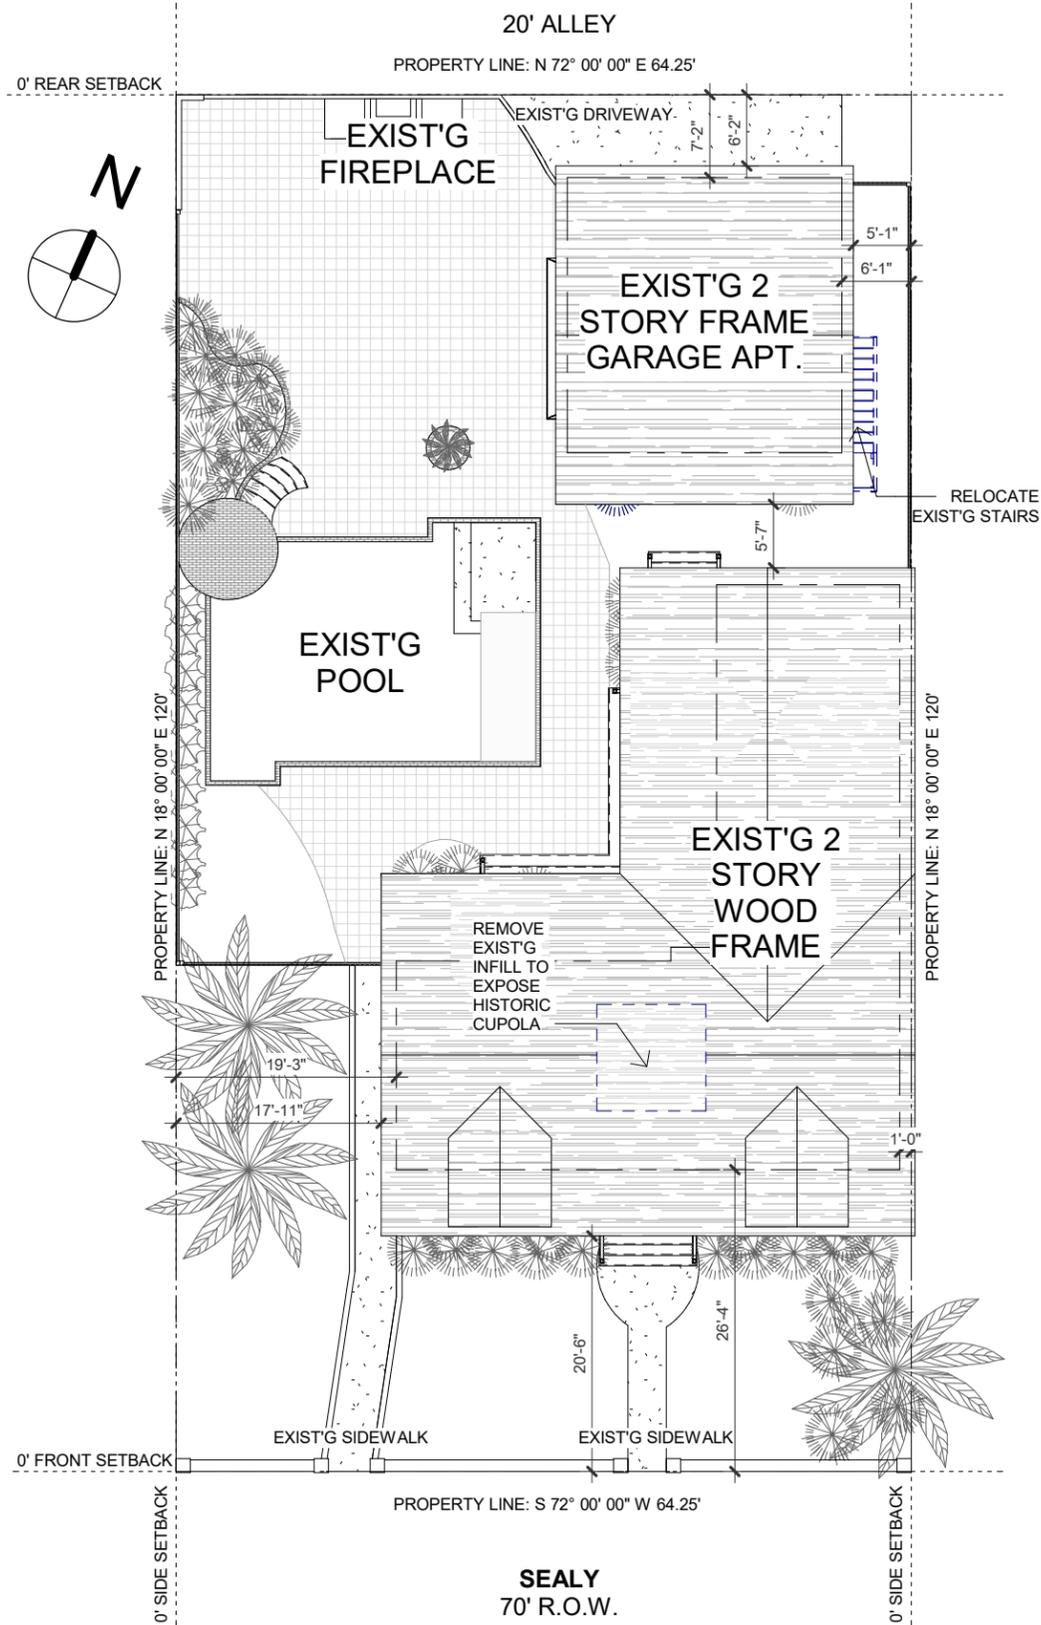
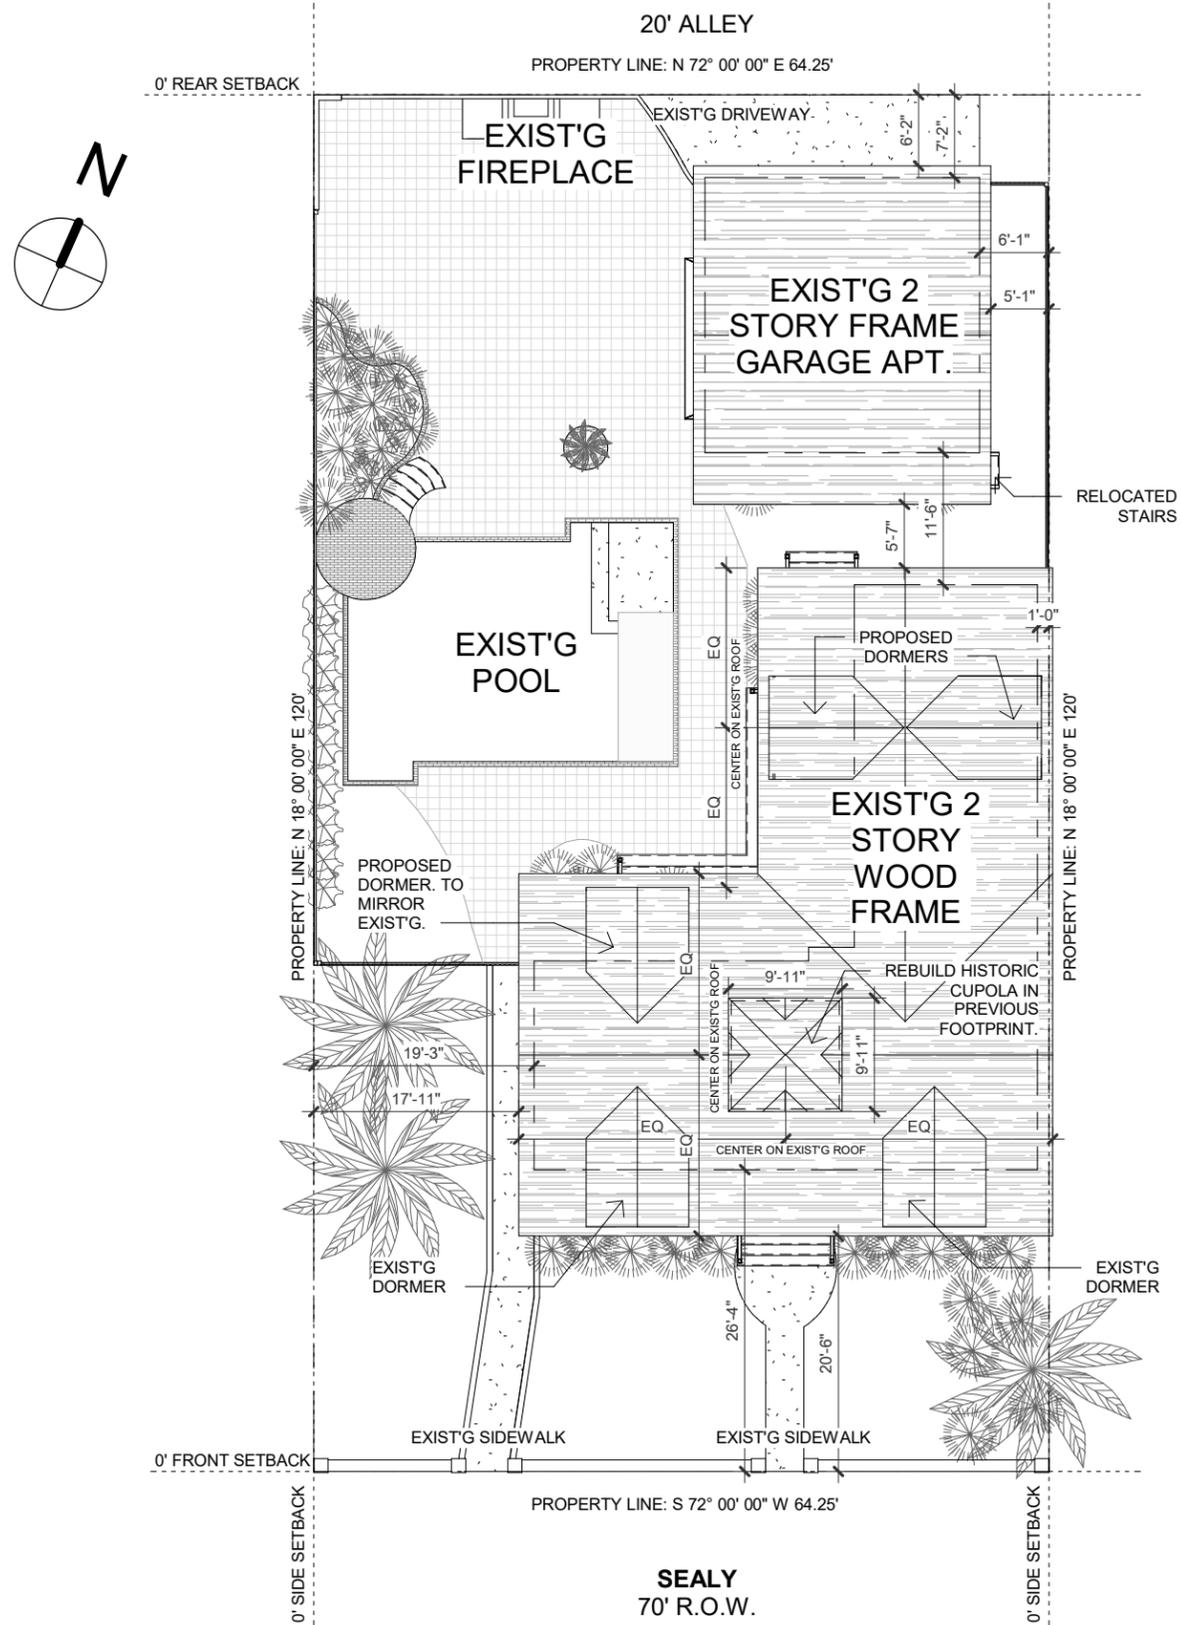
1 0- Site Plan Existing/Demo  
 1/16" = 1'-0"

2 0- Site Plan New/Proposed  
 1/16" = 1'-0"

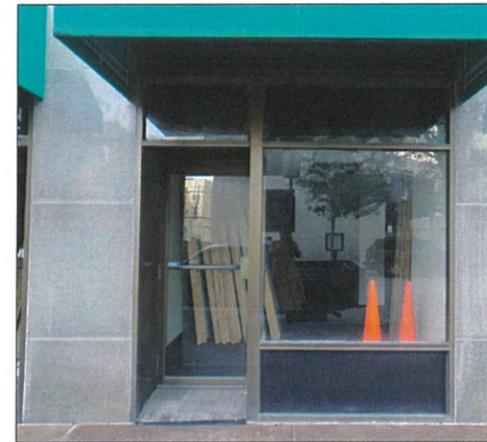
05 CIRCA 1970 ALUMINUM STOREFRONT ENTRY  
SCALE : N.T.S.

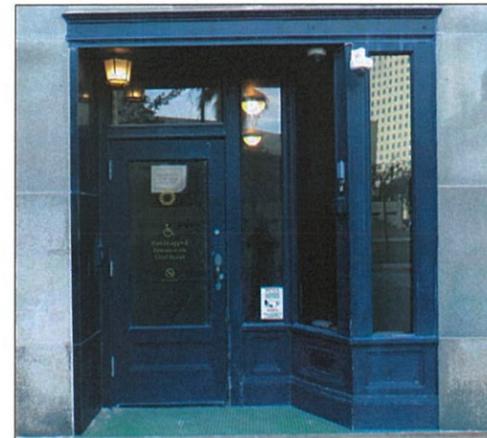
06 CIRCA 1990 REPLICATION OF CAST IRON ENTRY  
SCALE : N.T.S. MATERIAL | MAHOGANY WOOD, PAINTED BLACK

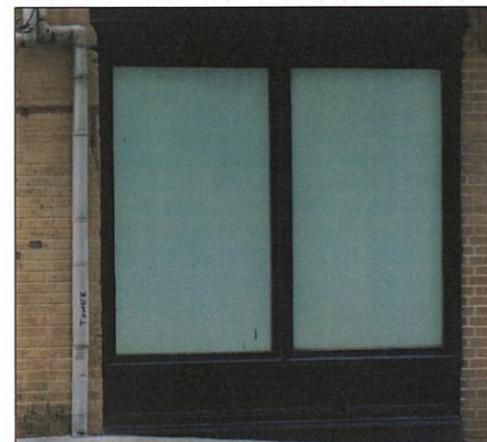
07 CIRCA 1990 REPLICATION OF ALLEY SIDE WINDOWS  
SCALE : N.T.S. MATERIAL | MAHOGANY WOOD, PAINTED BLACK
