**AGENDA**  
**LANDMARK COMMISSION**  
**REGULAR MEETING**  
**4:00 p.m. Monday, February 17, 2020**  
**City Council Chambers, 2<sup>nd</sup> Floor of City Hall**  
**823 Rosenberg, Galveston, Texas**

- A. 20LC-009 (1212 19th Street) Request For Verification As A Participant In The Substantial Rehabilitation For Historic Properties Tax Exemption Program. Property Is Legally Described As The South 47 Feet Of Lot 1 (1-1), Block 18, In The City And County Of Galveston, Texas. Applicant: Barbara Canetti, Carios LLC Property Owner: Same

- D. 20LC-011 (1827 Avenue M) Request For A Certificate Of Appropriateness For Modifications To The Structure Including The Removal And Relocation Of The Side Staircase And The Replacement Of The Existing Door With A Window And Infill Of A Rear Door. Property Is Legally Described As The North 54-Feet Of Lot 1 (1-3), In The Northwest Block 20, Galveston Outlots, In The City And County Of Galveston, Texas. Applicant: Brax Easterwood, AIA Property Owner: Mary Elizabeth Pennington

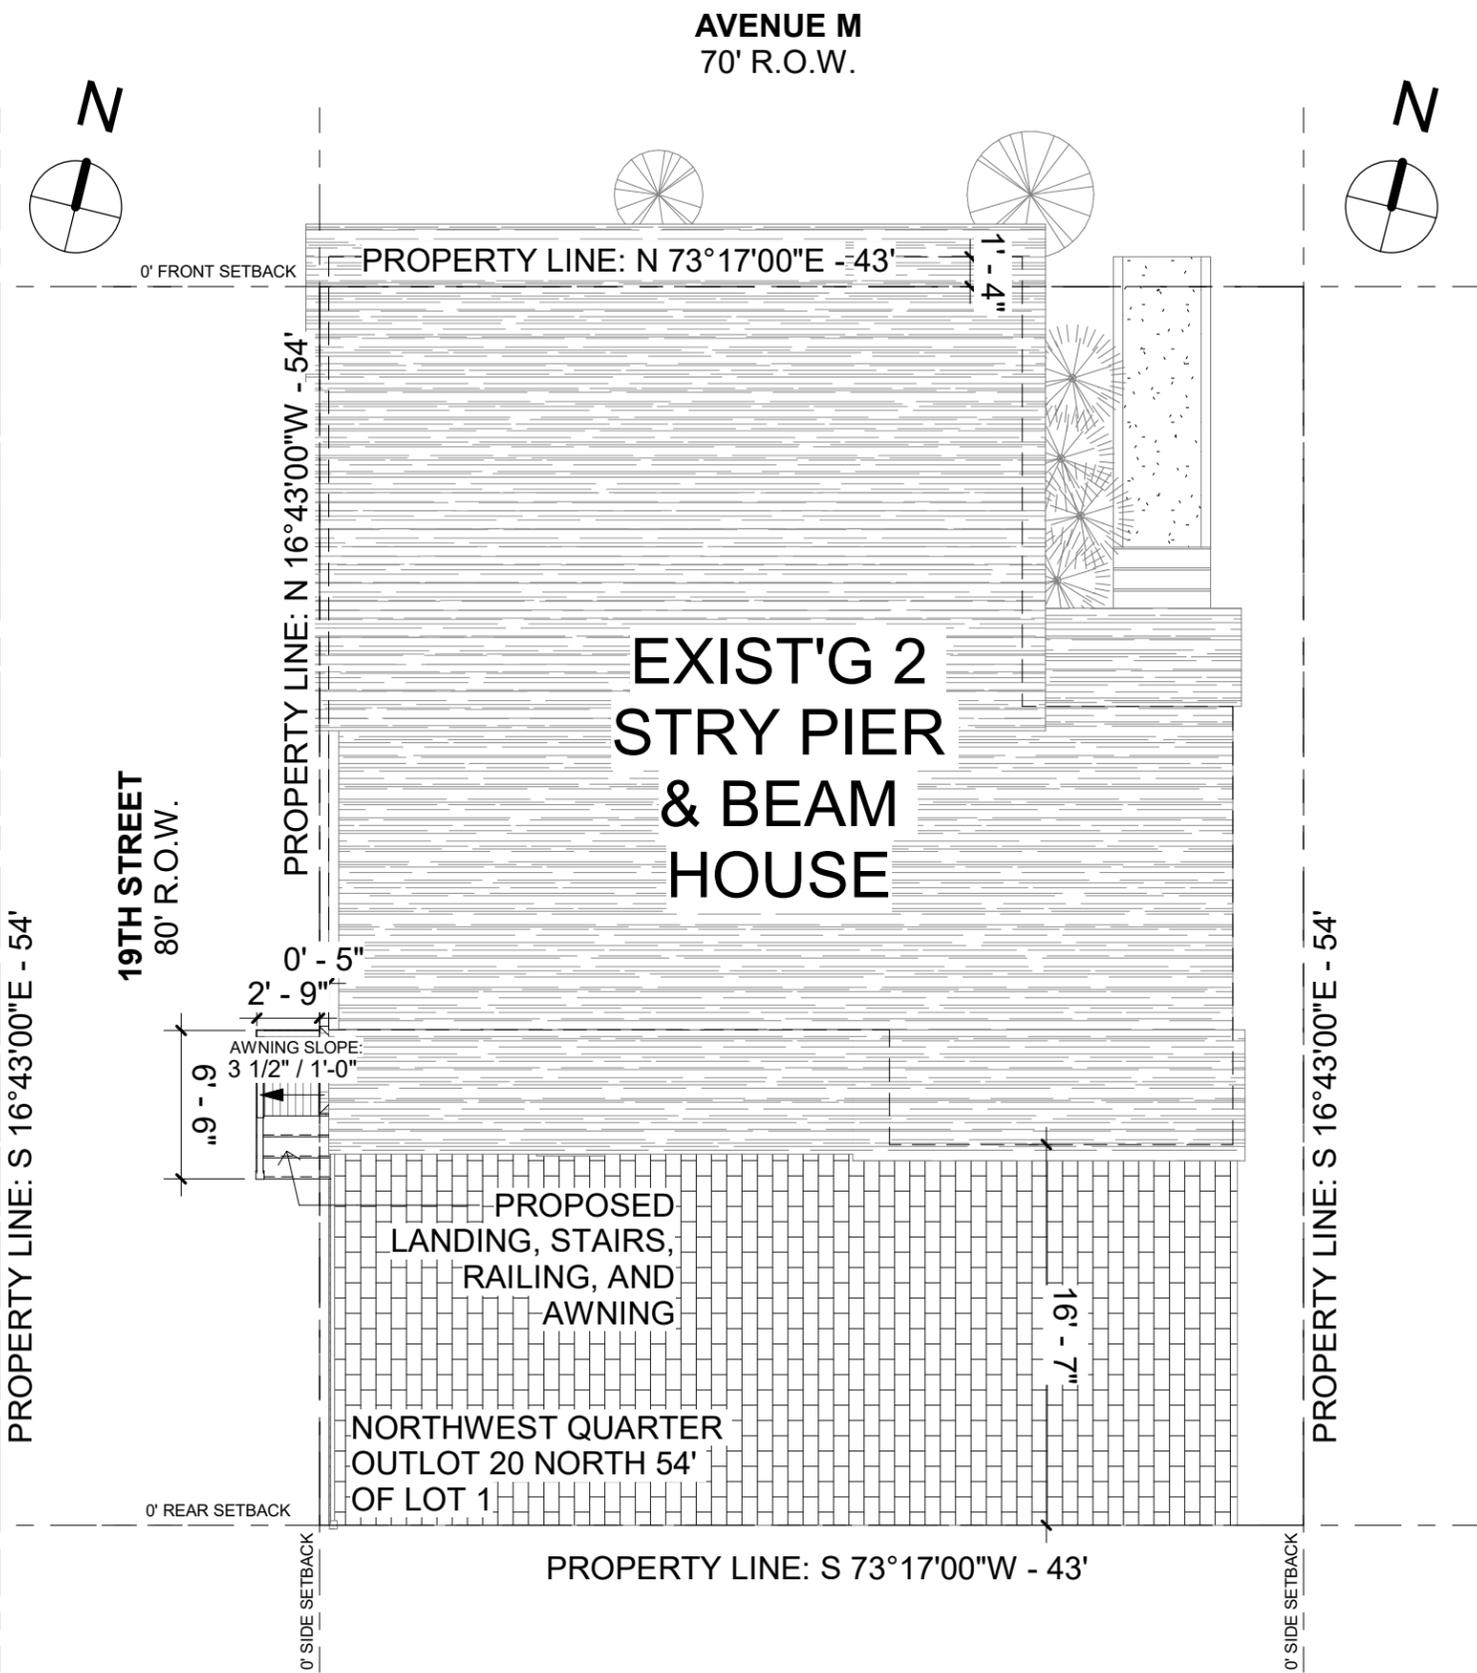
② PROPOSED SITE PLAN  
1/8" = 1'-0"

NOTE: DASHED LINES INDICATE DEMOLITION. SALVAGE ALL HISTORIC WOOD TRIM, DOORS, AND WINDOWS.

REMOVE DOOR & EXIST'G THRESHOLD

DEMO RAILING & FENCE AS REQUIRED

The applicant is requesting approval of a Certificate of Appropriateness in order to move the existing door with an awning, stairs and railing south to the existing rear porch and replace the door opening with a wood window. Additionally, a rear door will be filled in and siding installed over the opening to match the existing siding.

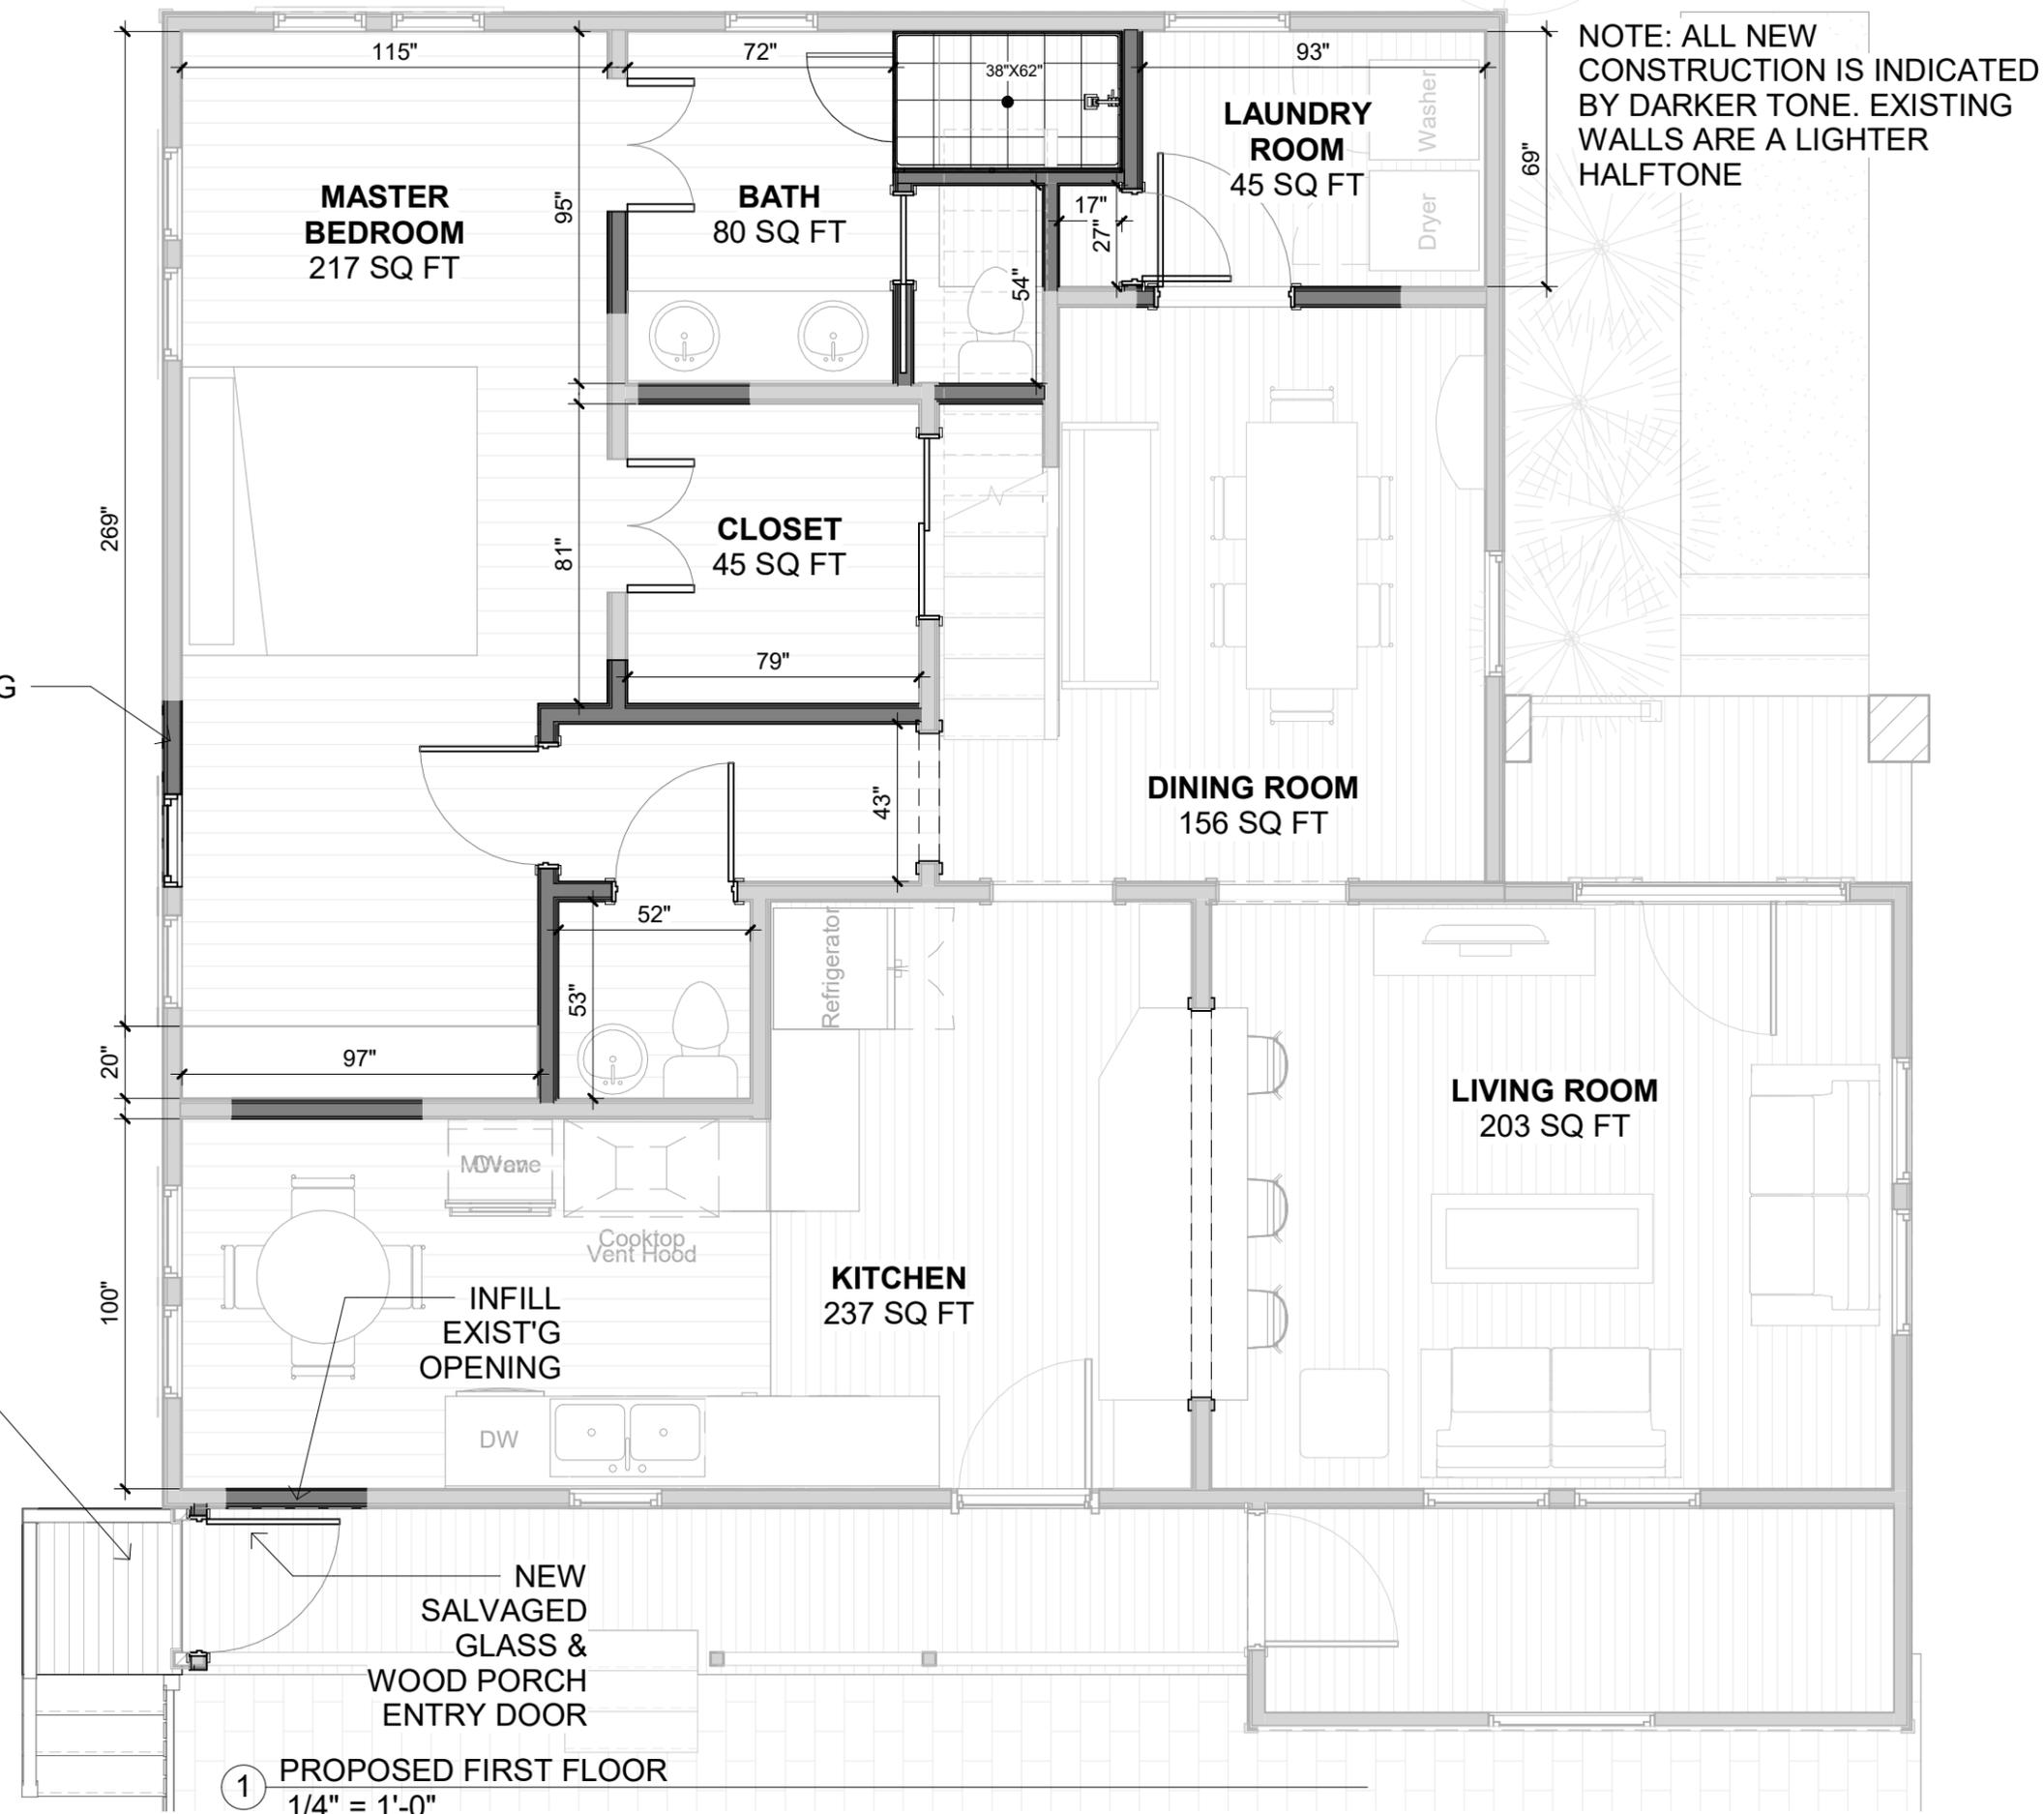
1 PROPOSED FIRST FLOOR  
1/4" = 1'-0"

NOTE: ALL NEW CONSTRUCTION IS INDICATED BY DARKER TONE. EXISTING WALLS ARE A LIGHTER HALFTONE

INFILL EXIST'G OPENING

NEW SALVAGED GLASS & WOOD PORCH ENTRY DOOR

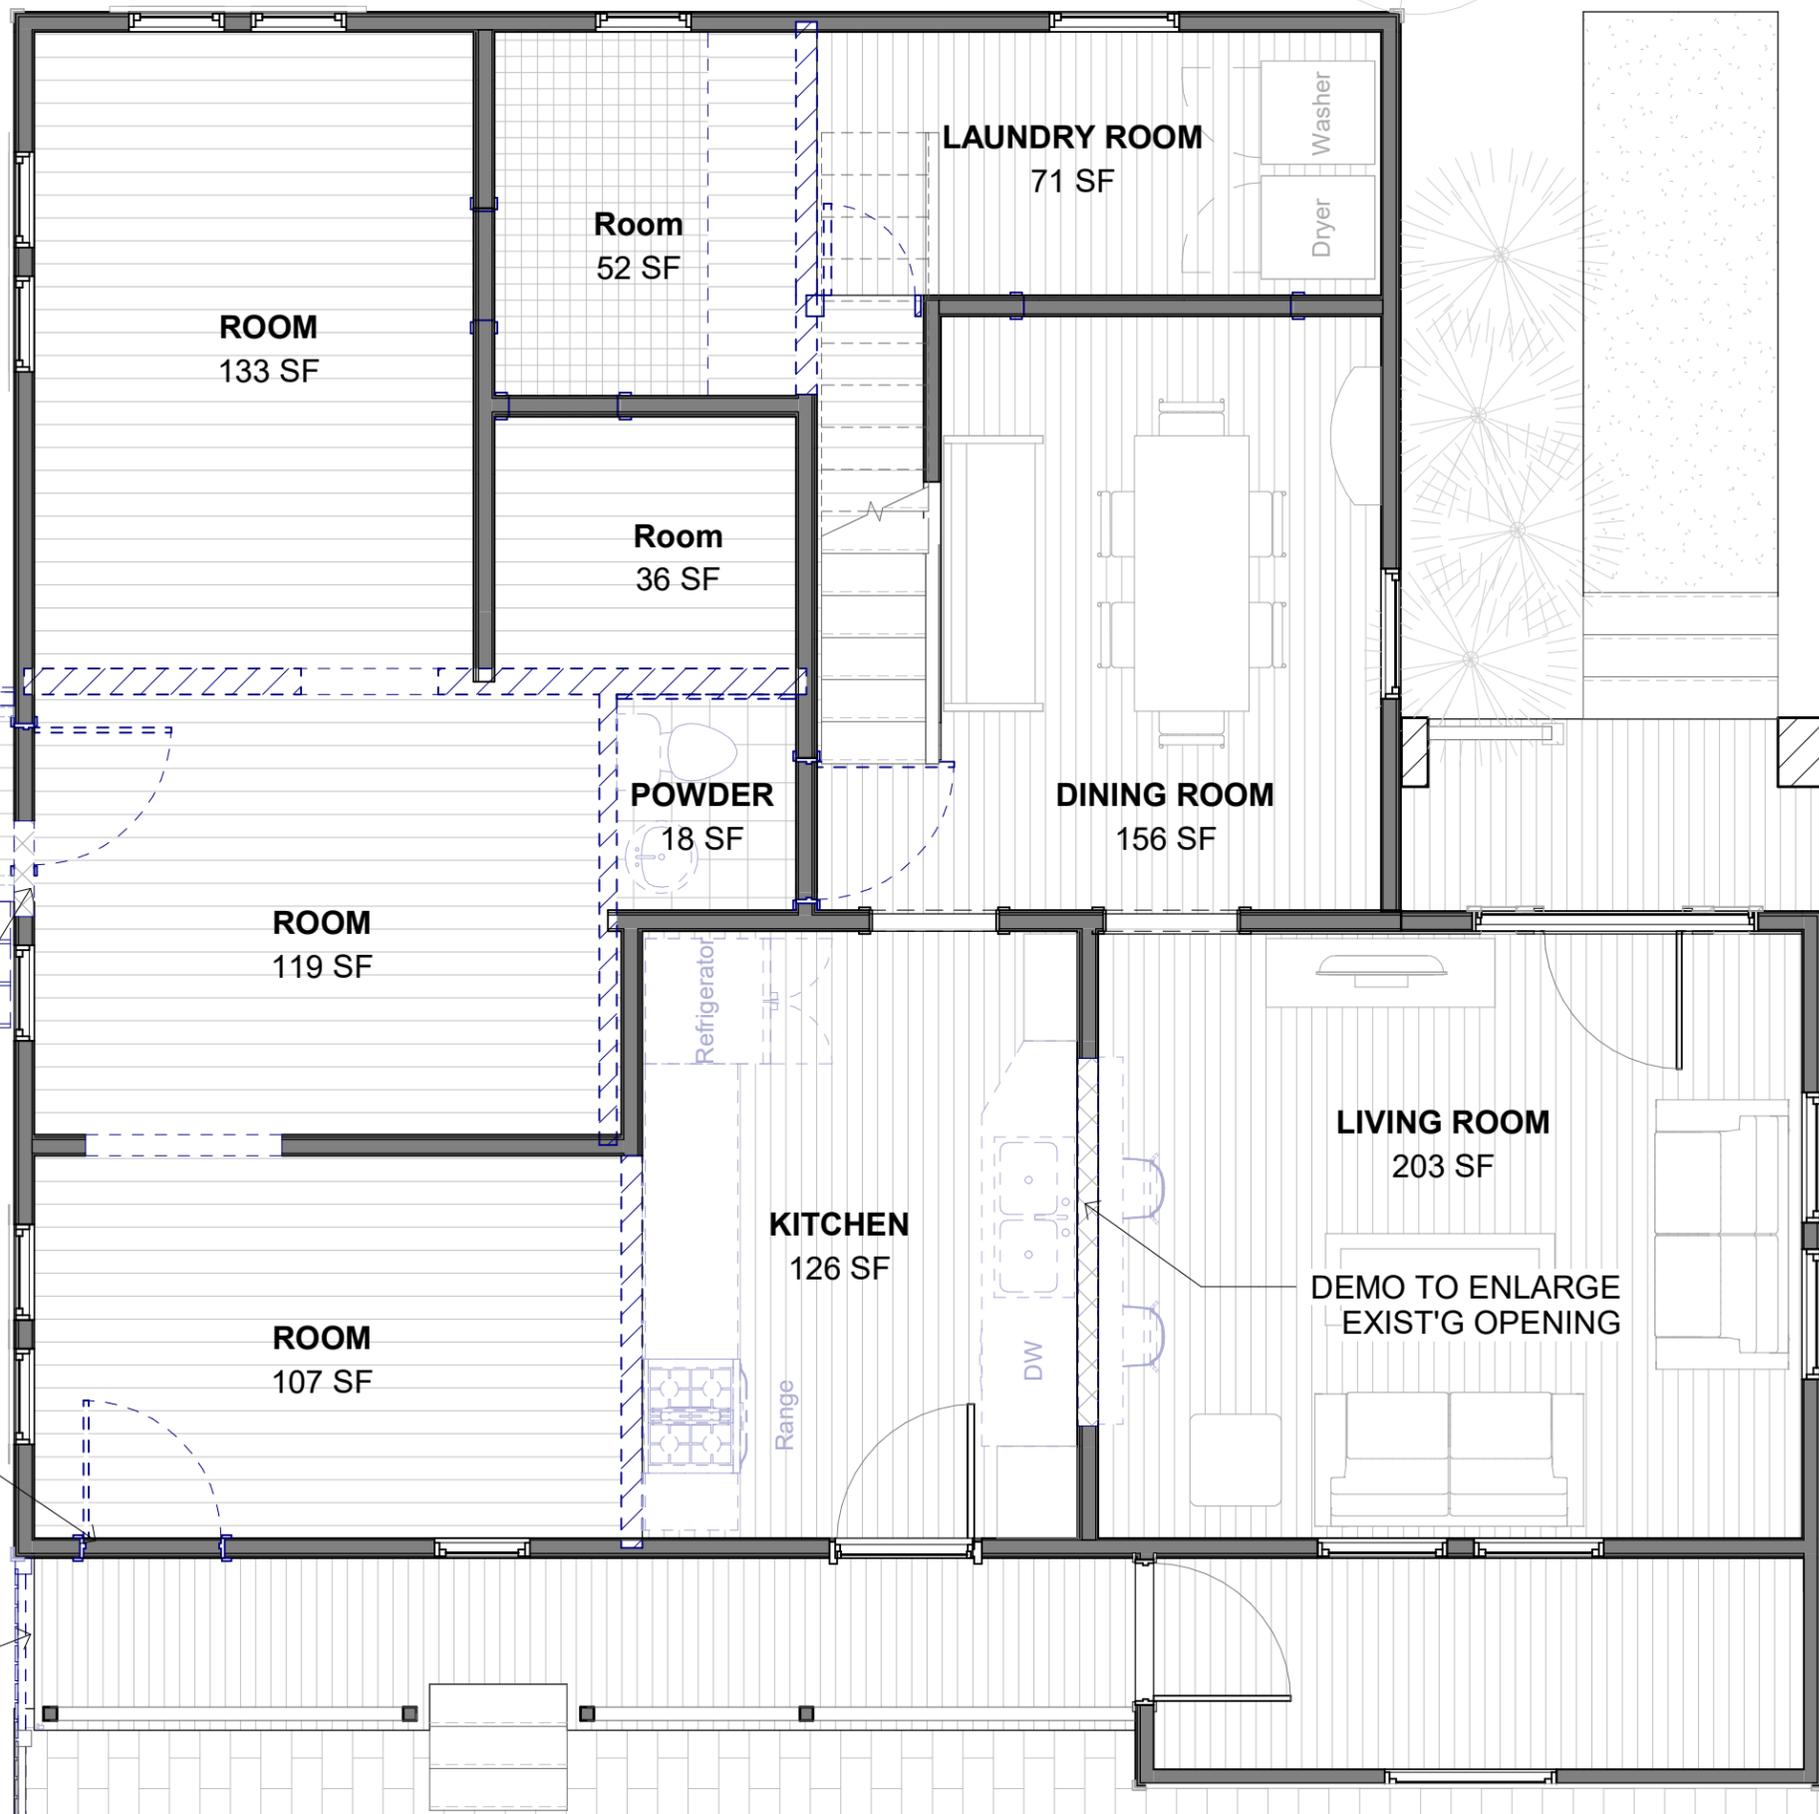
1 EXISTING FIRST FLOOR  
1/4" = 1'-0"

REMOVE DOOR & EXIST'G THRESHOLD

DEMO RAILING & FENCE AS REQUIRED

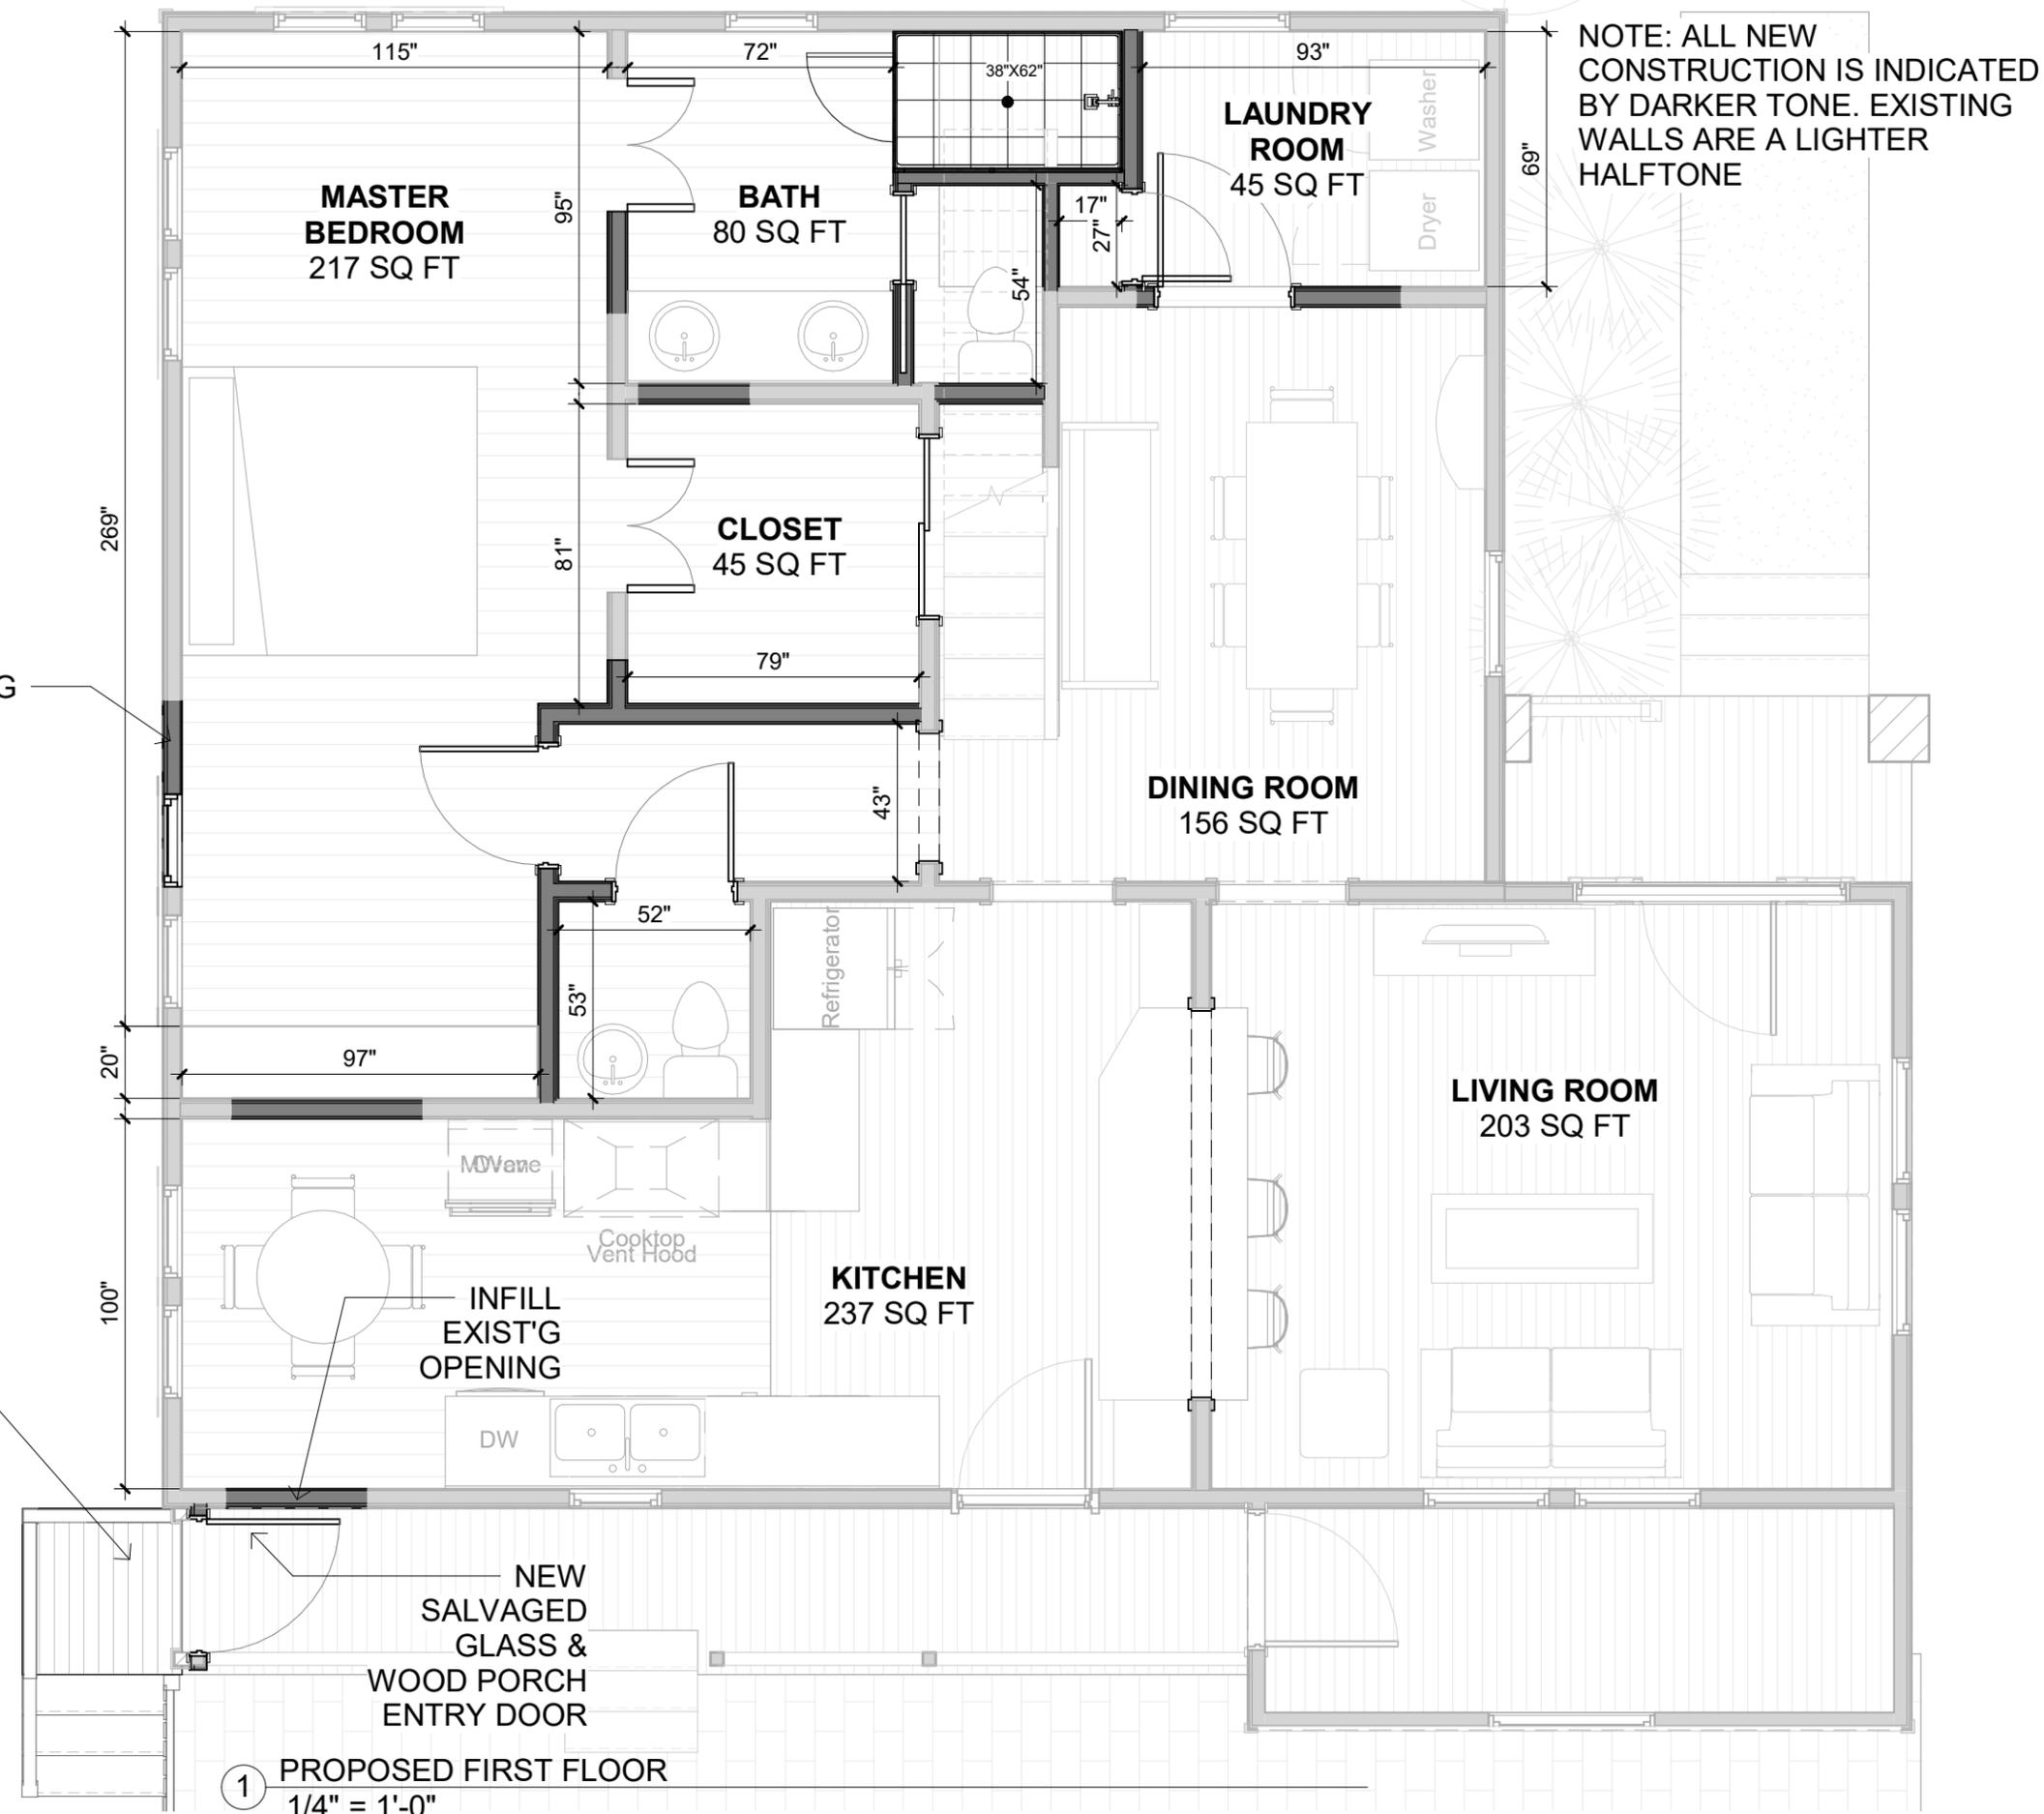
1 PROPOSED FIRST FLOOR  
1/4" = 1'-0"

NOTE: ALL NEW CONSTRUCTION IS INDICATED BY DARKER TONE. EXISTING WALLS ARE A LIGHTER HALFTONE

**Impact on Transportation System** There is a sidewalk along 19<sup>th</sup> Street and the existing and new proposed stairs and awning will not block the sidewalk or cause pedestrian access to be obstructed. The right of way is approximately 10-feet in width. The newly constructed stairs and awning will be 2-feet 9-inches into the existing 10-foot right of way.

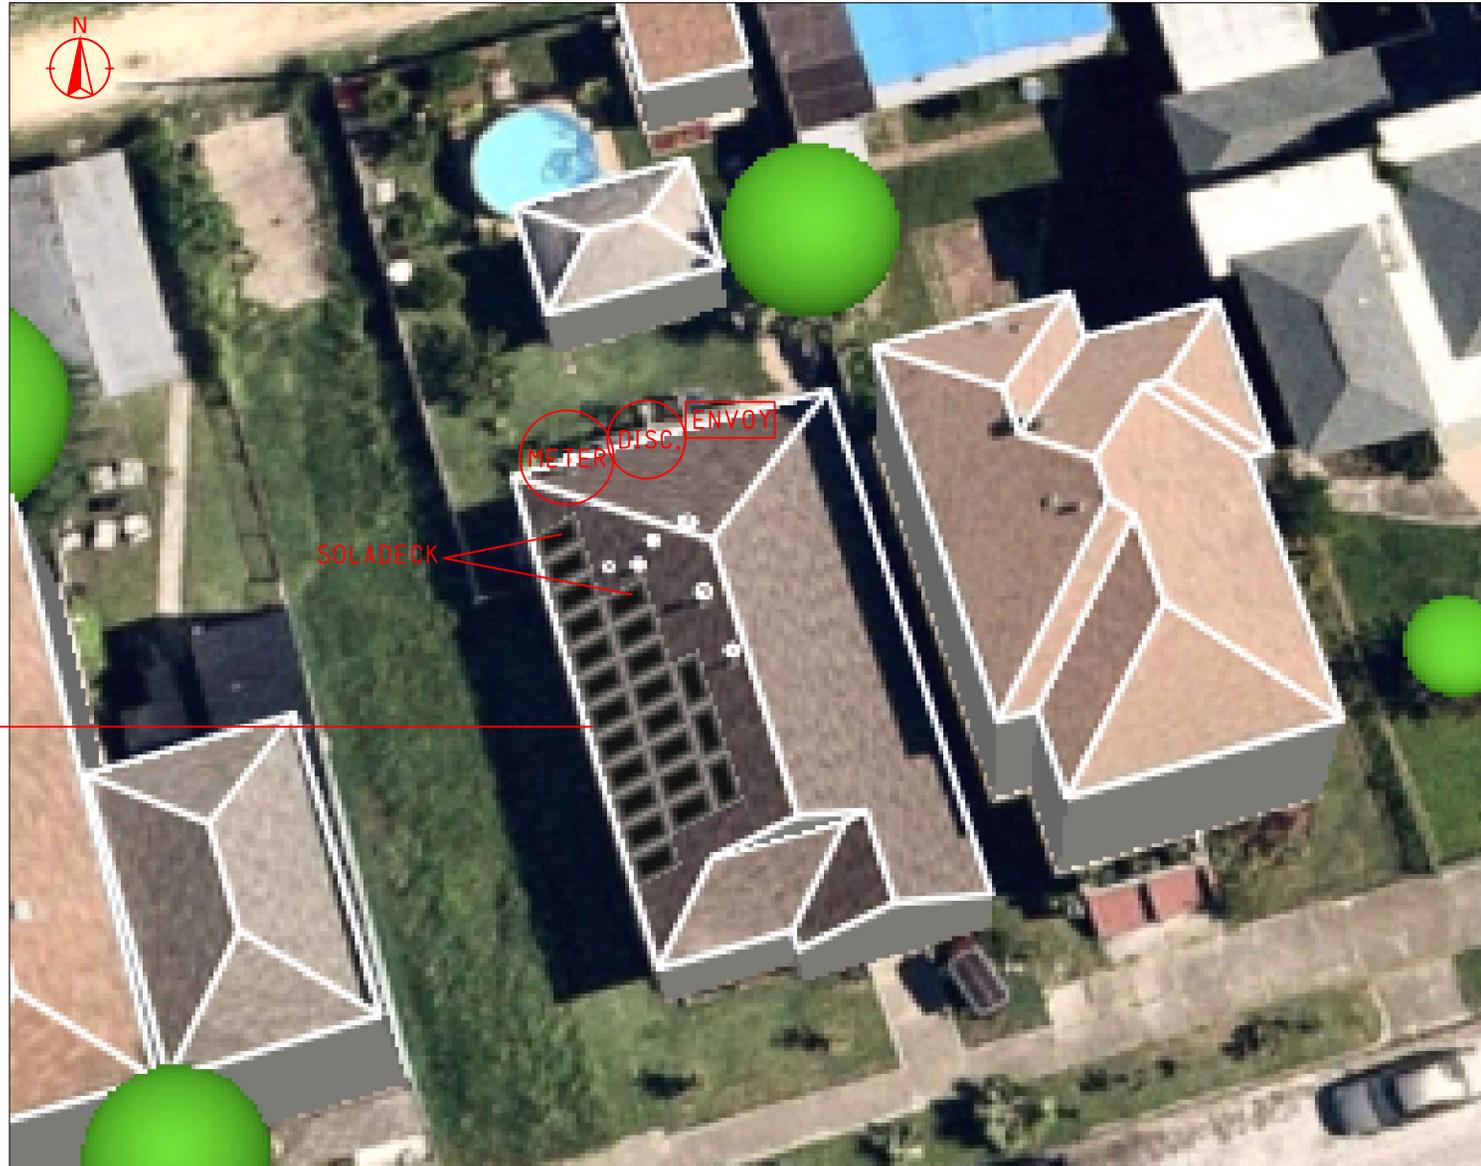
# Install Map - Michel Boyer

Quantity: 23  
 Panel: LG 335  
 Inverter: Enphase iQ7

ARRAY : 7.71 kW  
 AZIMUTH : 253  
 PITCH : 31

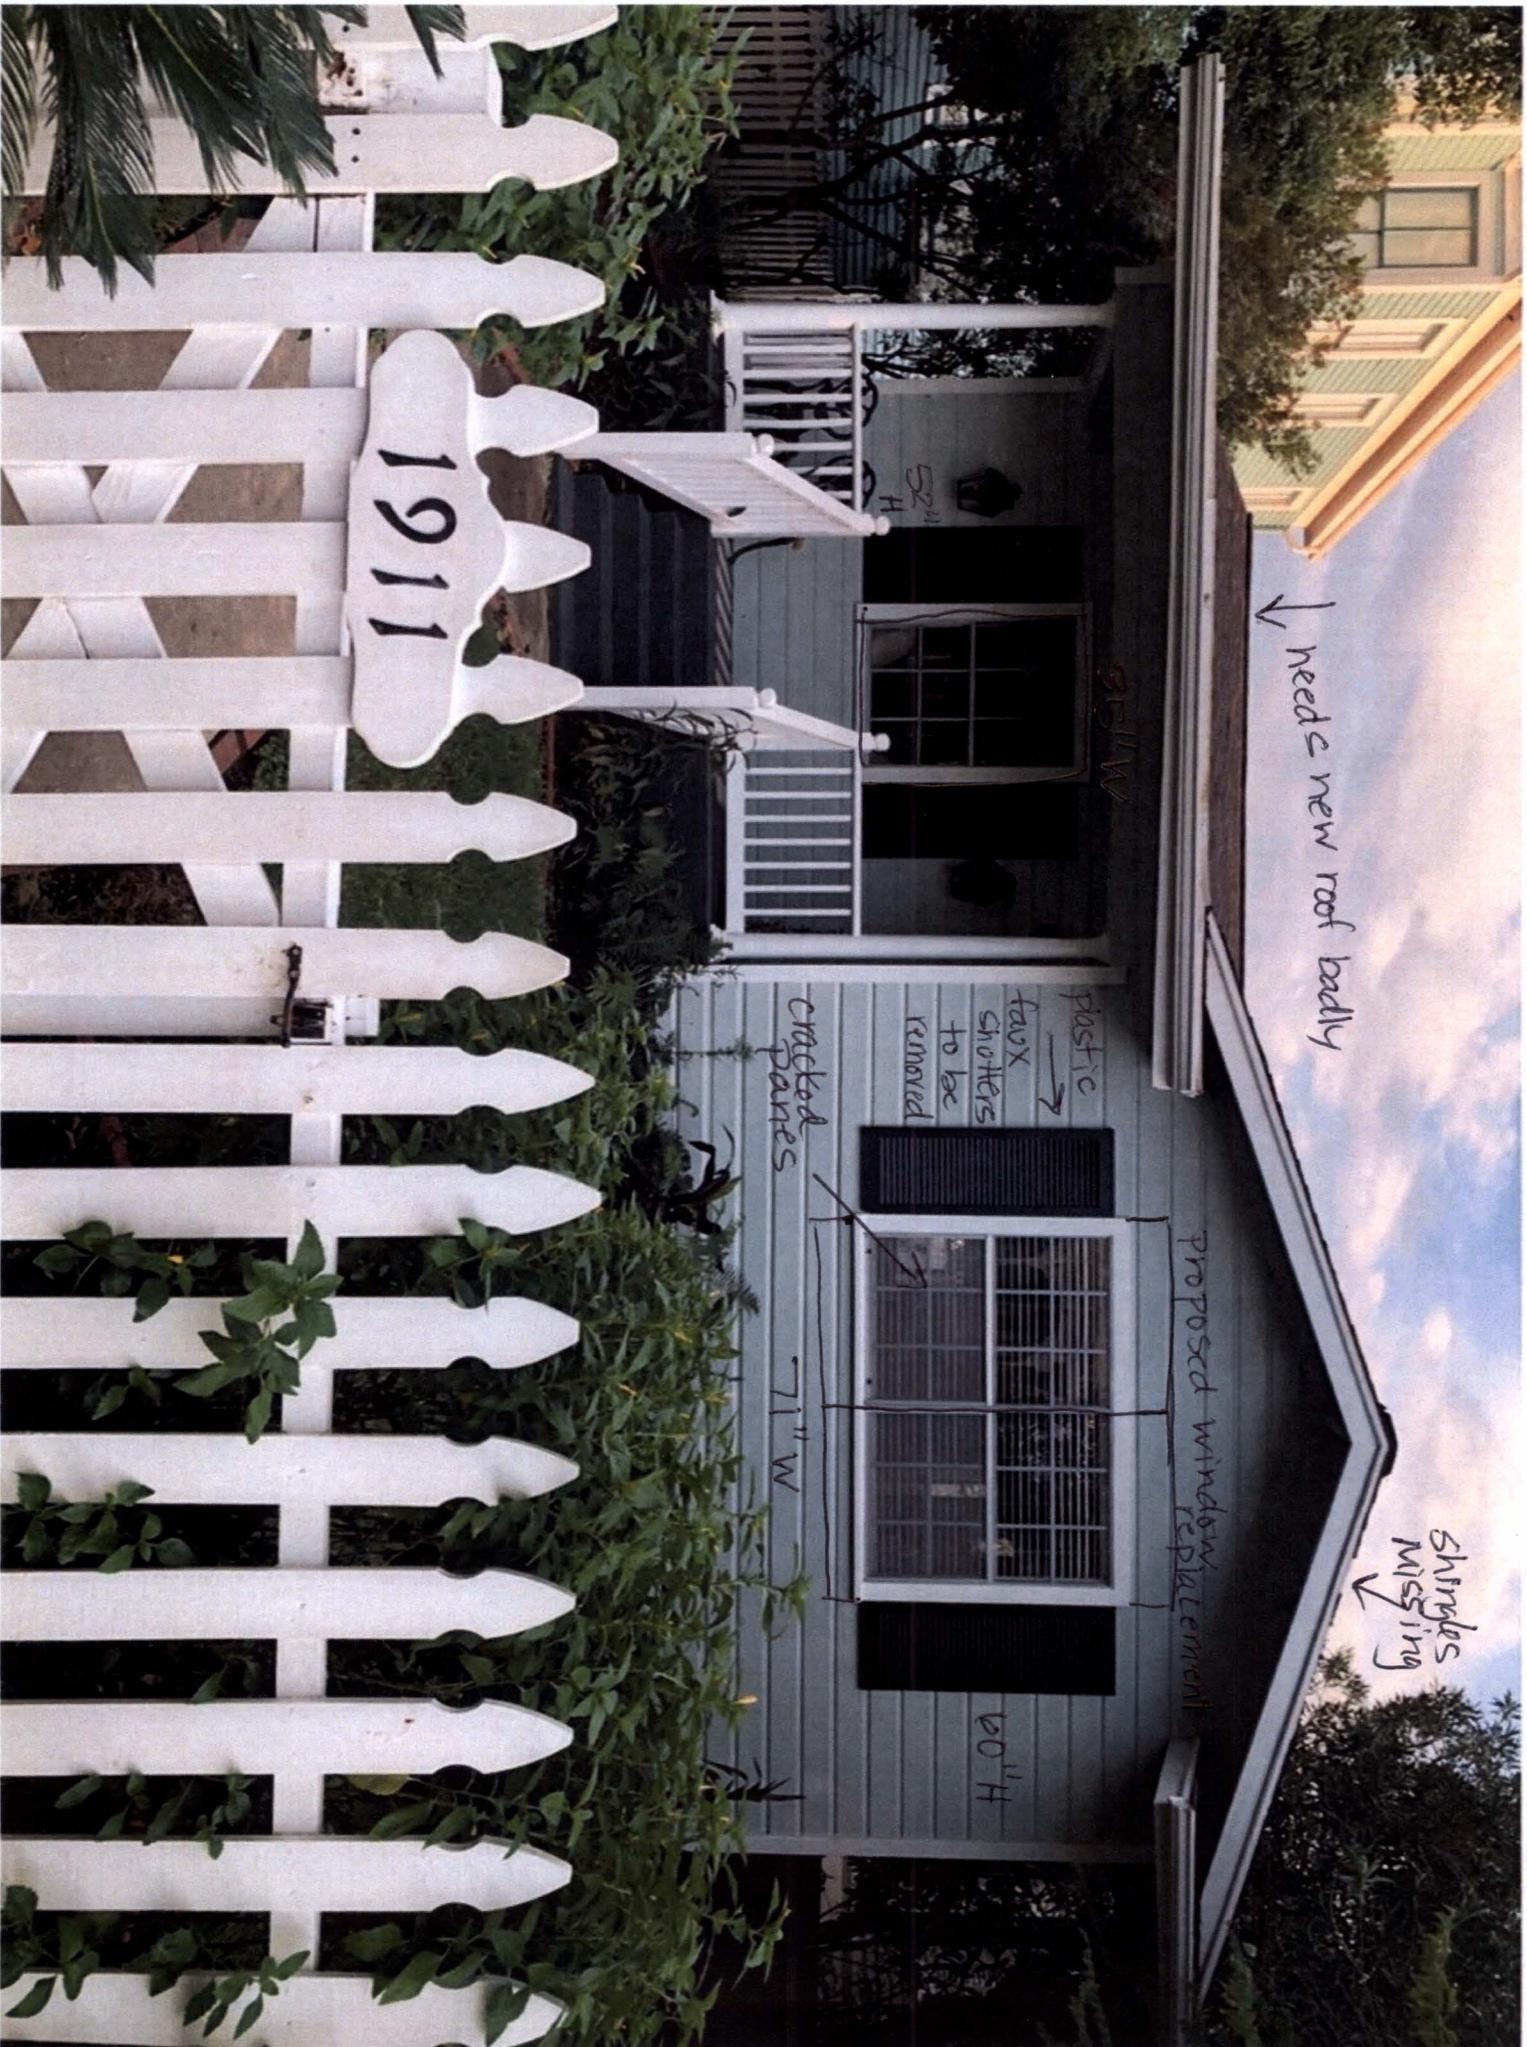
needs new roof badly

shingles missing

Several  
cracked  
panes

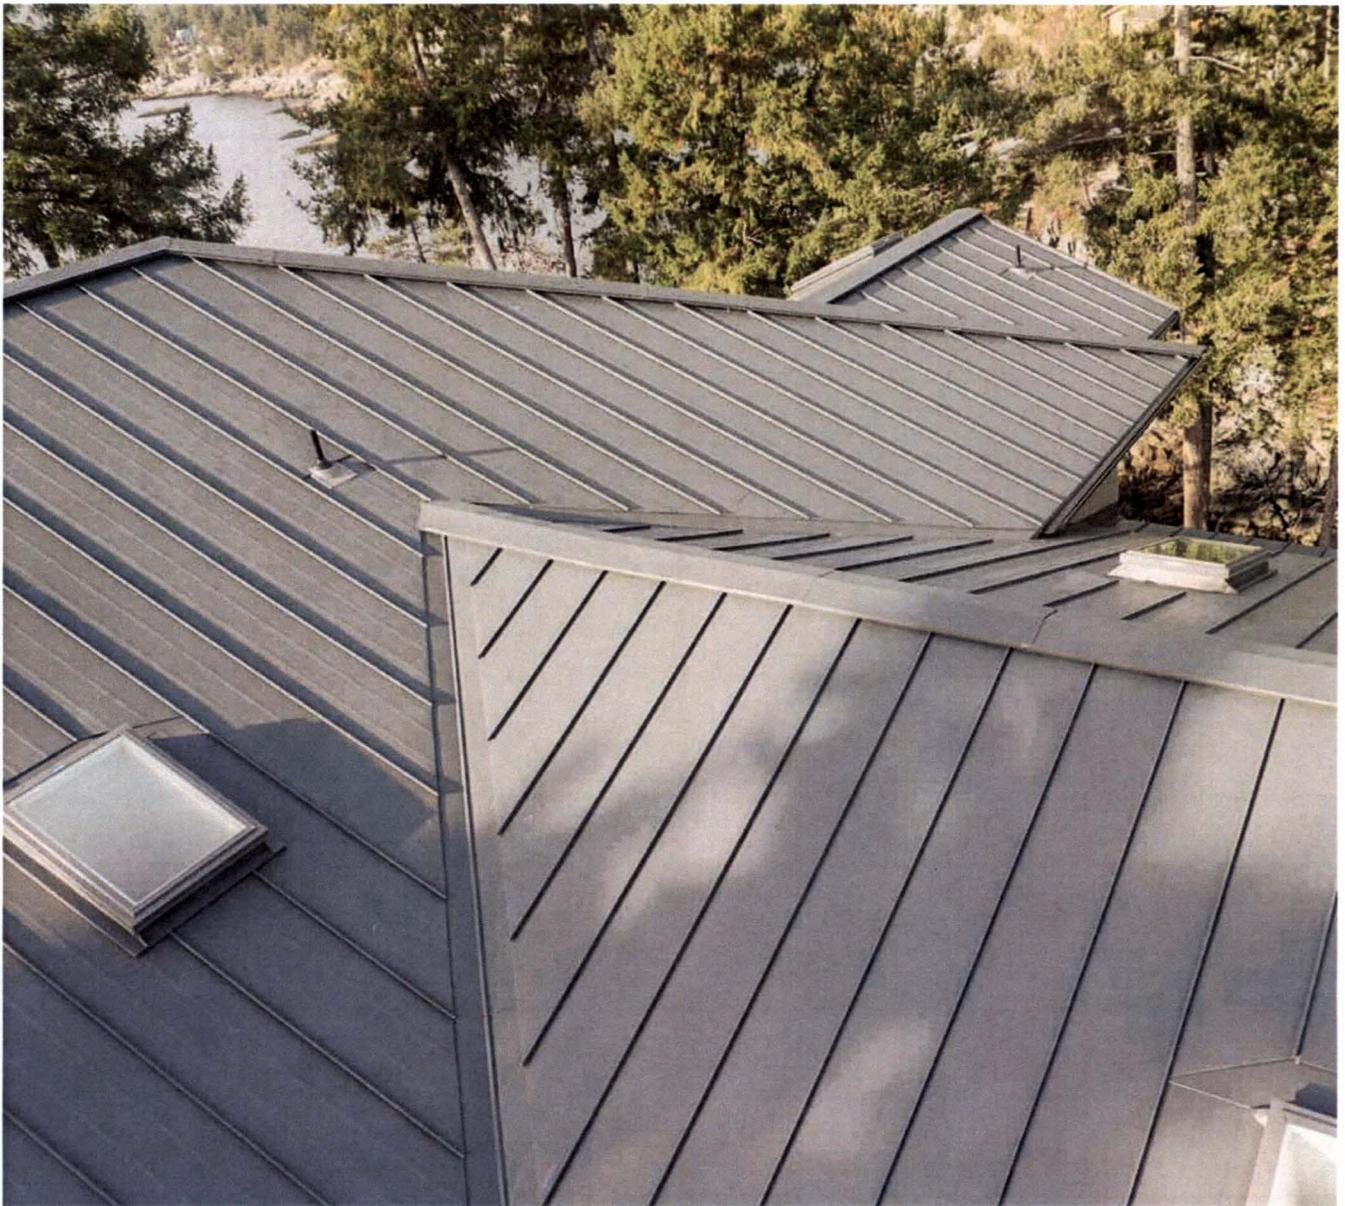
Proposed roof for 1911+1915 Avenue M  
Aluminum, standing seam, color: charcoal grey

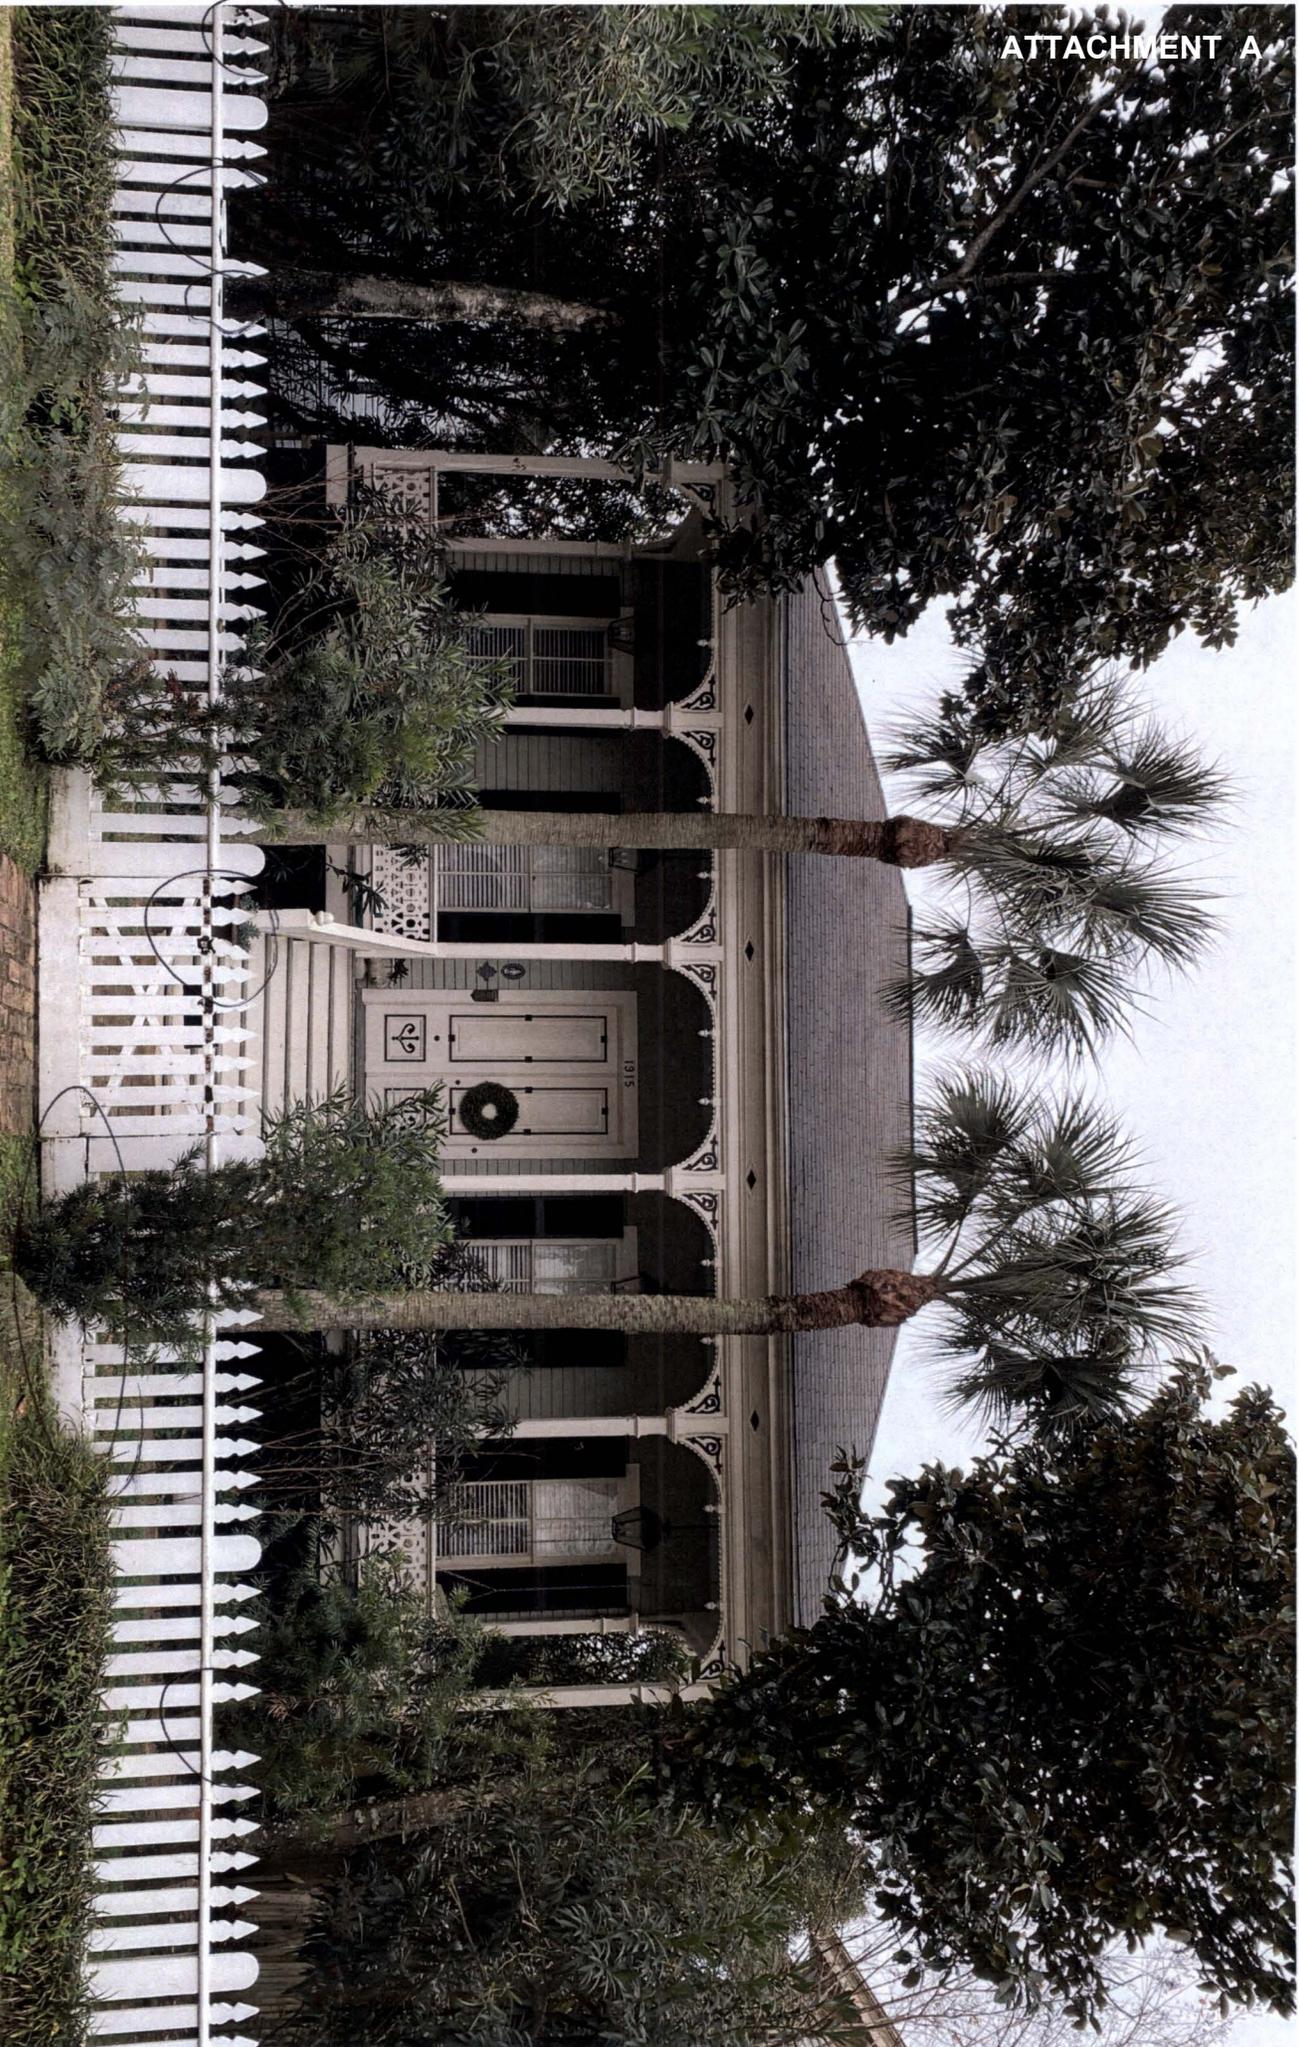
1915 Avenue M -

Many Missing / rotten boards  
Fence in bad shape. Would  
really prefer maintenance free
