AGENDA
LANDMARK COMMISSION
REGULAR MEETING
4:00 p.m. Monday, March 16, 2020
City Council Chambers, 2nd Floor of City Hall
823 Rosenberg, Galveston, Texas

MINUTES OF THE LANDMARK COMMISSION OF THE CITY OF GALVESTON REGULAR MEETING – March 2, 2020

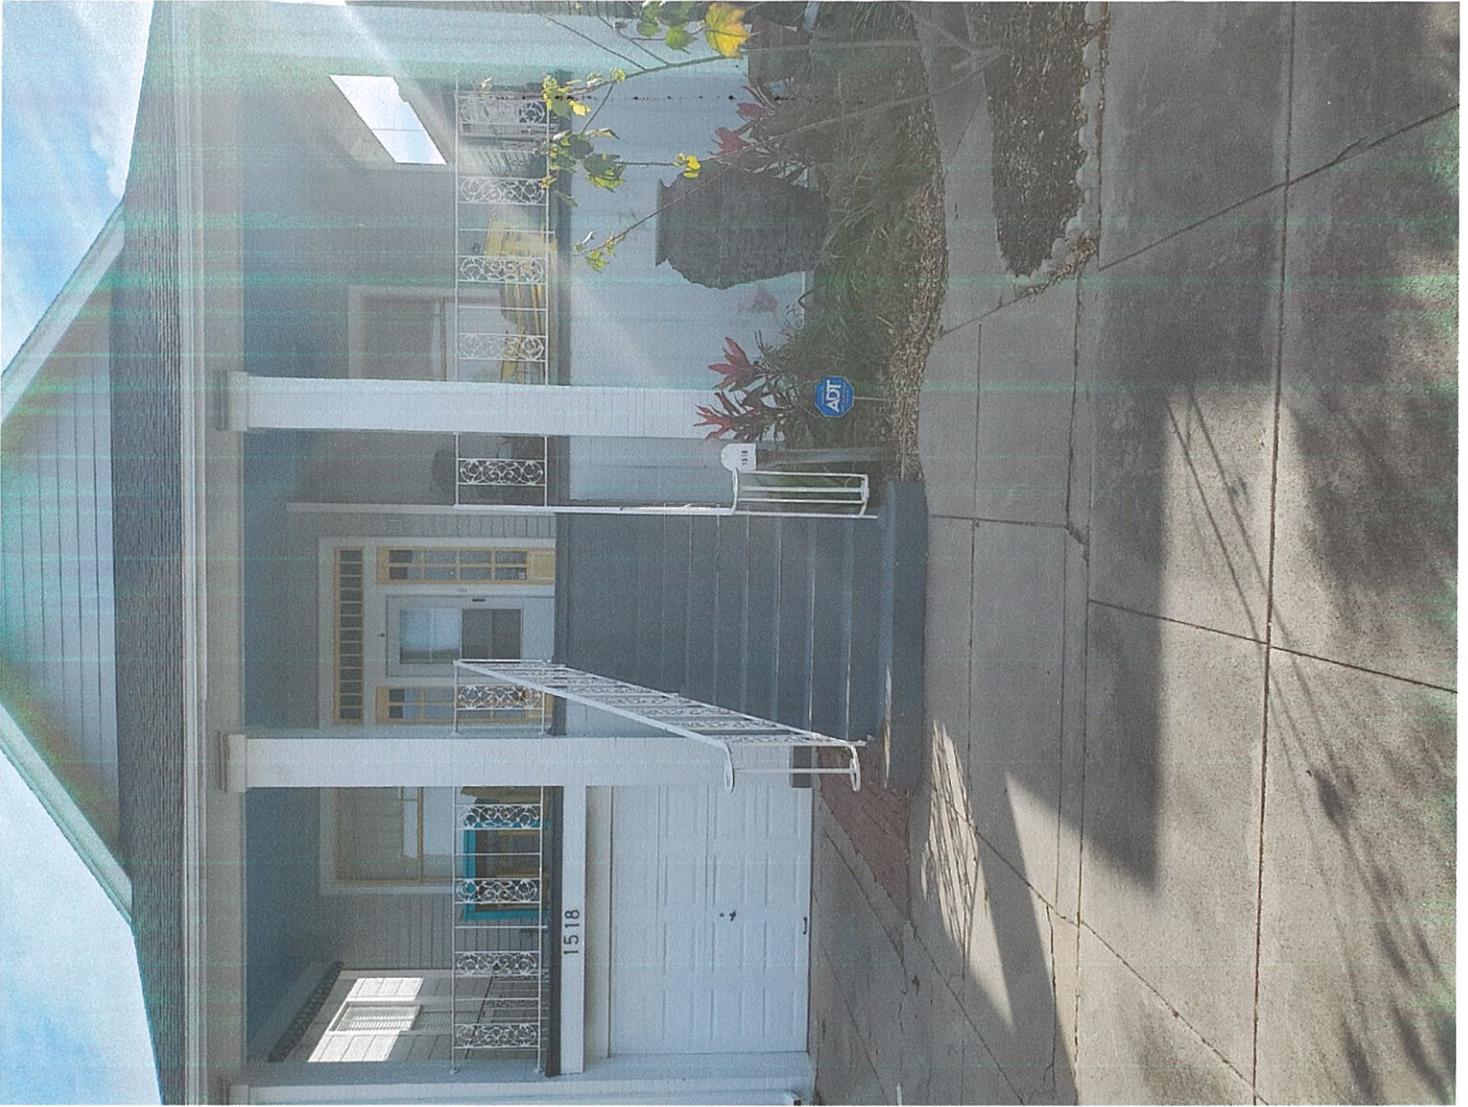
Case # 2020-017

Replace Metal Rails
With Wood

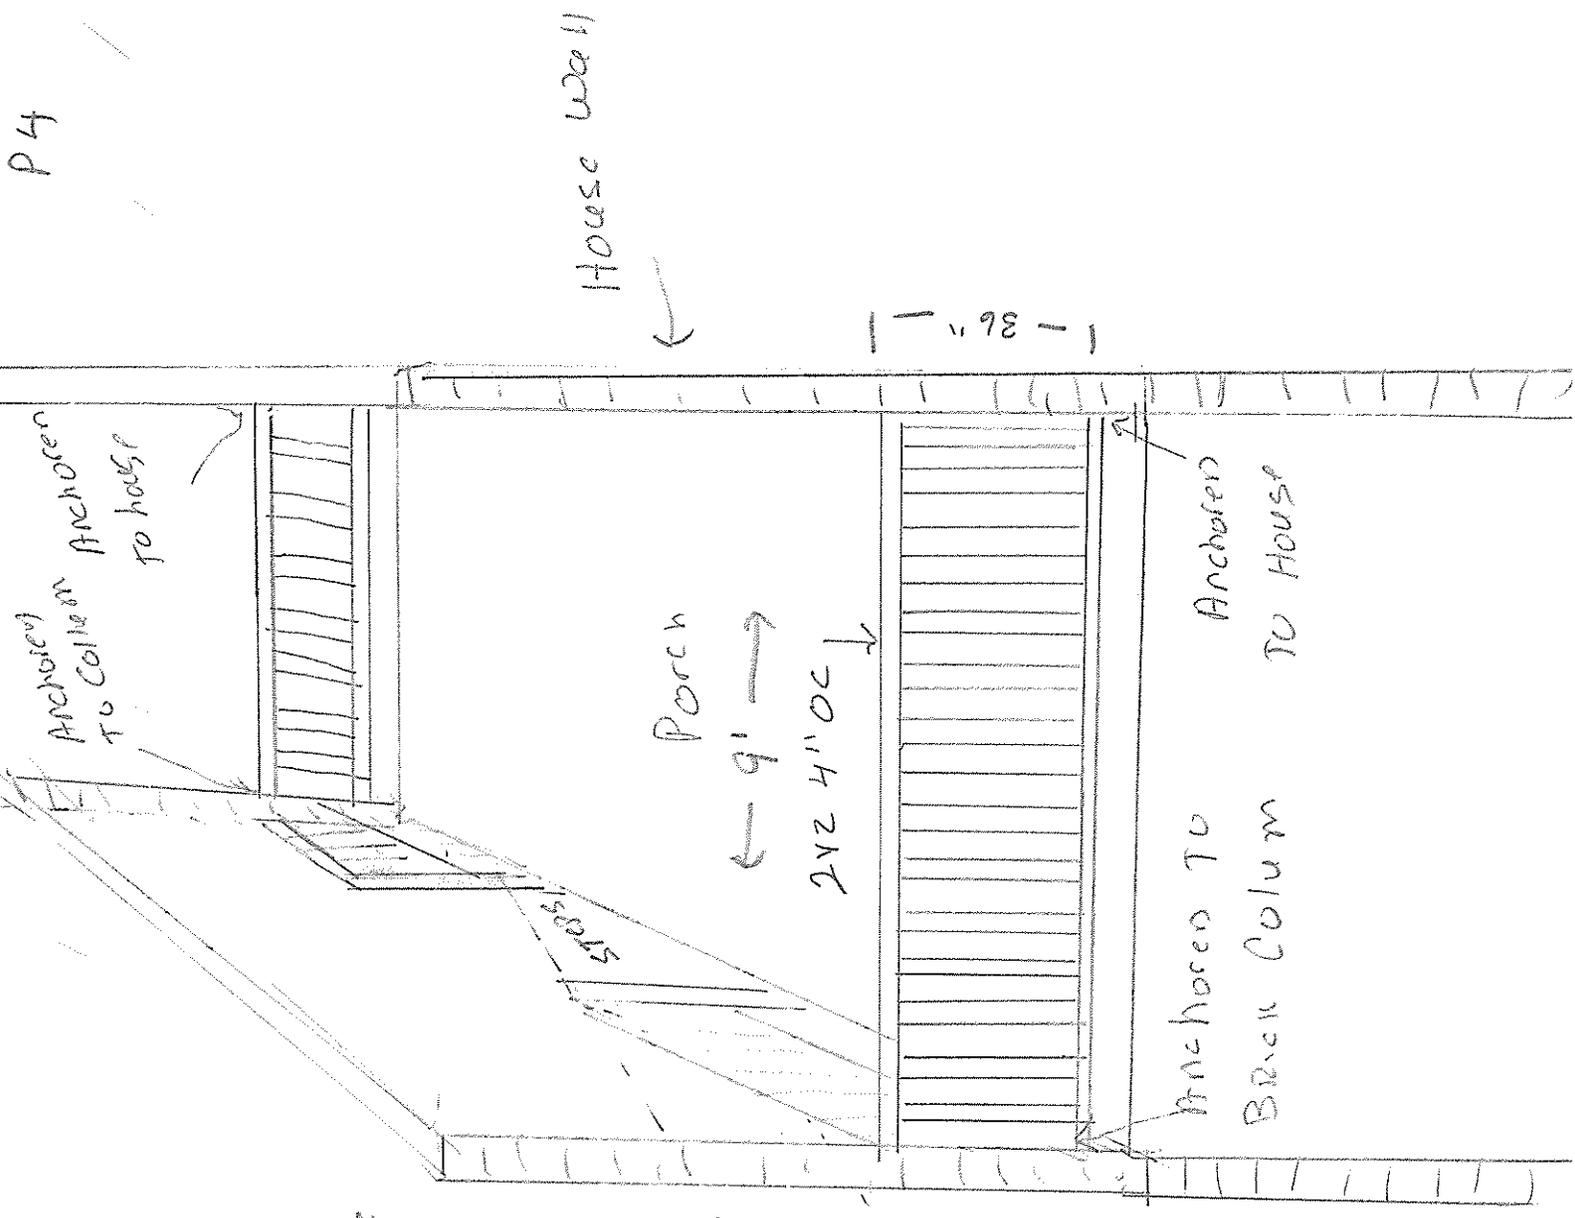
- All Rails & Spindles Painted White
- Rails Attached to Brick with 1/4 x 3" Simpson Straps
- The Zinc plated Sleeve Anchors
- Post Attached to Straps with 1/2 x 2" Simpson Straps
- The Zinc plated Wedge Anchors
- Post will be Attached to Porch-Surface with Simpson Strong-Tie ABA Zmax Galvanized Post Base
- Finish height 36"
- Spindel Spacing 4" O.C.

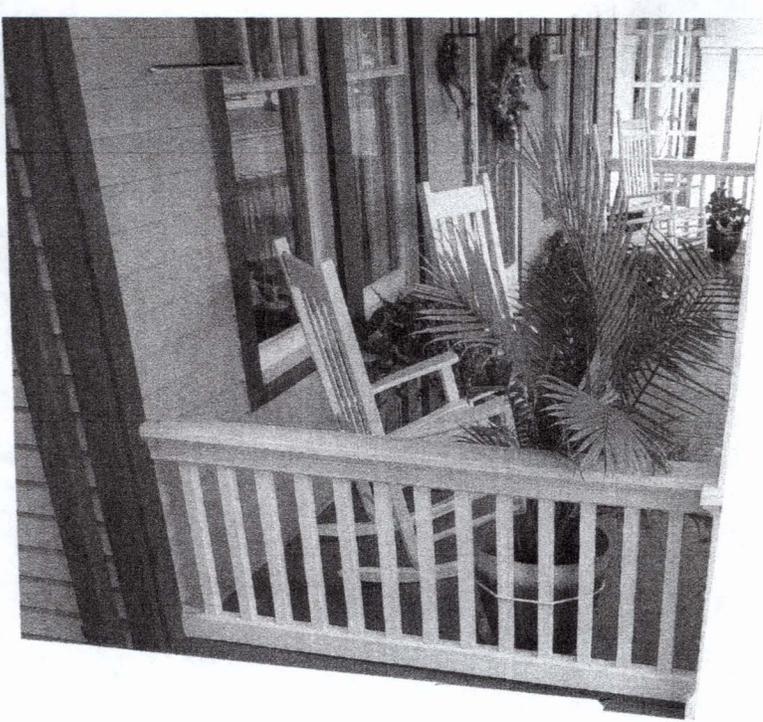
TYPICAL Section Detail

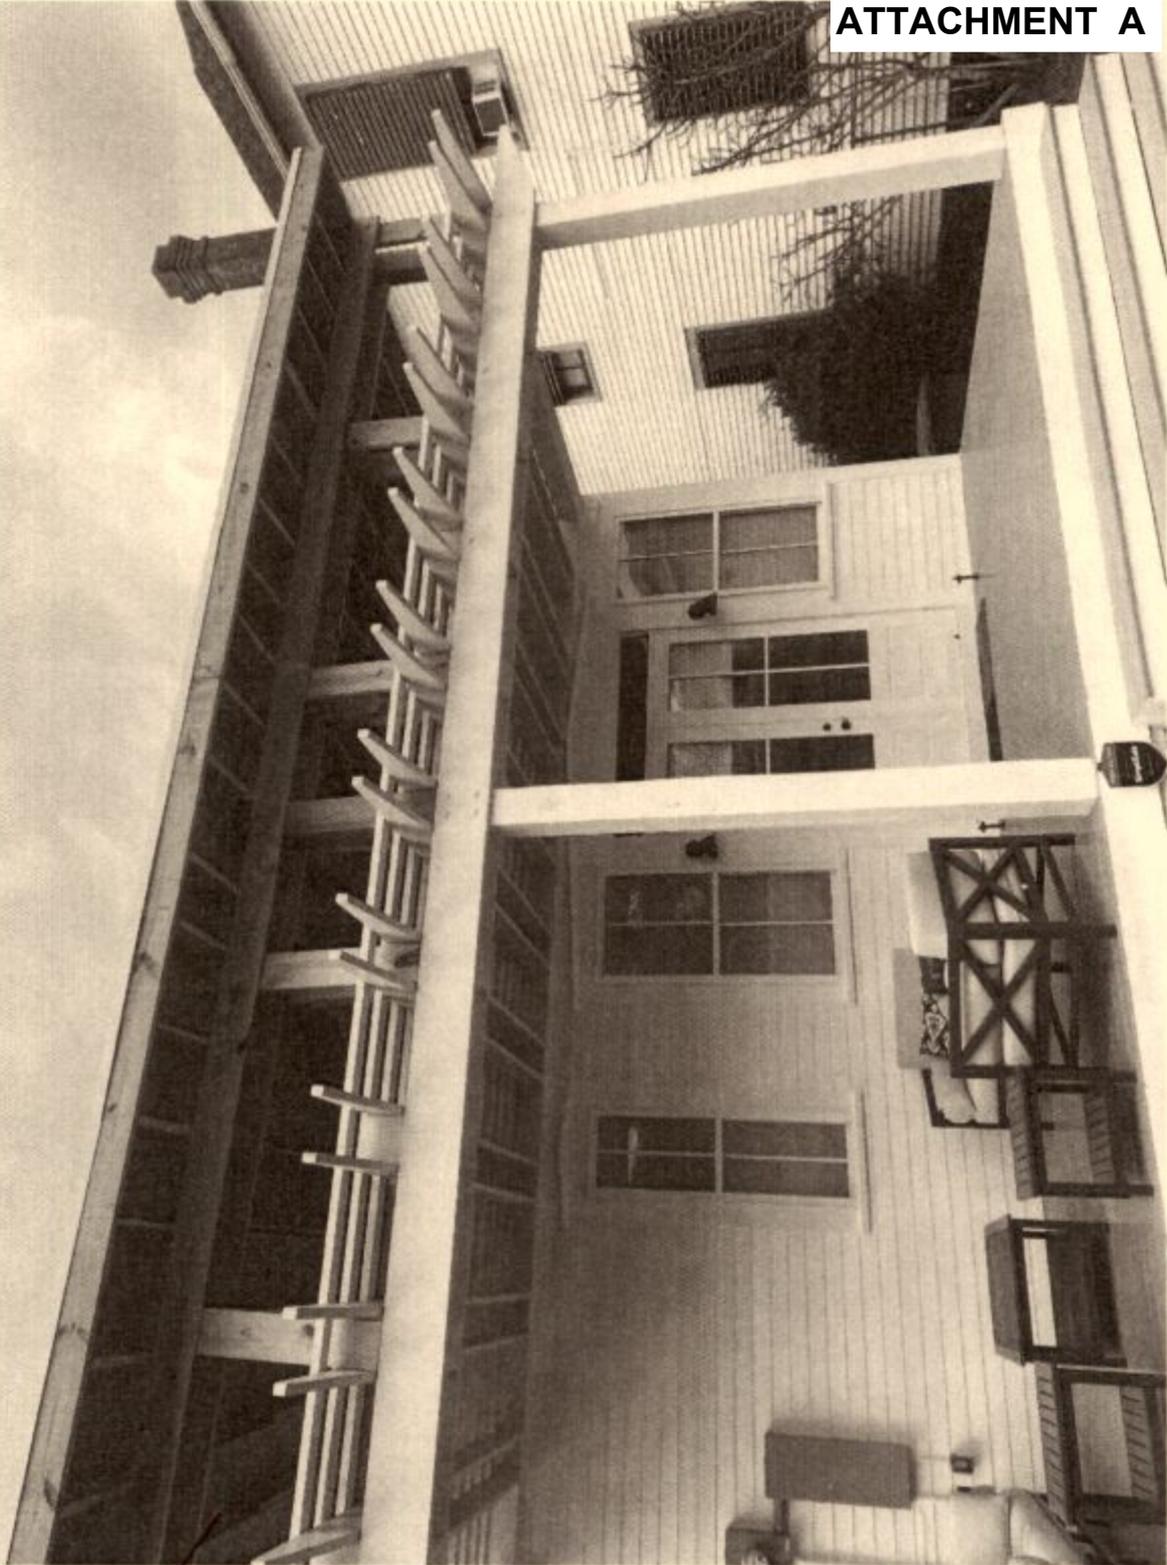
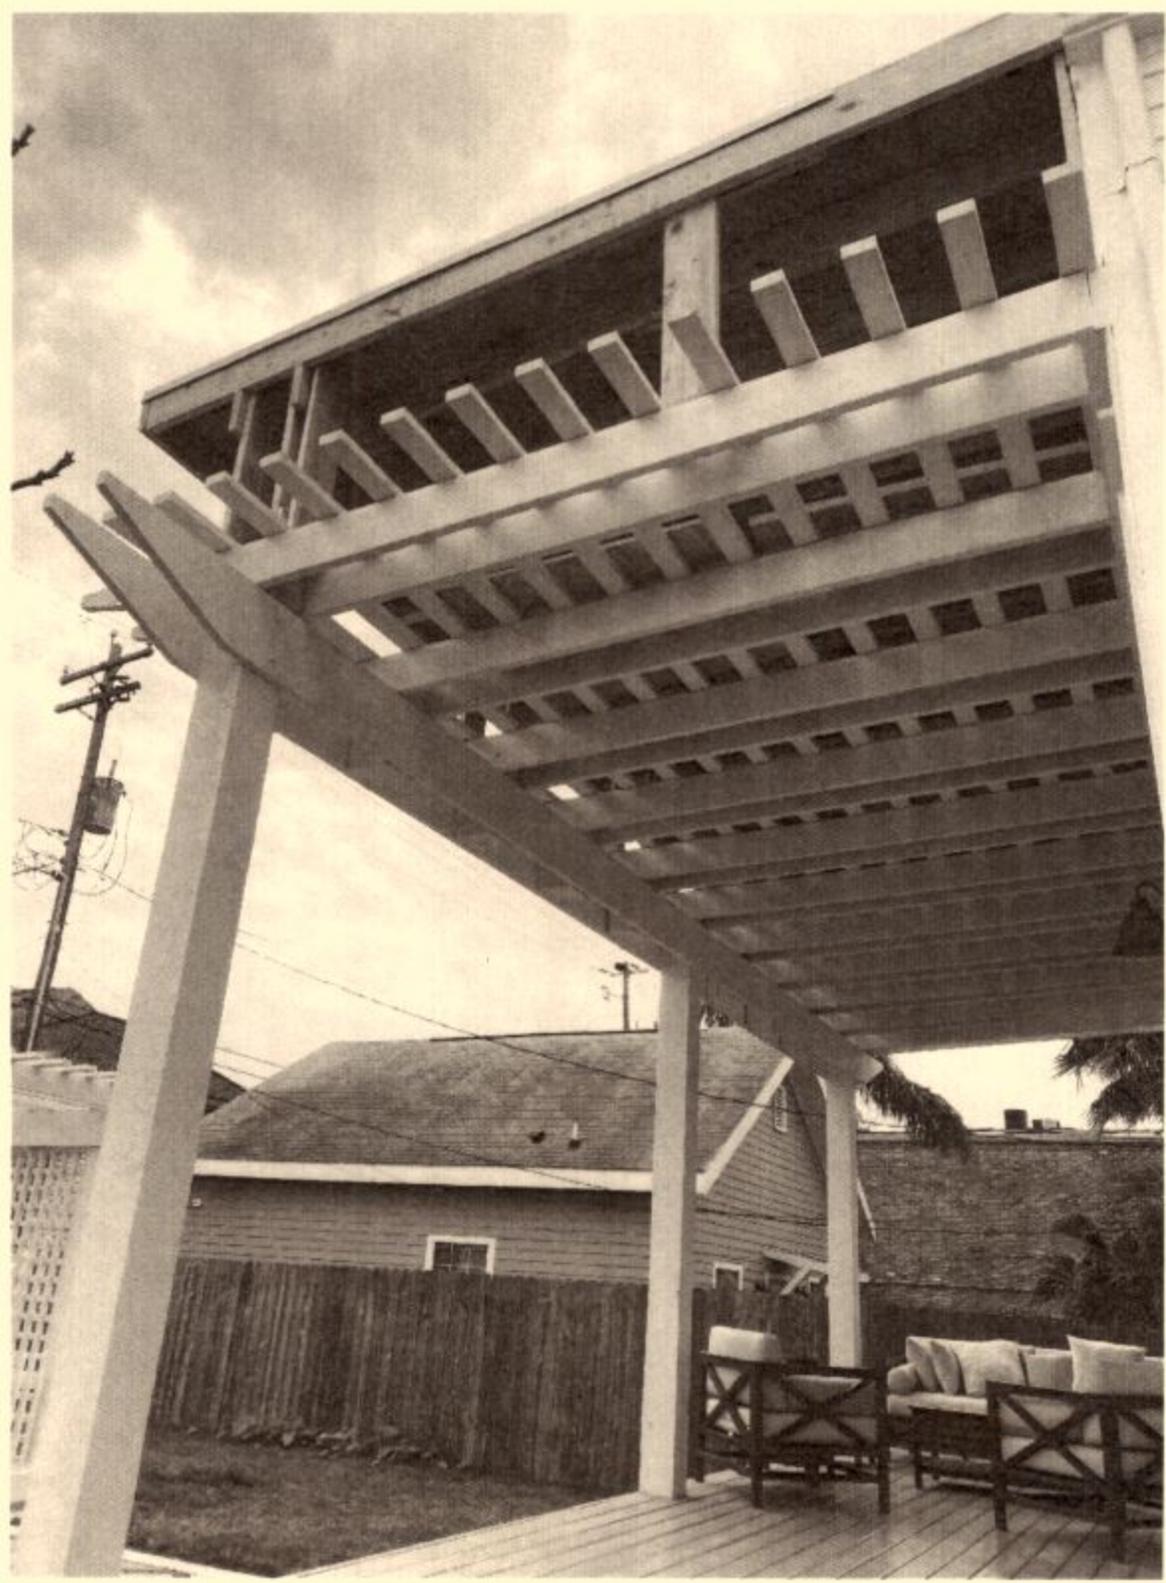
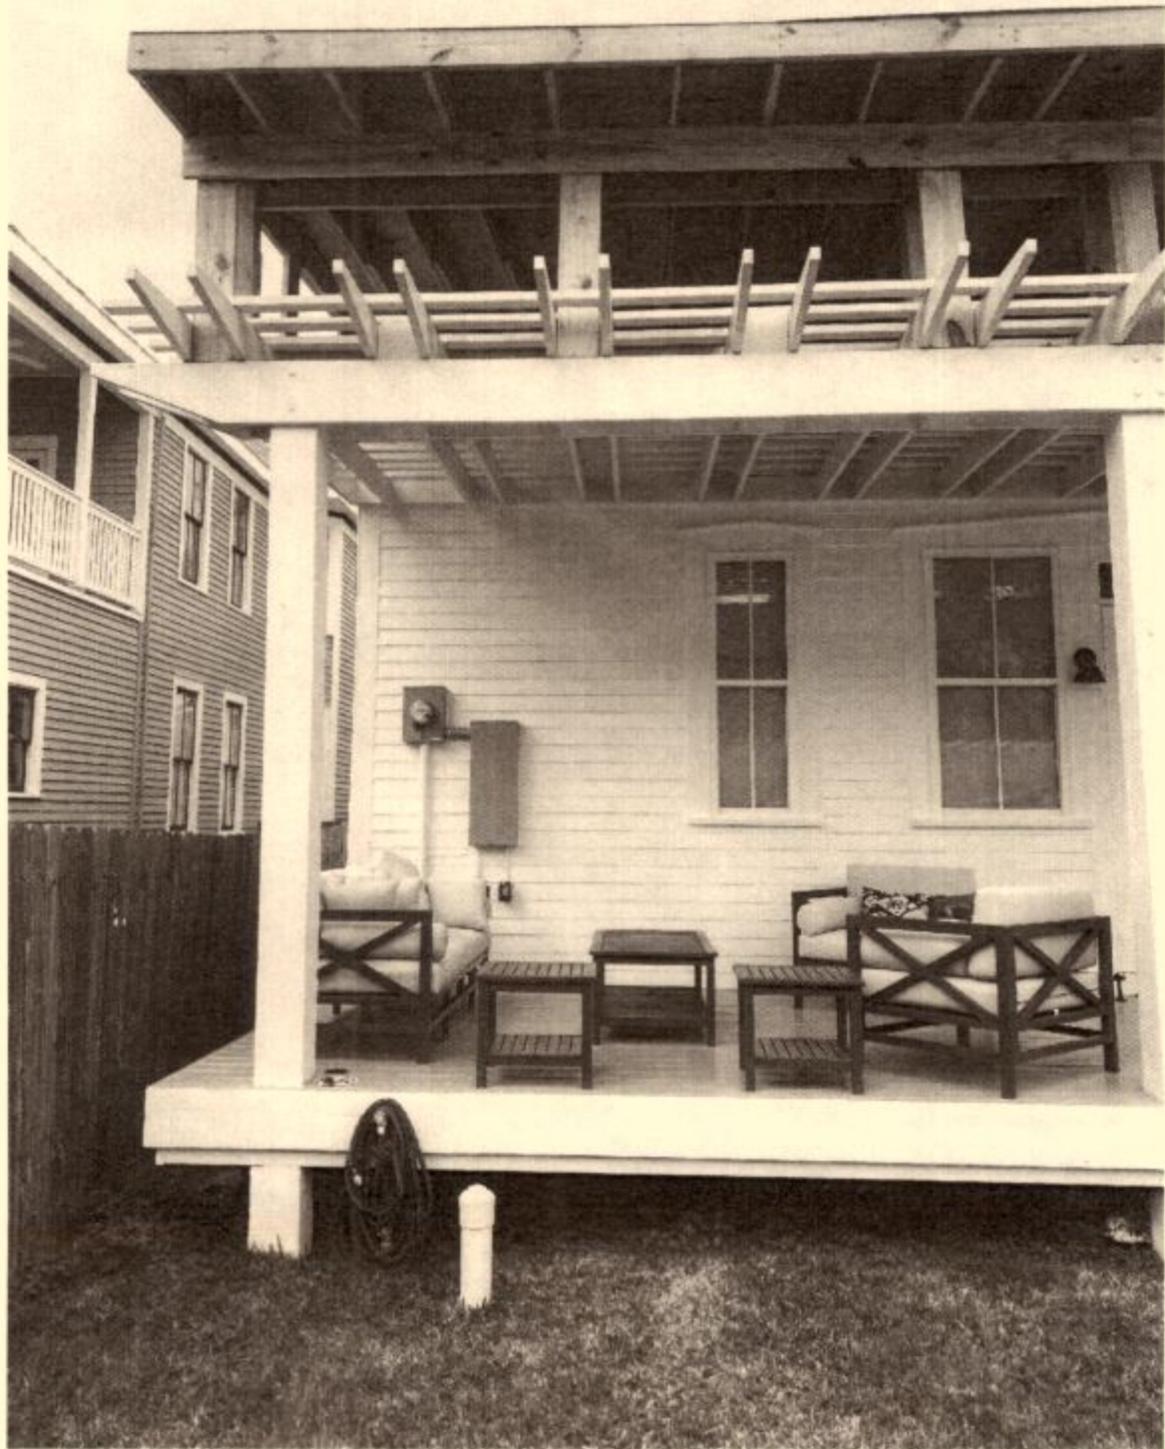
The applicant is requesting a Certificate of Appropriateness to modify the rear roof in order to improve runoff. The previously installed rear roof was not sloped sufficiently, creating a valley, which retained water at the junction of the roof and the rear wall of the house. Increasing the roof pitch solved the problem; however, this work was done without permit or Landmark Commission review. Photos of the roof and water damage are included in Attachment A of the staff report.

Staff finds that the request generally conforms to the Design Standards. The modified roof is located in Location D: Not Typically Visible Rear Façade. More flexibility in treatment may be considered, especially for compatible replacement or alteration that is not visible from the street. The previously existing roof was also a shed-type design with a shallow slope, which the current design mimics. The new roof also overframes and encloses an existing rear pergola; this structure is a much later addition and not historic. Sanborn insurance maps included in Attachment C indicate that the current rear addition was added sometime after 1947, and is not original to the house.

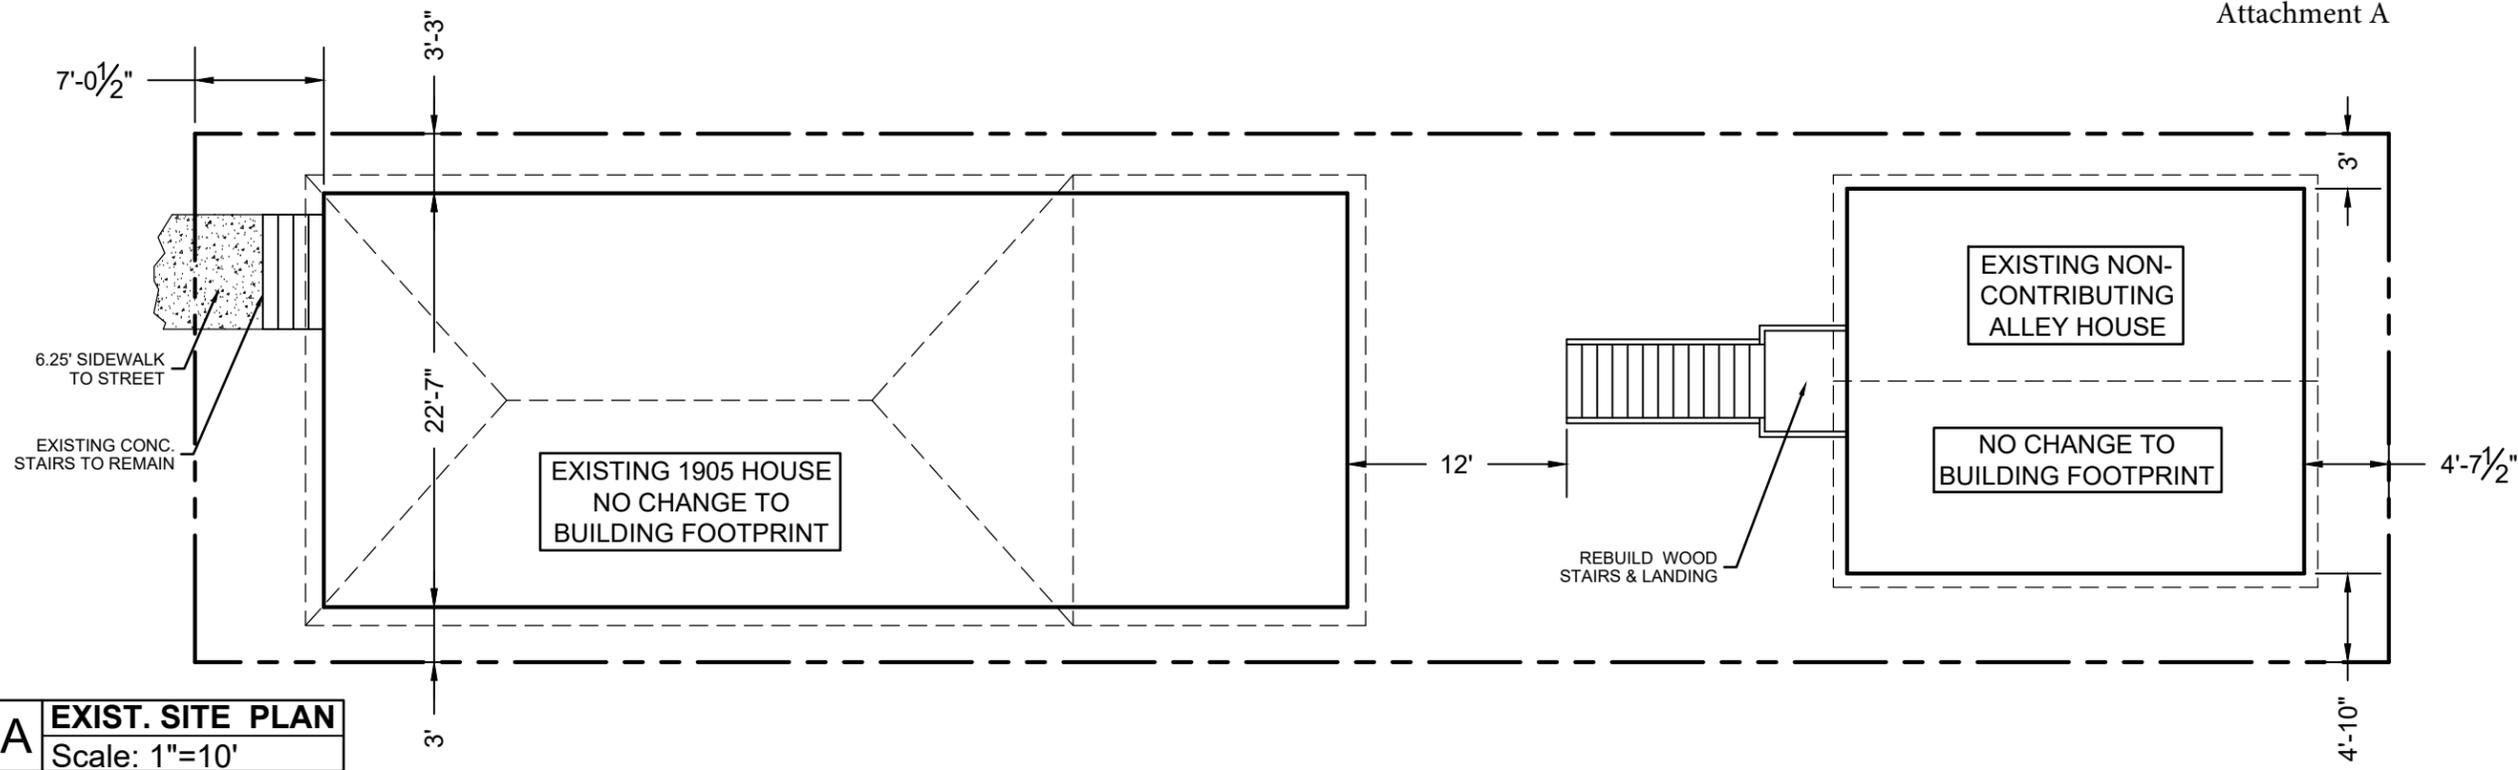
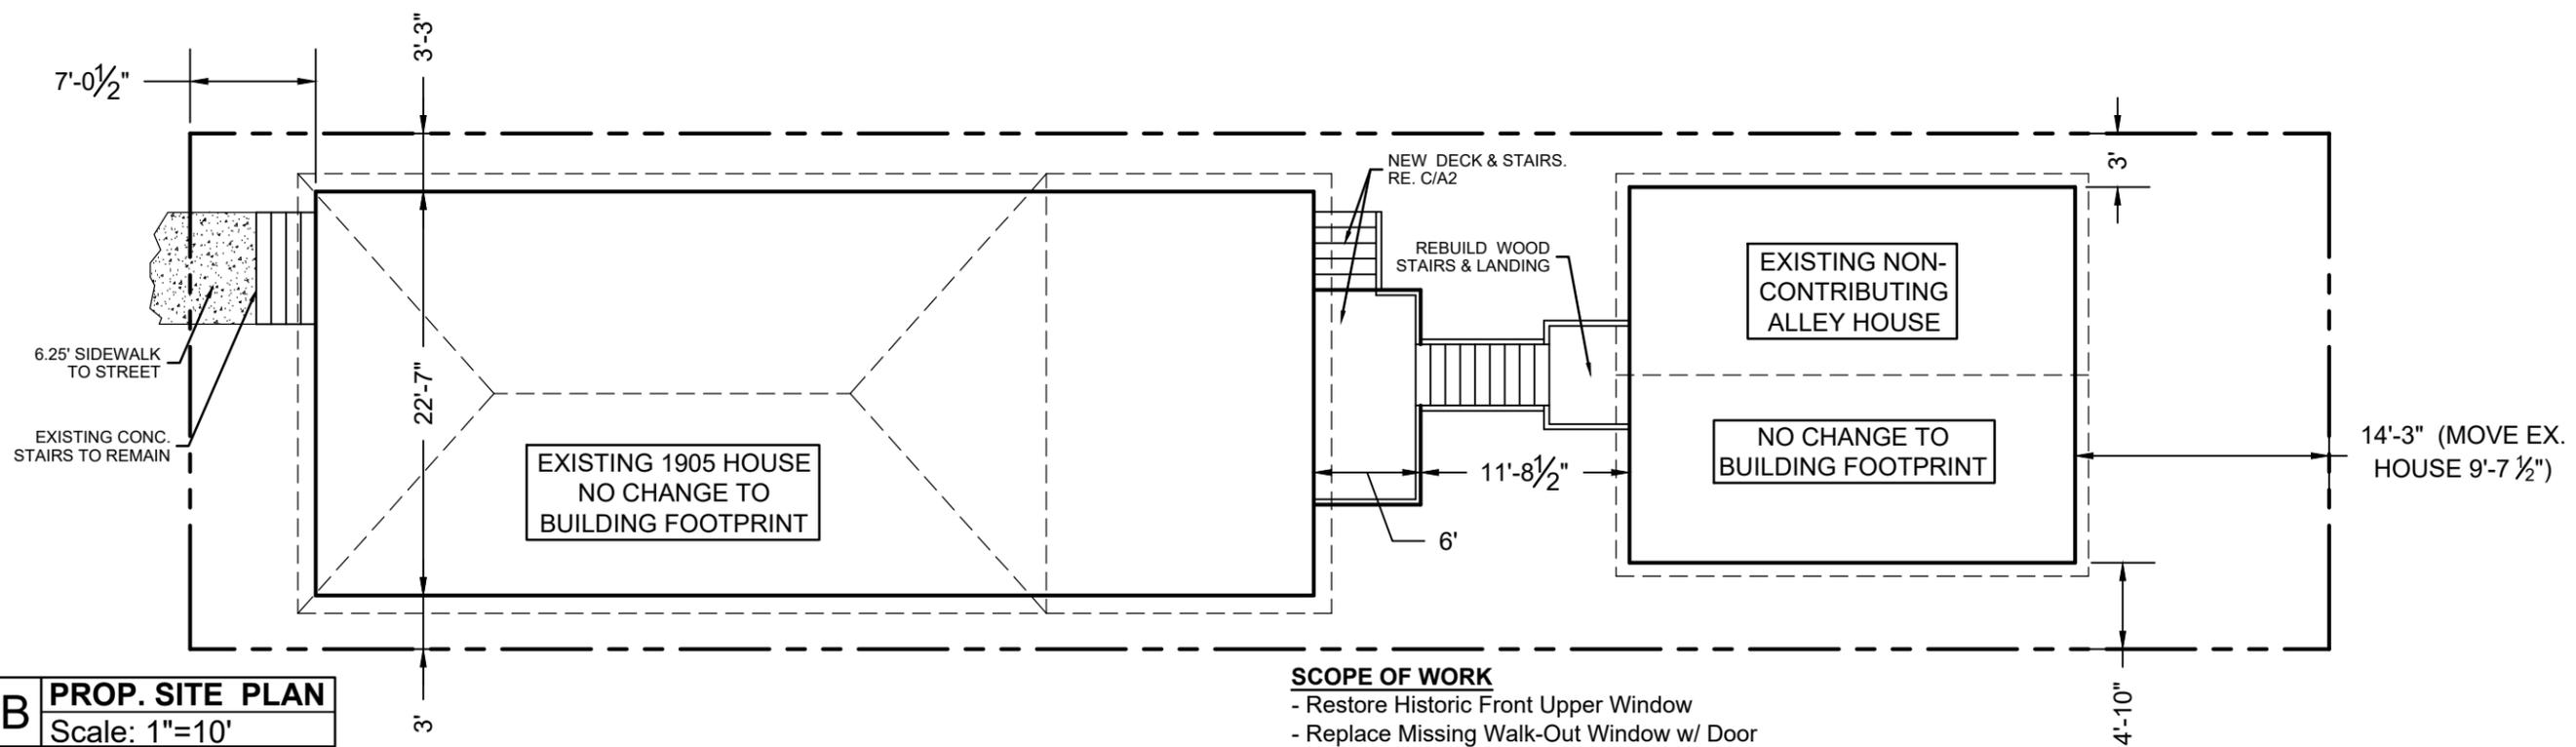
Situs Address: 1021 Avenue I (Sealy) Galveston 77550
 Legal Description: Abstract 628 M.B. Menard Survey East 28'-10" of Lot 2 (2-1) Block 190 PID 101560
 Zoning: Residential Single Family (R-3) East End Historic District, Contributing (Medium)

- A1 Existing Site Plan
Proposed Site Plan
Code Review
- A2 Existing Front Elevation
Proposed Front Elevation

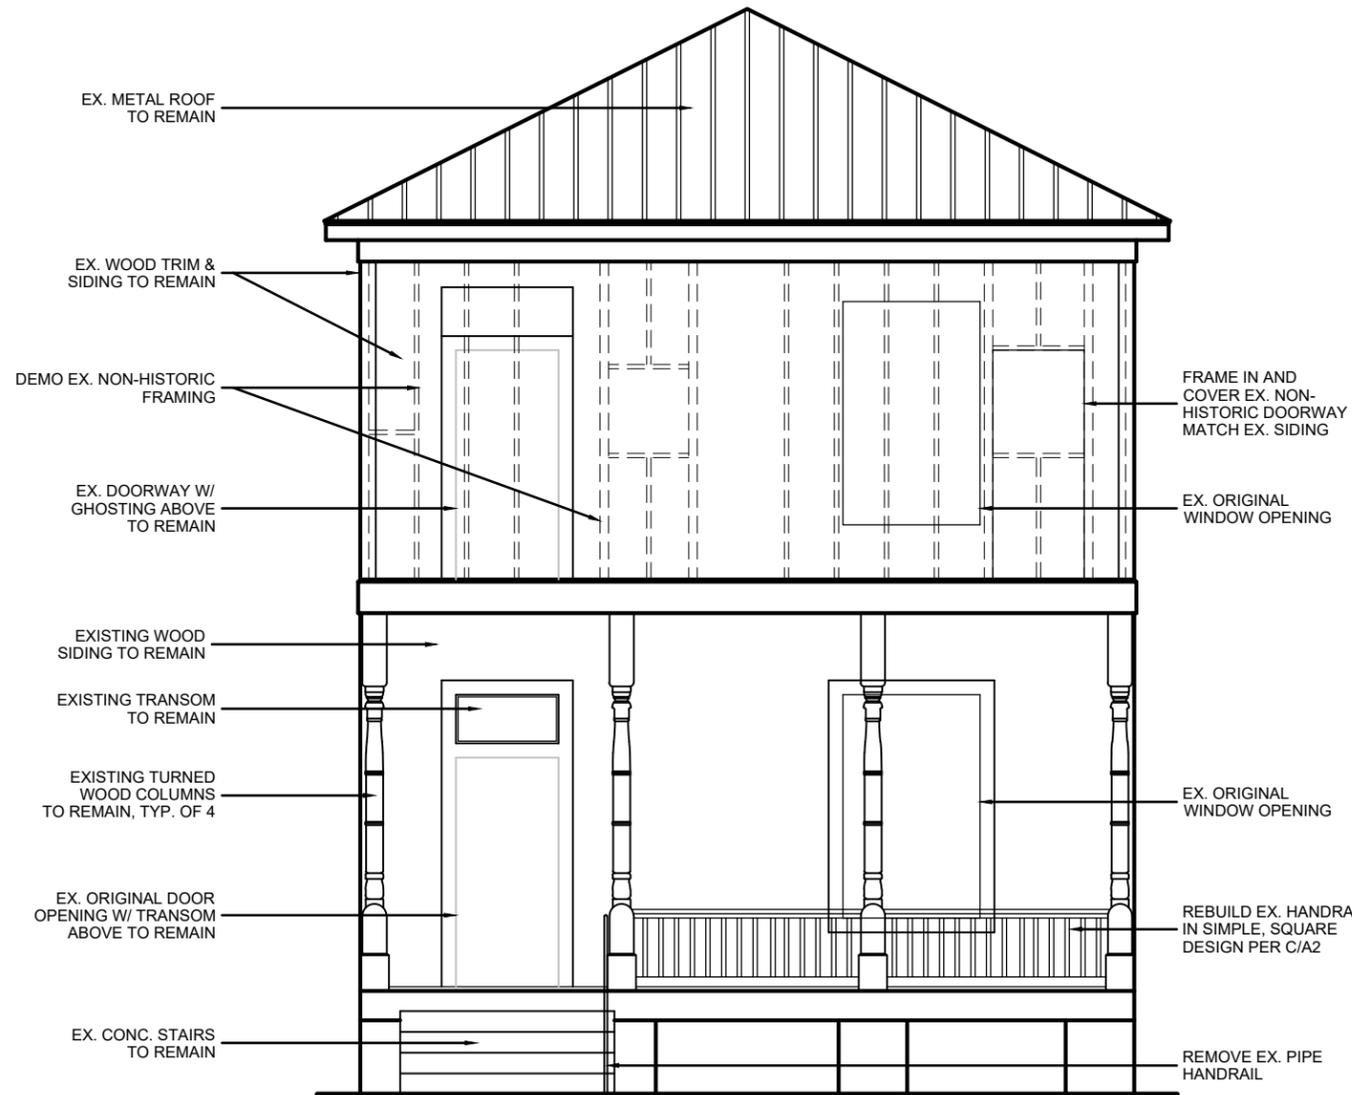
A EX. FRONT ELEVATION
Scale: 3/16" = 1'-0"

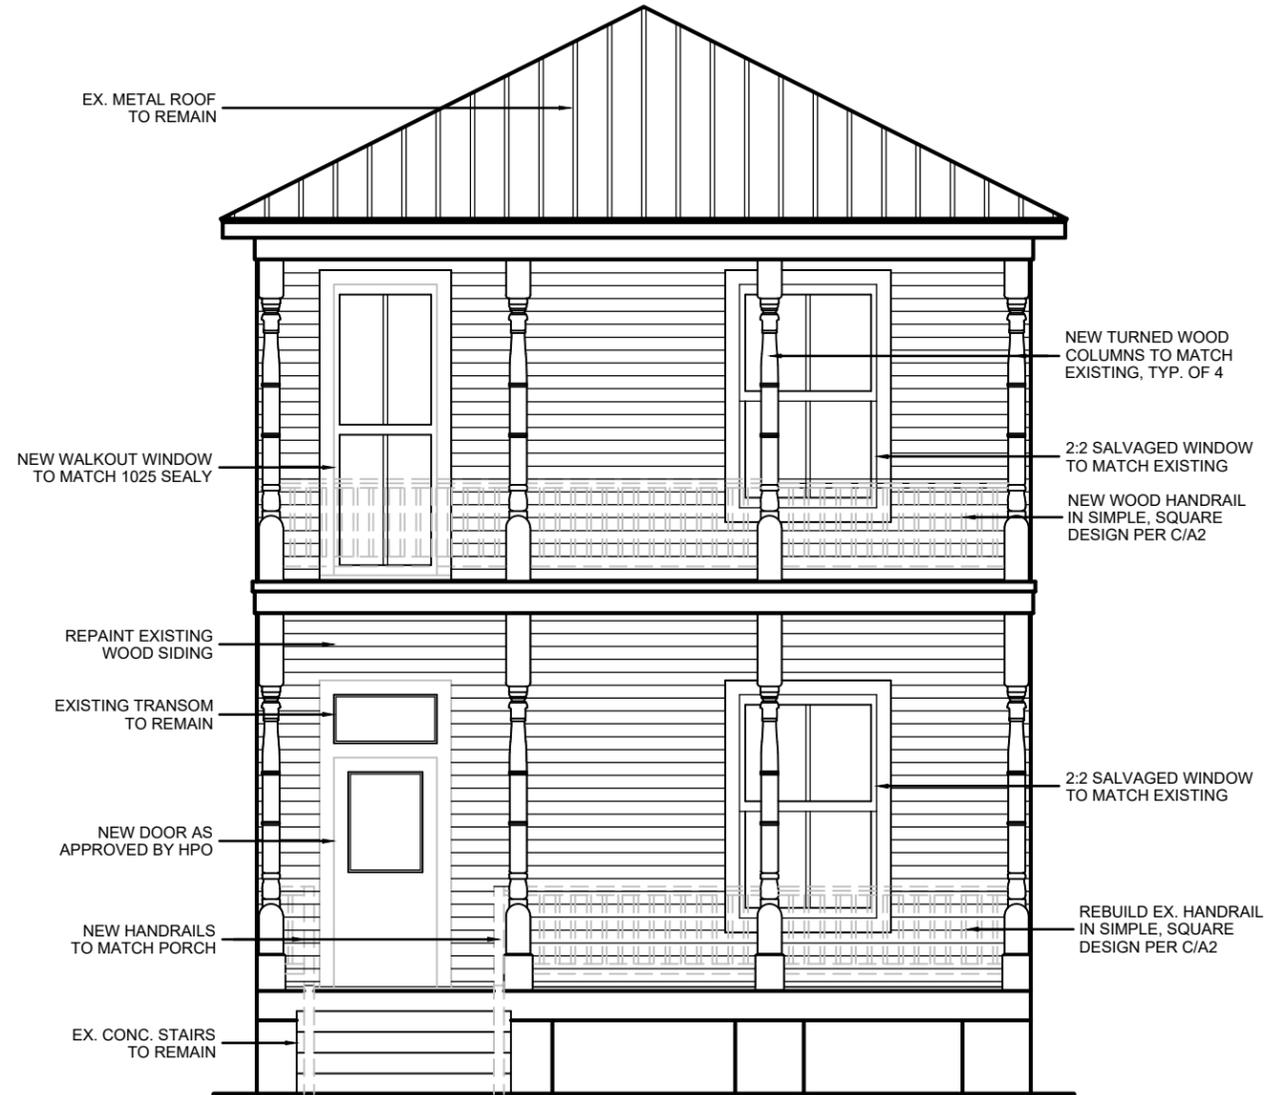
B PROP. FRONT ELEVATION
Scale: 3/16" = 1'-0"

- Restore Historic Front Upper Window
- Replace Missing Walk-Out Window w/ Door
- Replace Missing Upper Window with Salvaged Wood Window w/ 2-Over-2 Configuration and True Divided Lights and Muntins
- Replace Non-Historic Front Door
- Rebuild Existing Historic Windows on North, East, and West Facades
- Replace Upper and Lower Porch Columns, Handrails, and Decorative Scrollwork to Match that of "Sister" Houses at 1025 and 1027 Sealy (Re: Sheet A2)
- Rebuild Existing Stairs at Ex. Rear House
- Add New Deck at Rear of Front House
- Move Ex. Rear House 10' to North
