AGENDA
LANDMARK COMMISSION
REGULAR MEETING
4:00 p.m. Monday, March 16, 2020
City Council Chambers, 2nd Floor of City Hall
823 Rosenberg, Galveston, Texas

MINUTES OF THE LANDMARK COMMISSION OF THE CITY OF GALVESTON REGULAR MEETING – March 2, 2020

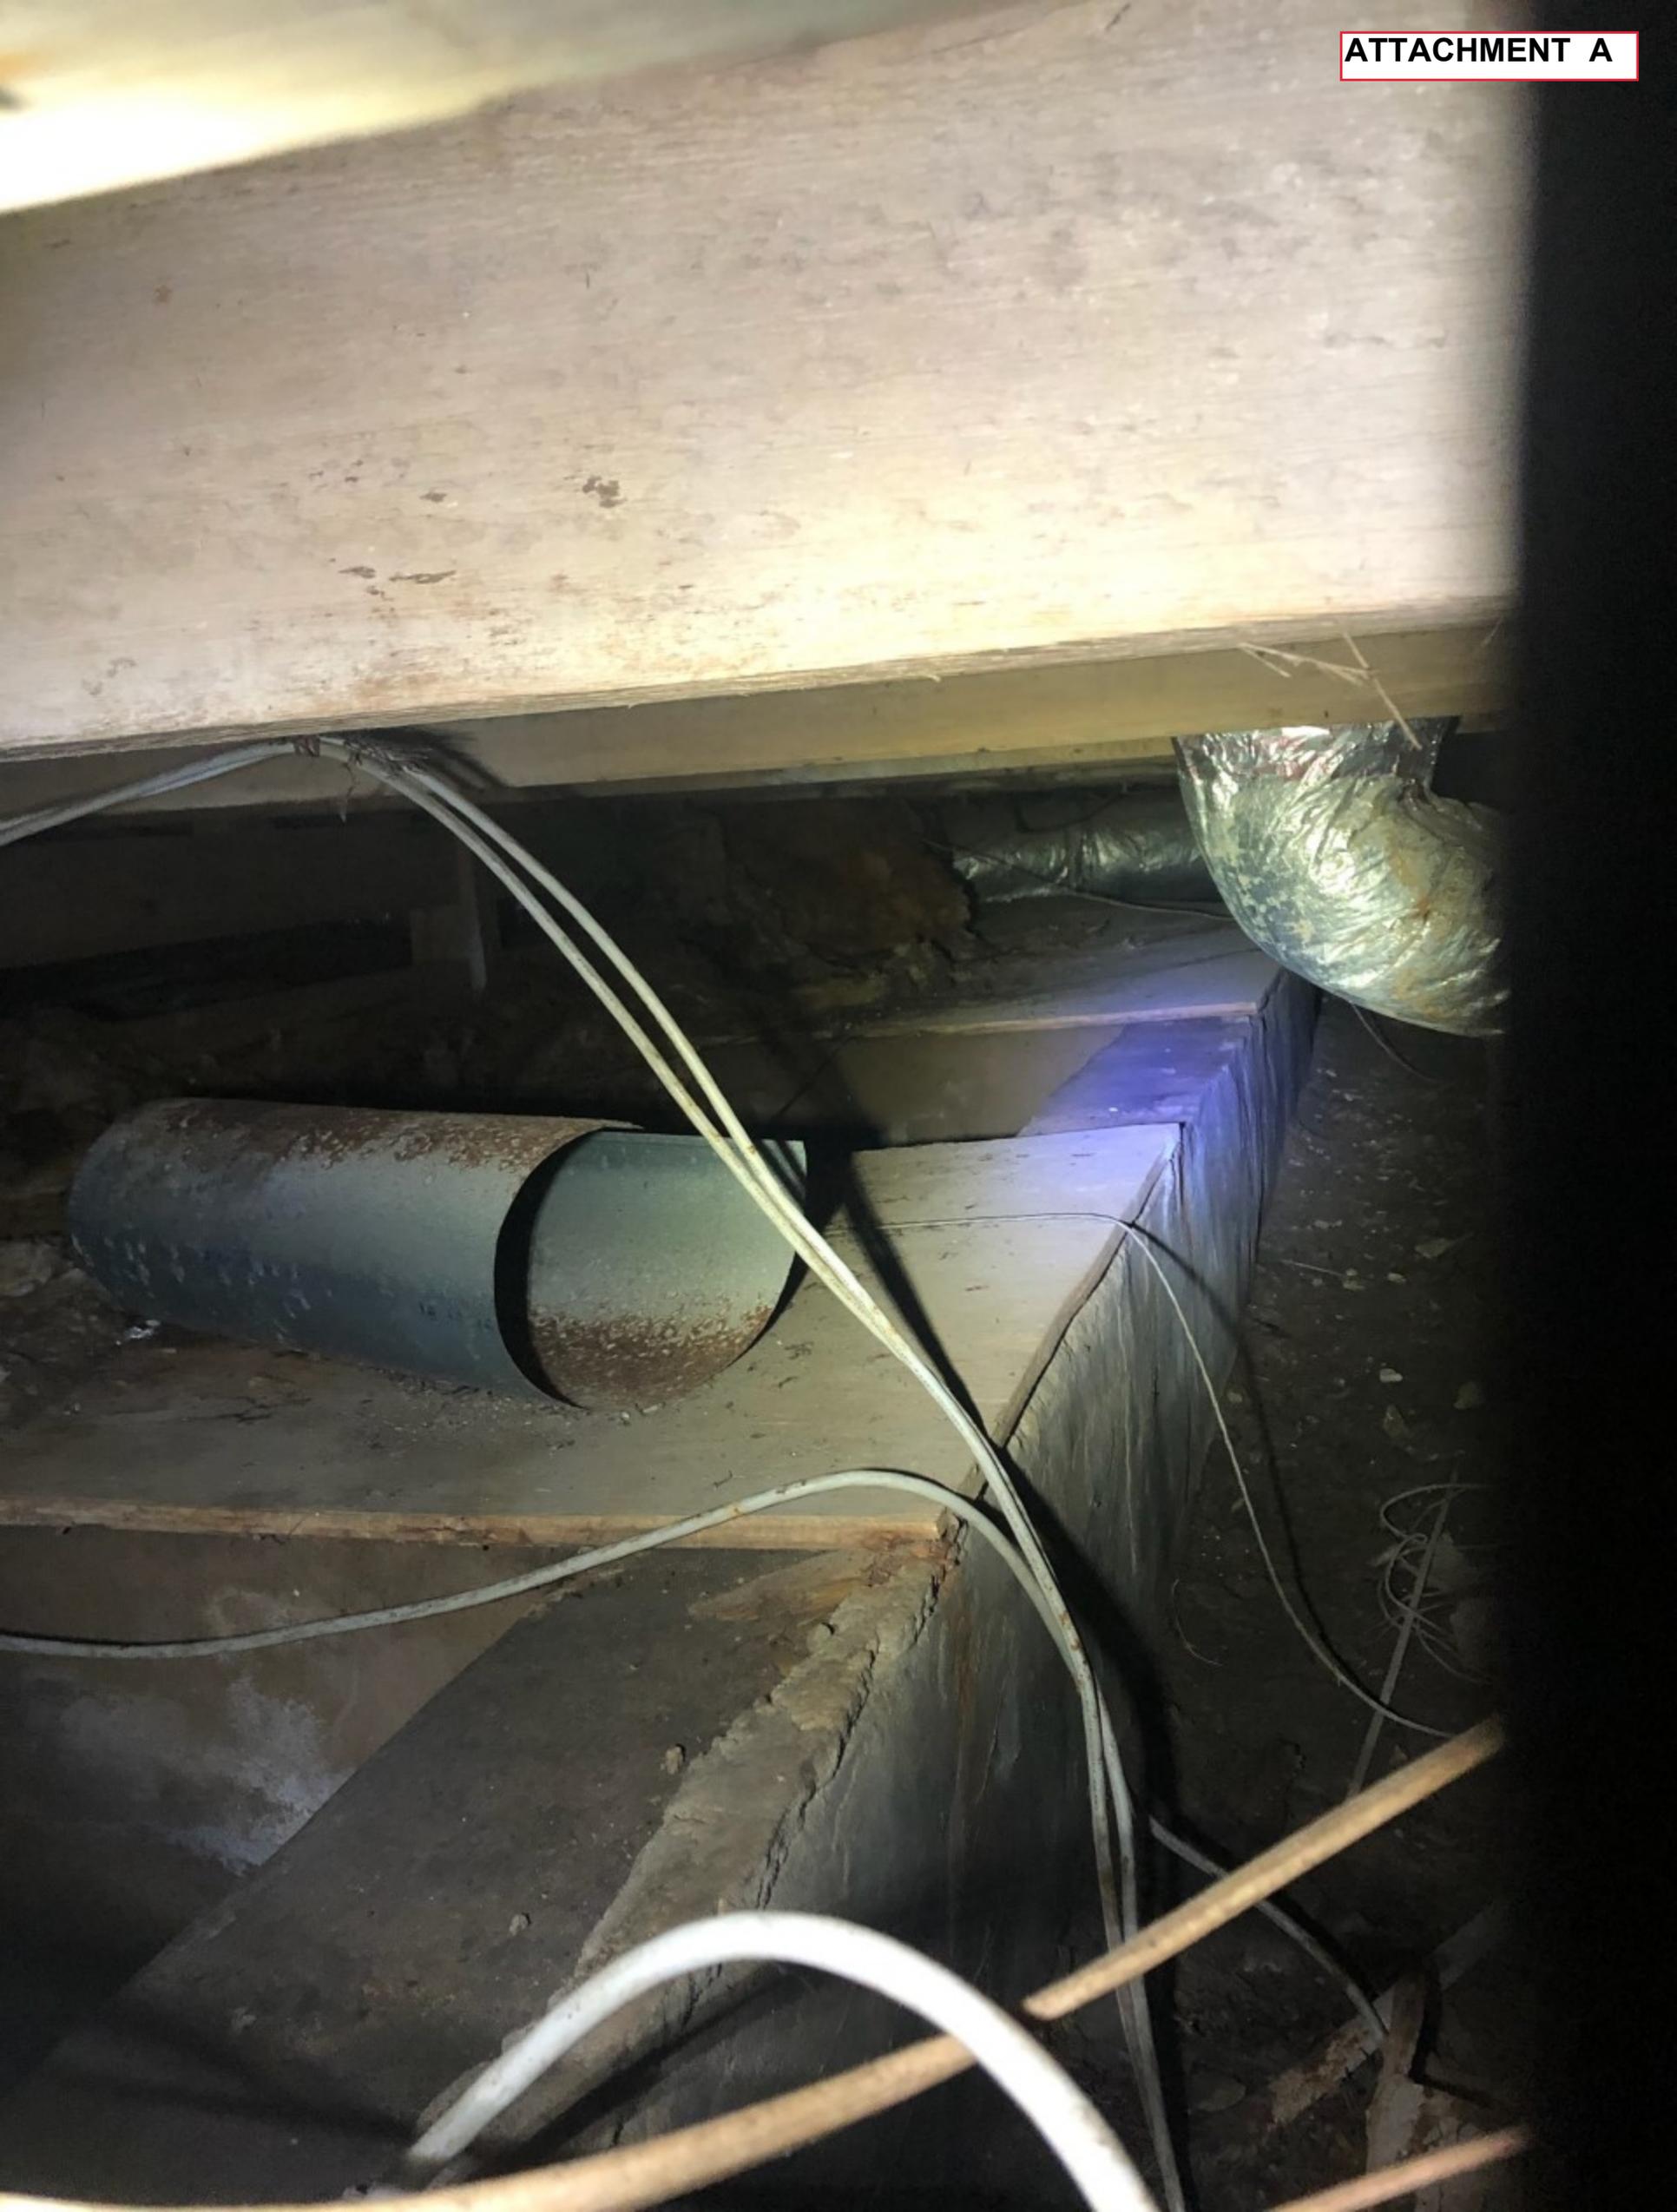
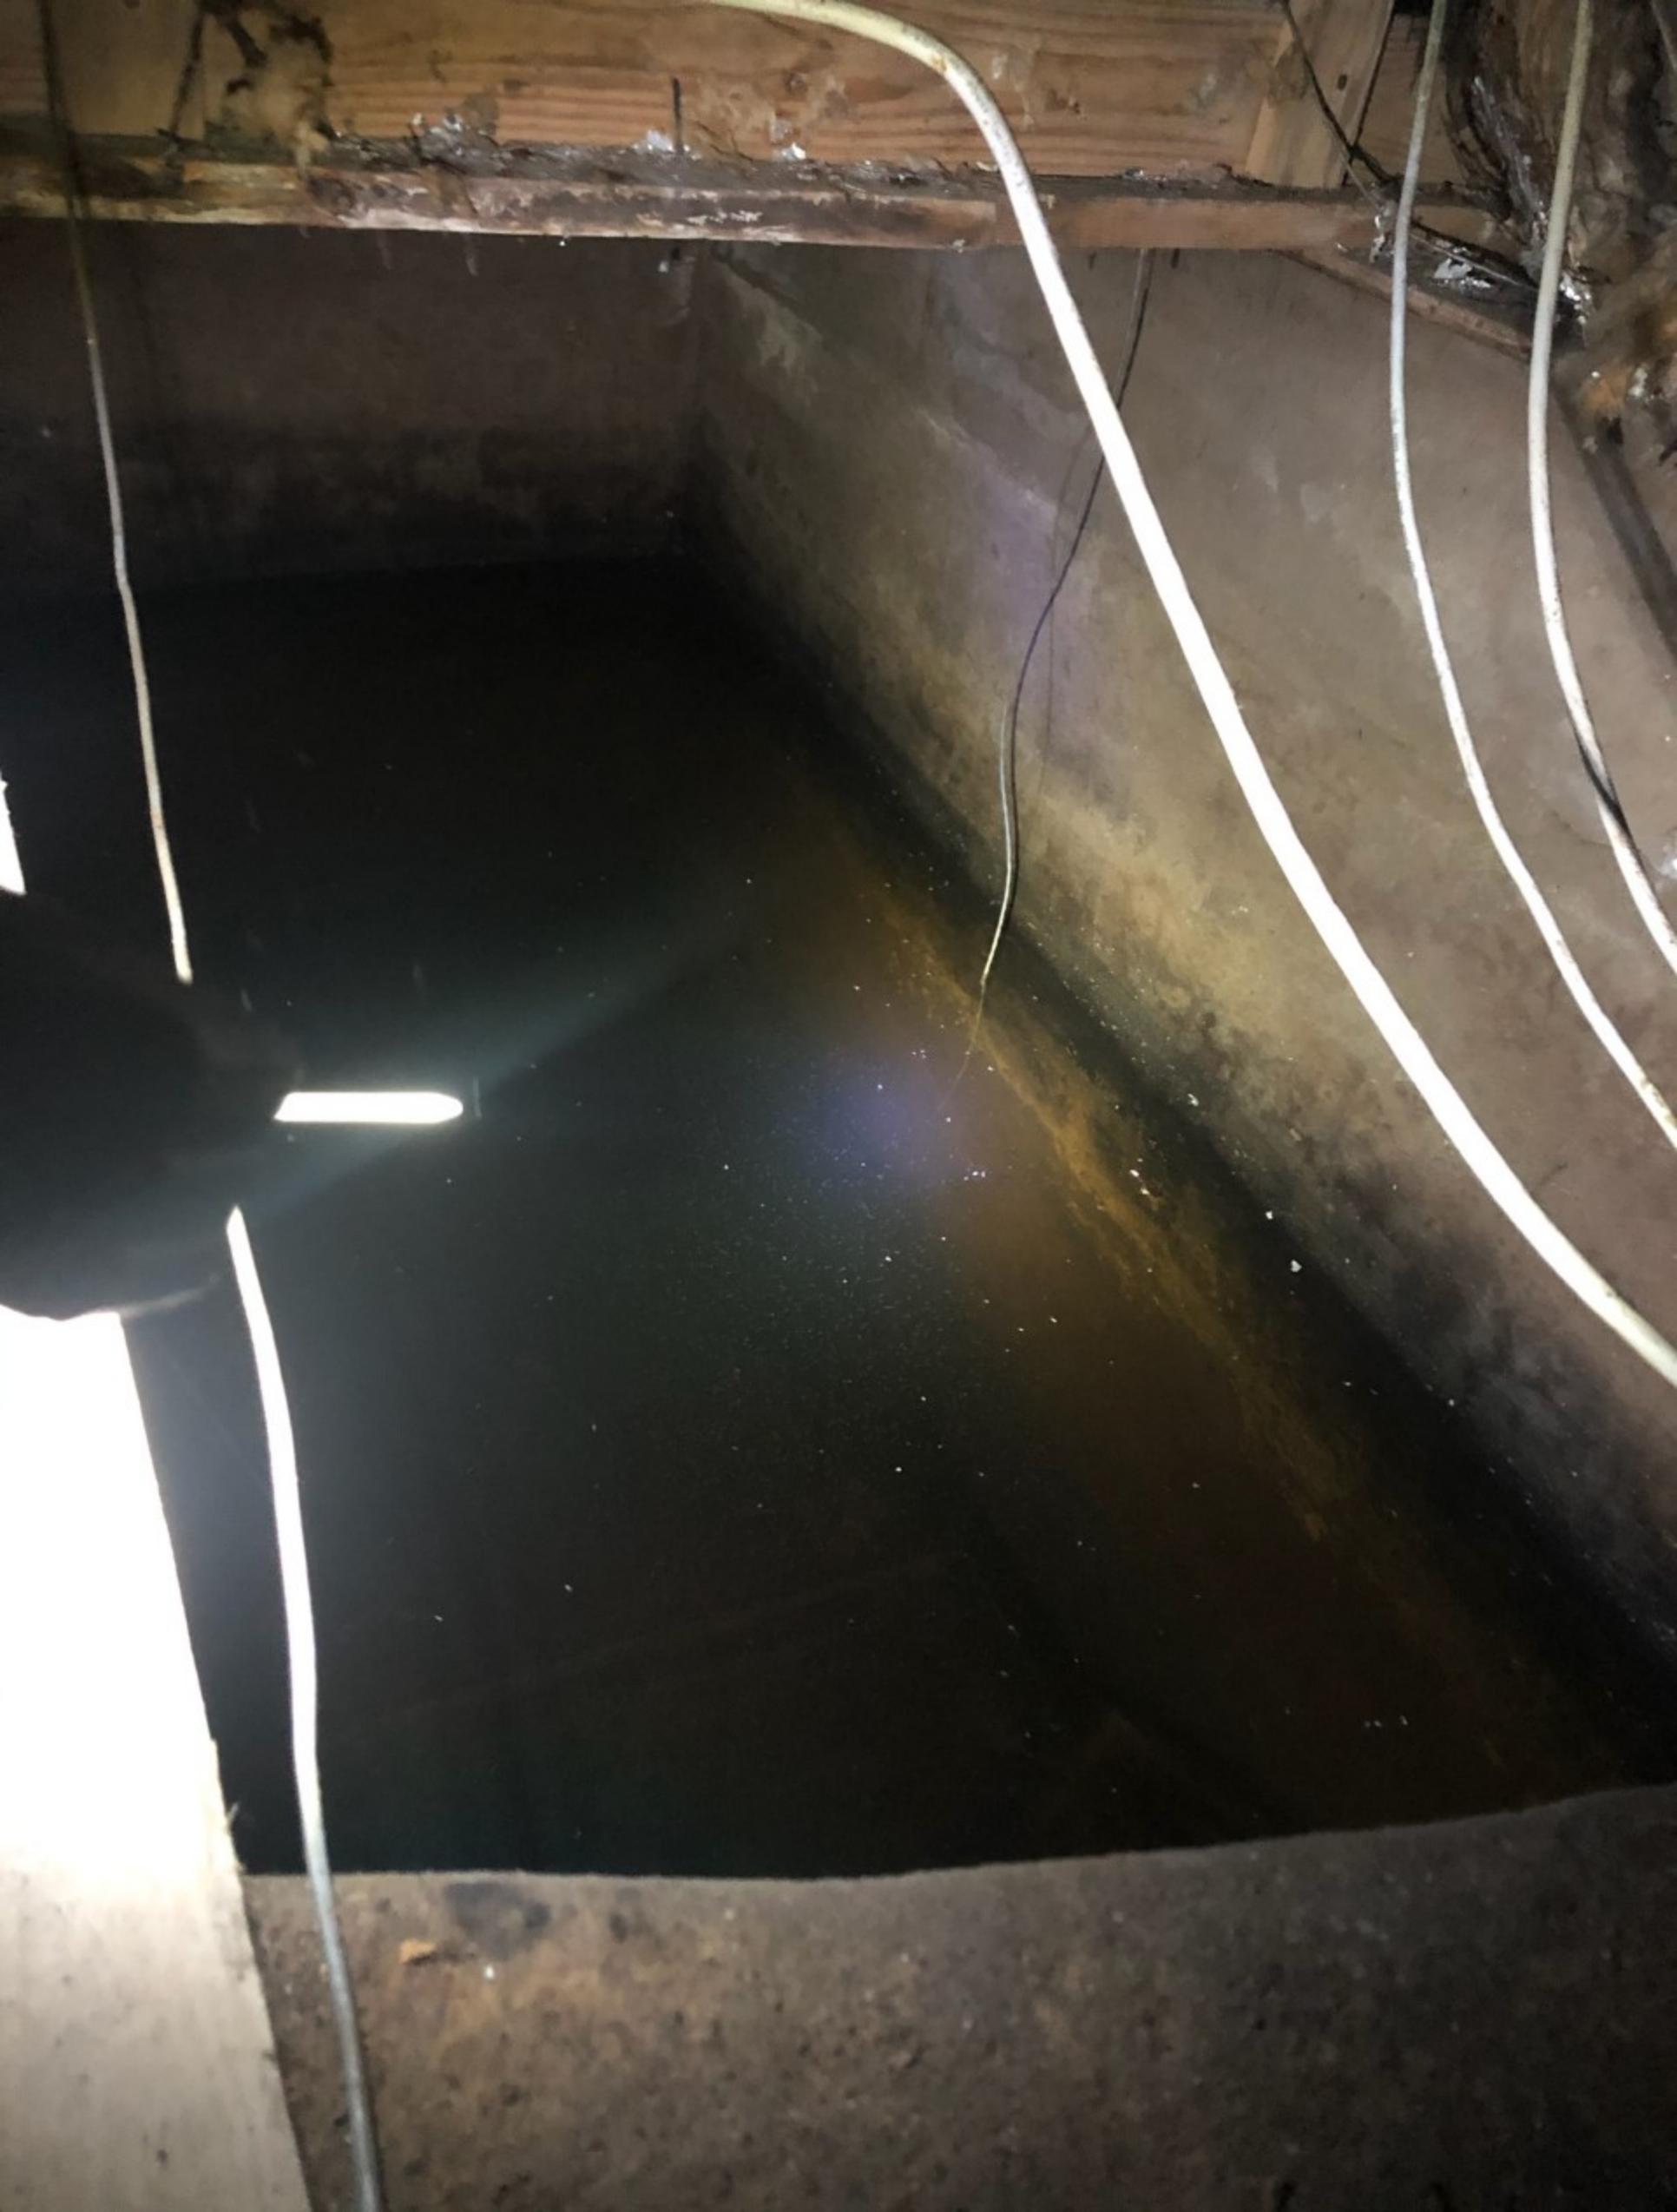
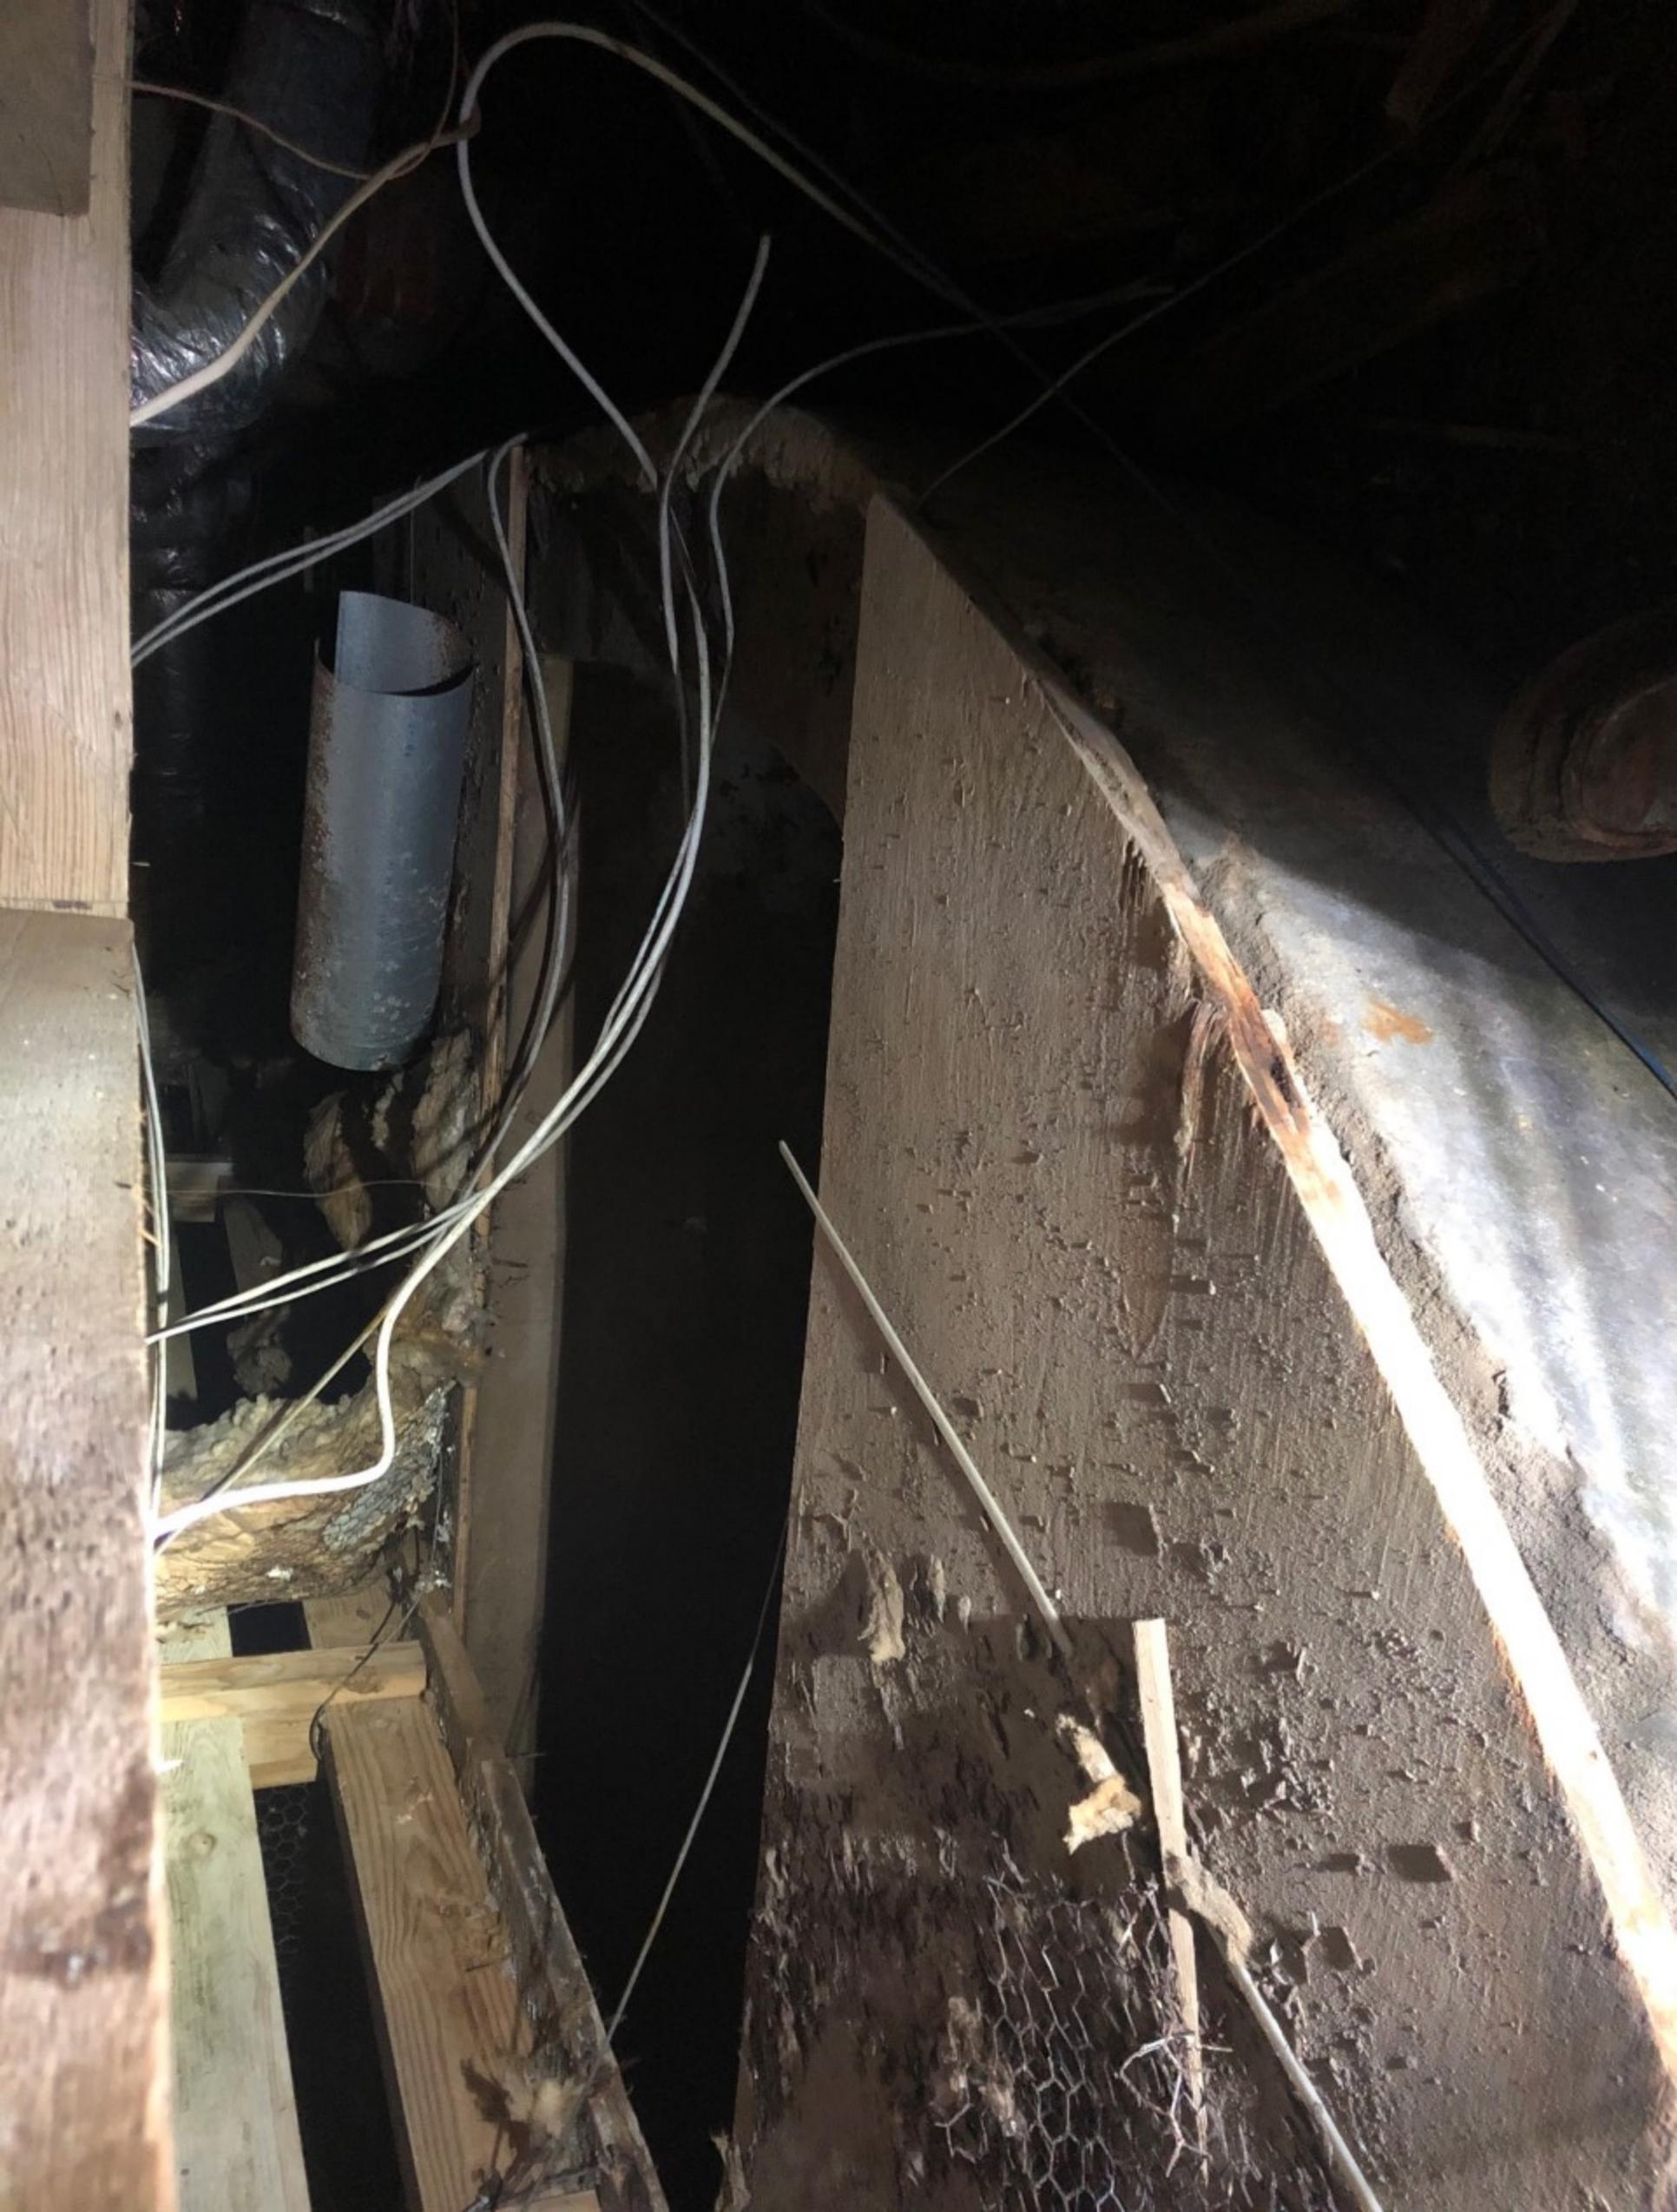
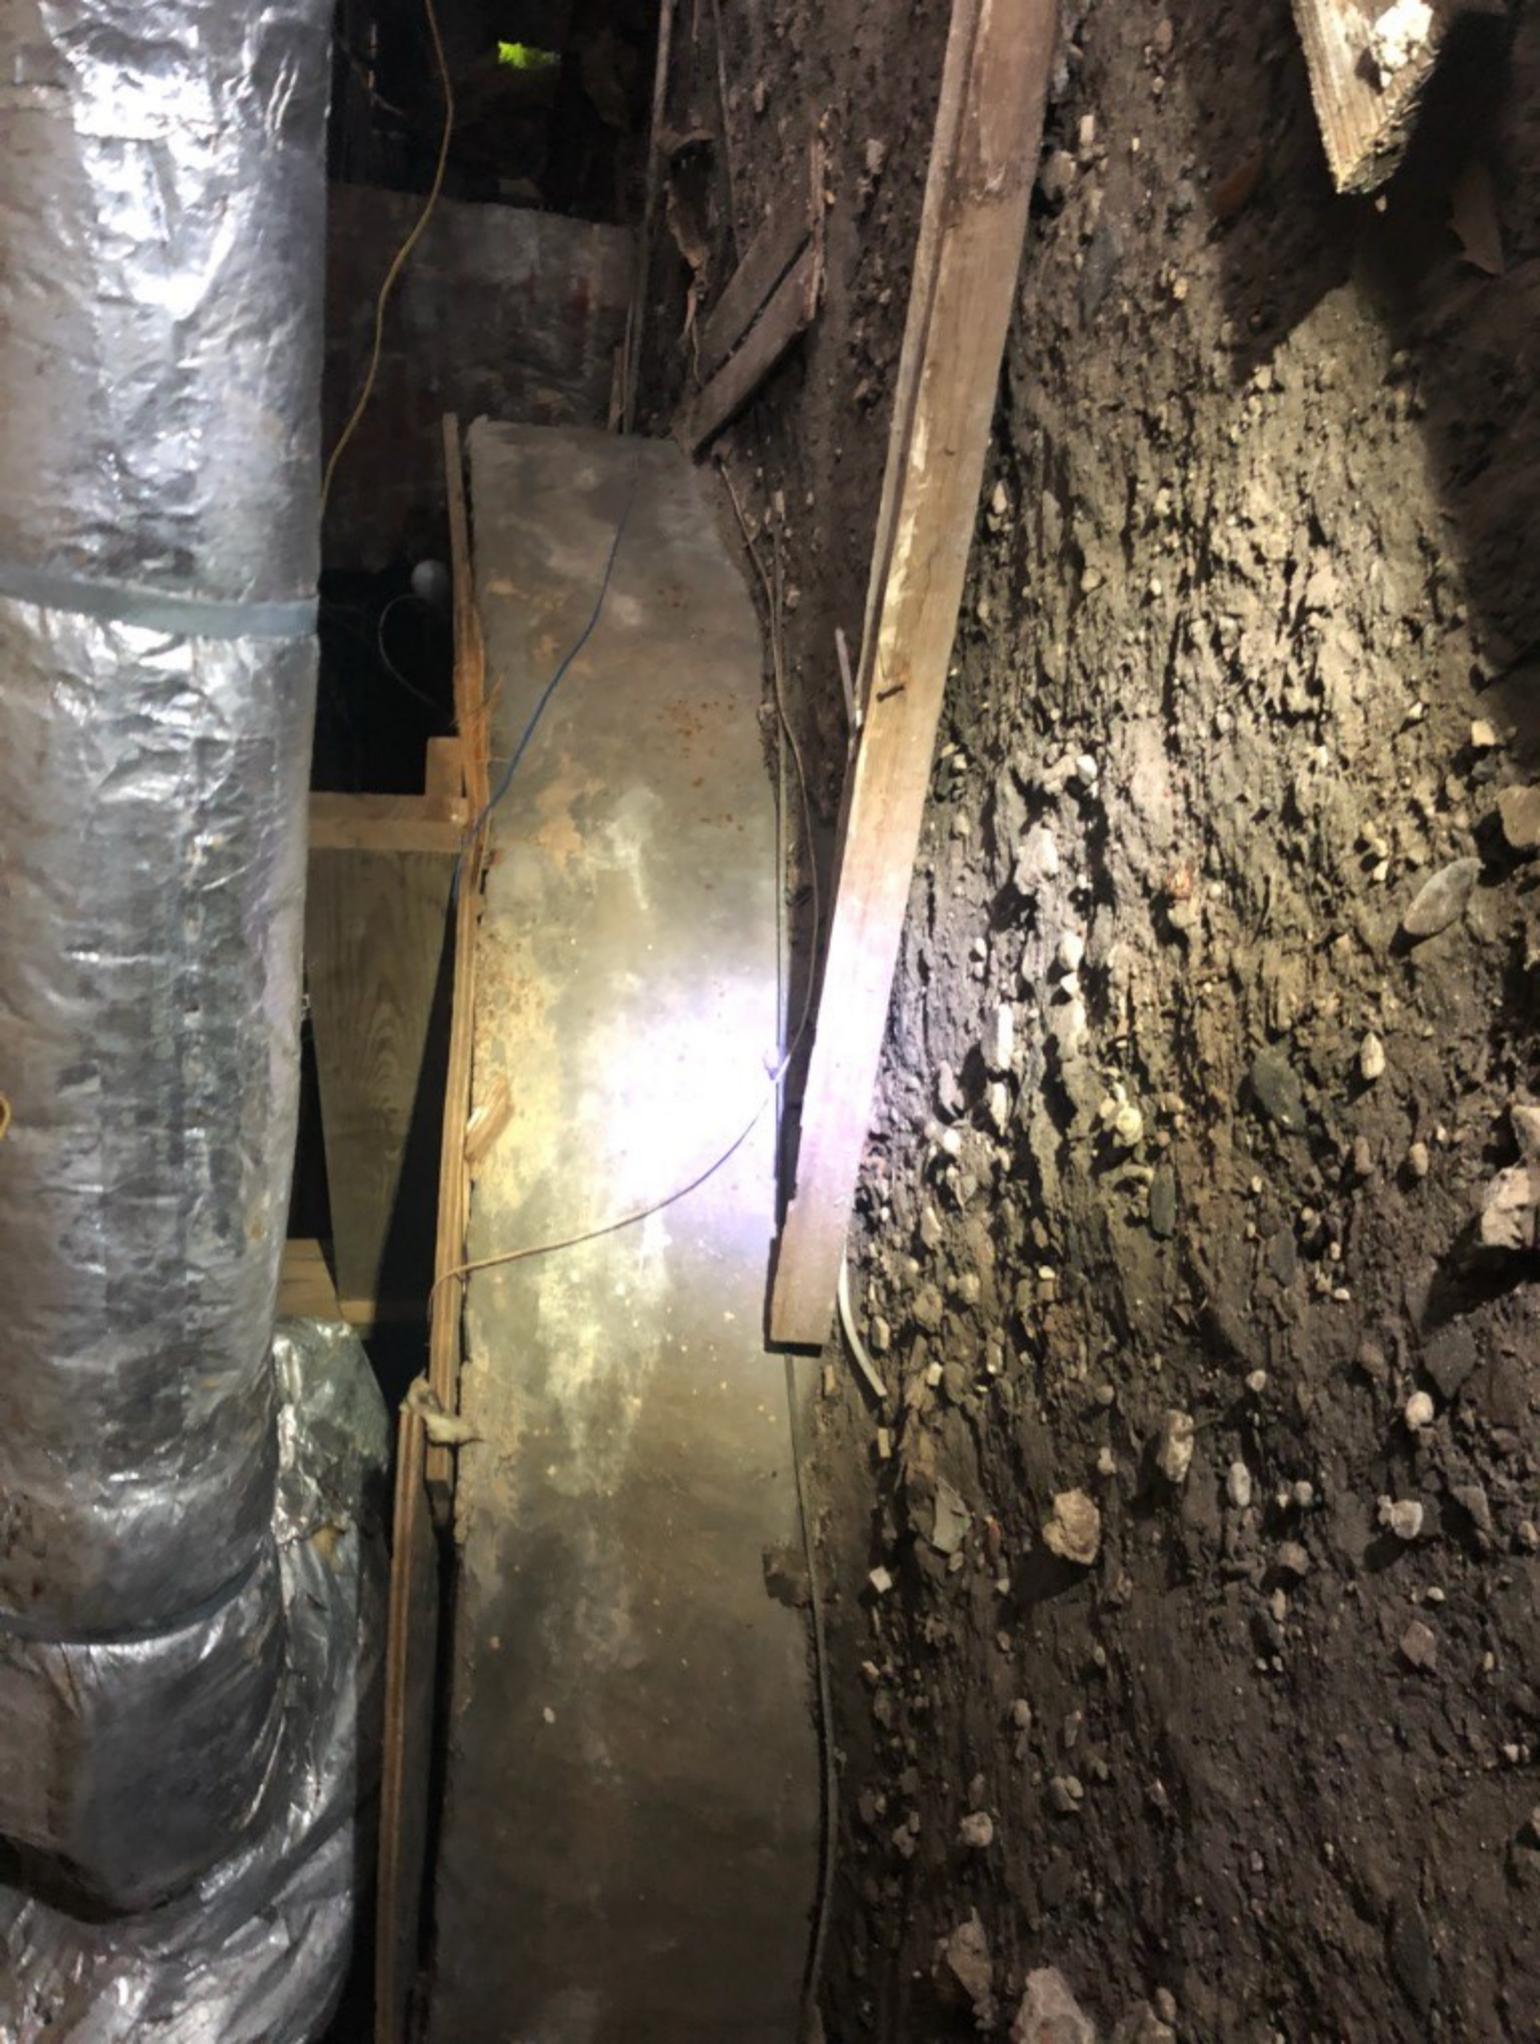
The applicant is requesting a Certificate of Appropriateness to reduce the height by 18 inches and fill in two underground brick rainwater cisterns under the house. Photos of the cisterns are provided in Attachment A. The age of the cisterns is unknown. The cisterns are not visible from the public right-of-way. The applicant wishes to infill the cisterns with sand to prevent water accumulating below the house and creating potential foundation issues and health hazards.

Staff finds that the request generally conforms to the Design Standards. While the Design Standards encourage the preservation of site features such as cisterns, the cisterns in question are beneath the house and not visible from the right-of-way. Due to their location, the standing water therein serves as a breeding ground for mosquitoes and presents a potential health hazard. Water leaking from the cisterns could potentially destabilize the surrounding foundation. Filling the cisterns with sand is an acceptable way to preserve the cisterns and mitigate these problems.
