**AGENDA  
LANDMARK COMMISSION  
REGULAR MEETING  
1:30 p.m. Monday, April 20, 2020  
City Council Chambers, 2<sup>nd</sup> Floor of City Hall  
823 Rosenberg, Galveston, Texas**

8. Consent Agenda
  - A. 20LC-017 (1518 Rosenberg/25th Street) Request For A Certificate Of Appropriateness For Modifications To The Structure Including Front-Porch Railing. Property Is Legally Described As The Lot 10, Northwest Block 42, Galveston Outlots Special Subdivision, In The City And County Of Galveston, Texas. Applicants: David Hyde And Donald Stewart  
Property Owner: David Hyde

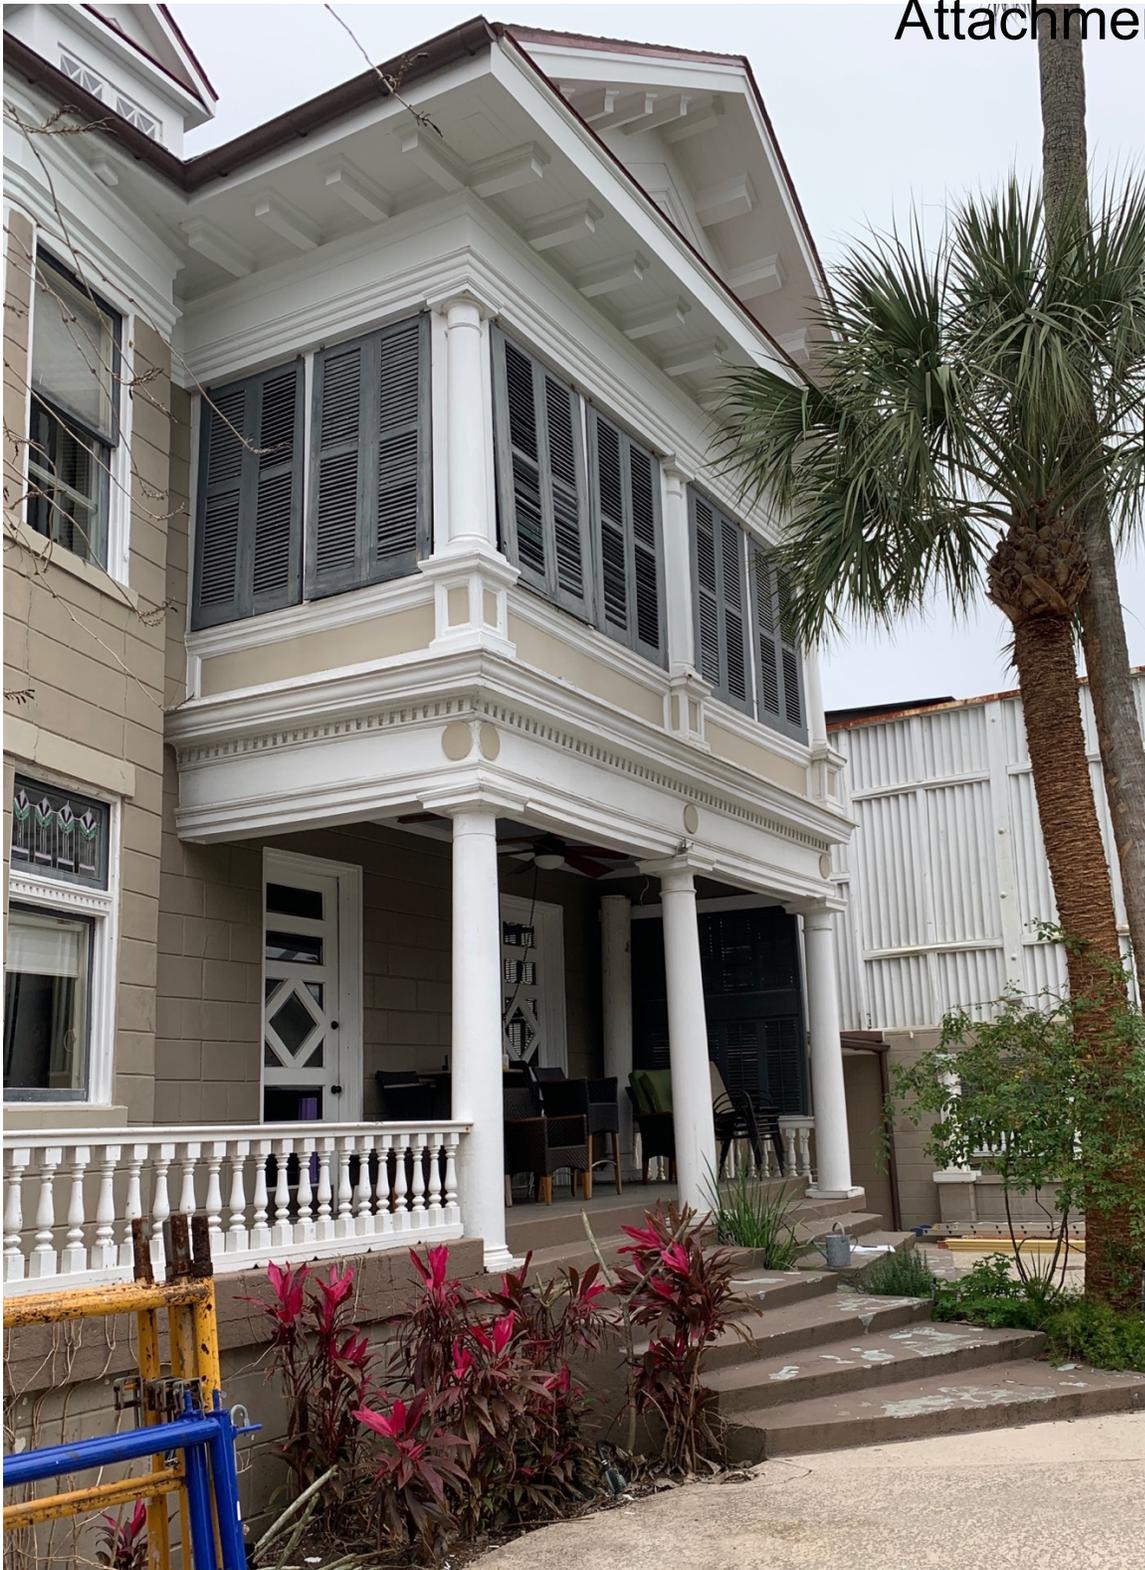
The west end and shutters between west end and center column are open air behind. The shutters from the center column to the east and east end have windows behind the shutters. Behind the windows is a solid wall to enclose an existing closet. The windows are rotten and the glass has slipped out of the frame behind the shutters. The shutters are fixed in place. The shutters are rotten and falling apart. It is proposed that the shutters be removed and a new energy efficient insulated wall constructed. Then, "shutter" panels constructed utilizing tear drop siding. Refer to examples of completed projects and detail drawings.

- Enclose the existing porch using energy-efficient, insulated walls;
- Replace the existing fixed shutters with teardrop siding panels that mimic shutters with the exception of two panels, which will be glassed in;
- Remove existing windows behind the shutters on the southeast corner of the porch; and
- Repair the base of the second-floor columns to match original existing detailing.

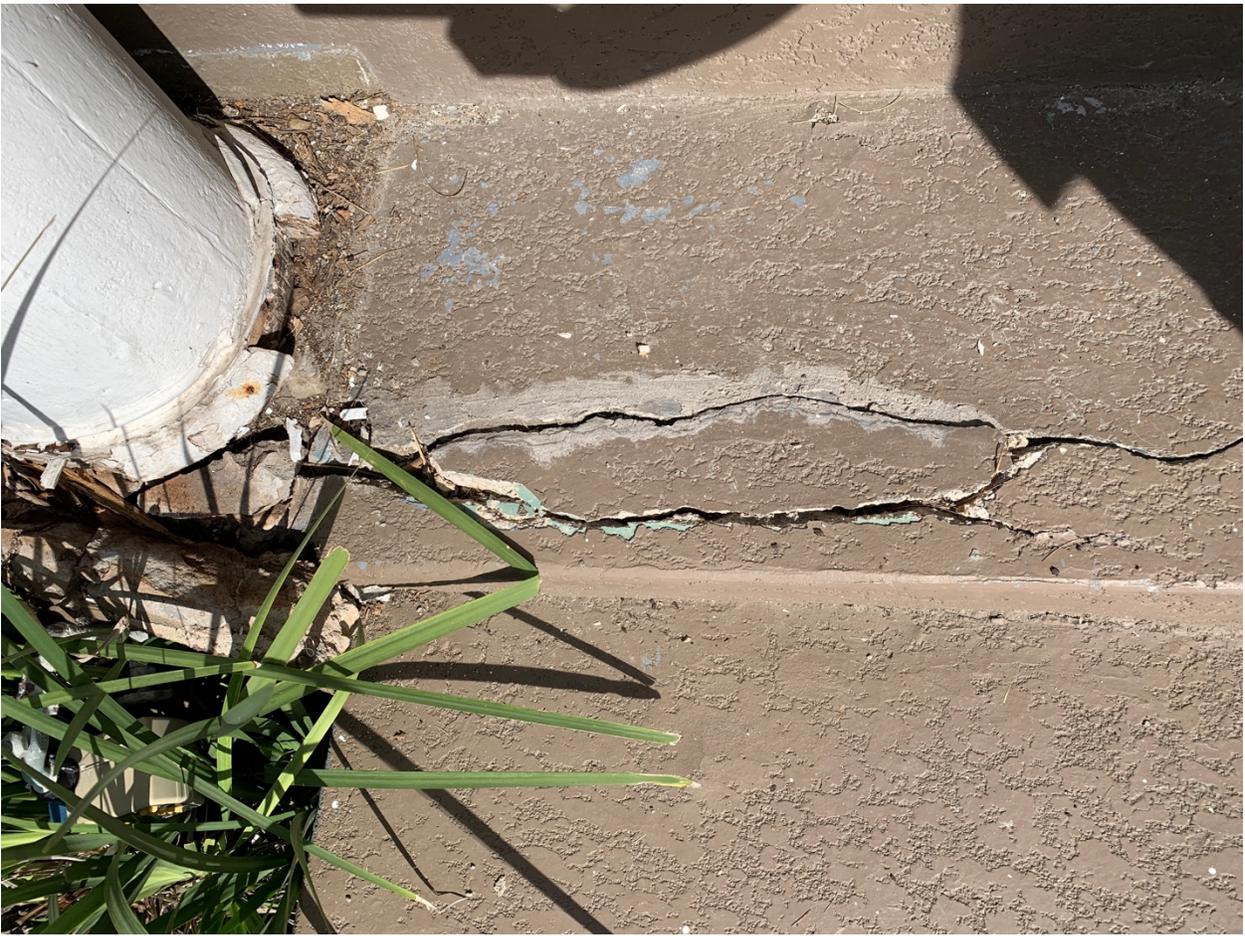
West End of Porch- Remove shutters and replace with solid wall and tear drop siding detail to replicate shuttered sleeping porch. The base of the second floor columns will be repaired to match original existing detailing. The sagging box beam will be internally reinforced to prevent further sagging of the second floor porch framing.

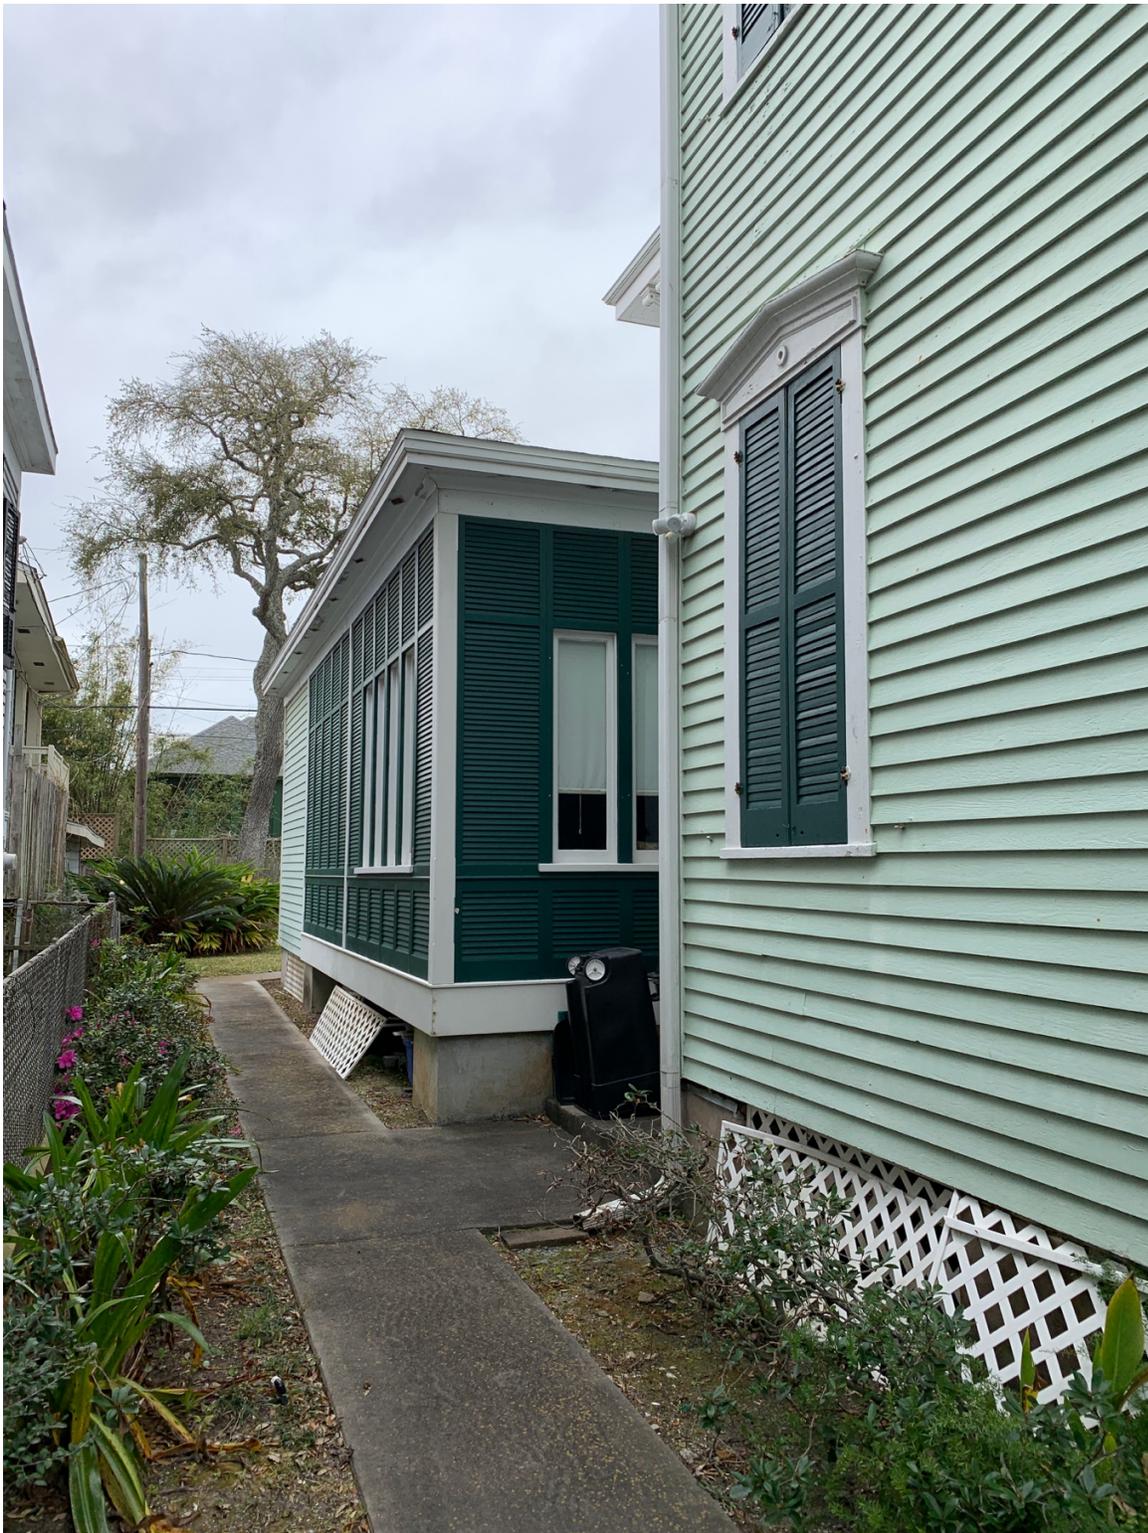
A concrete porch suspended over a crawl space was added at some point. The steel reinforcing has caused the concrete to spall and break apart. The column bases are rotting and collapsing. The existing concrete porch will be removed. New treated wood floor joists with wood tongue and groove porch decking will be installed. The column bases will be repaired.

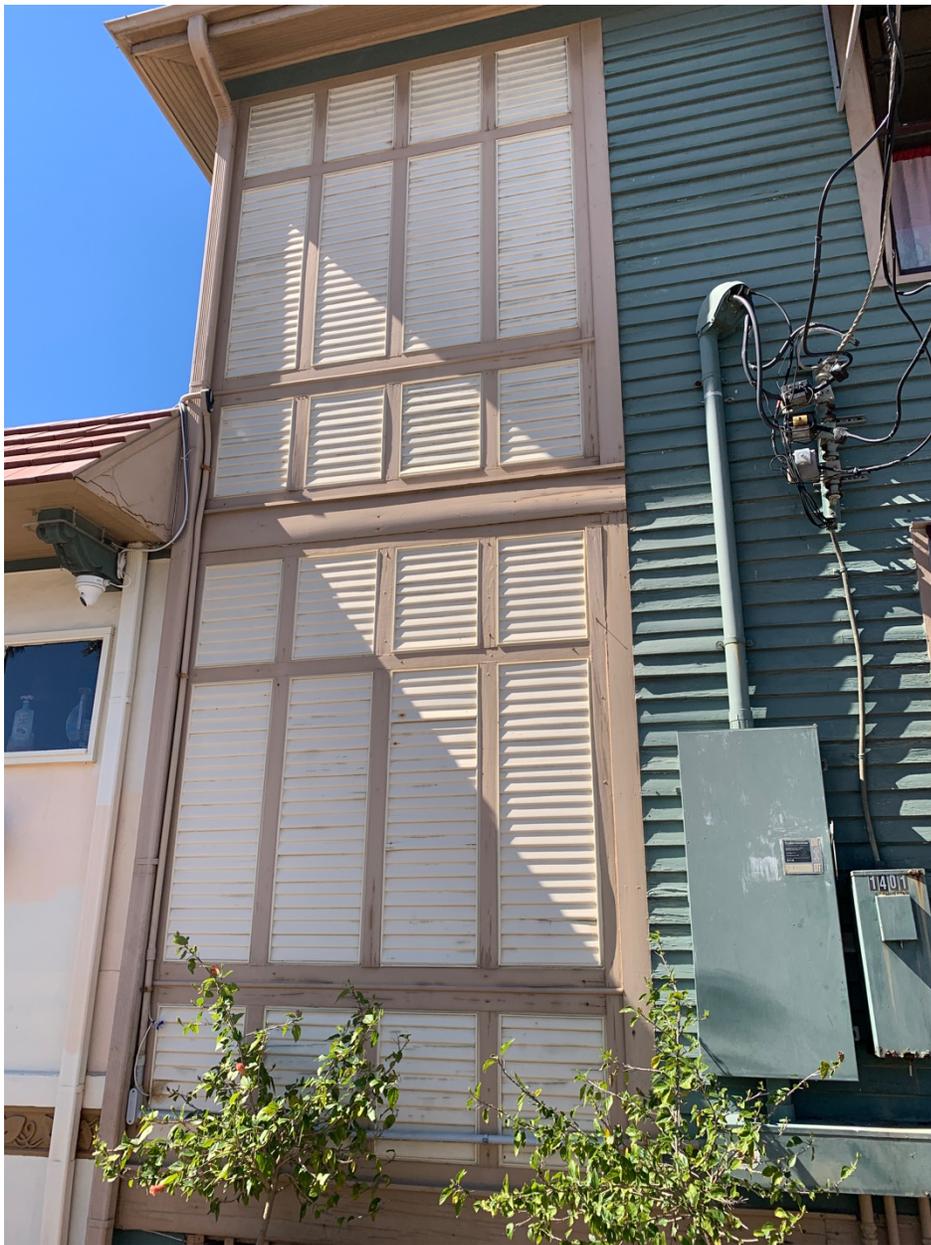
1920 Avenue M- "Shutter" porch utilizing proposed details including tear drop siding to replace rotten and falling apart shutters.

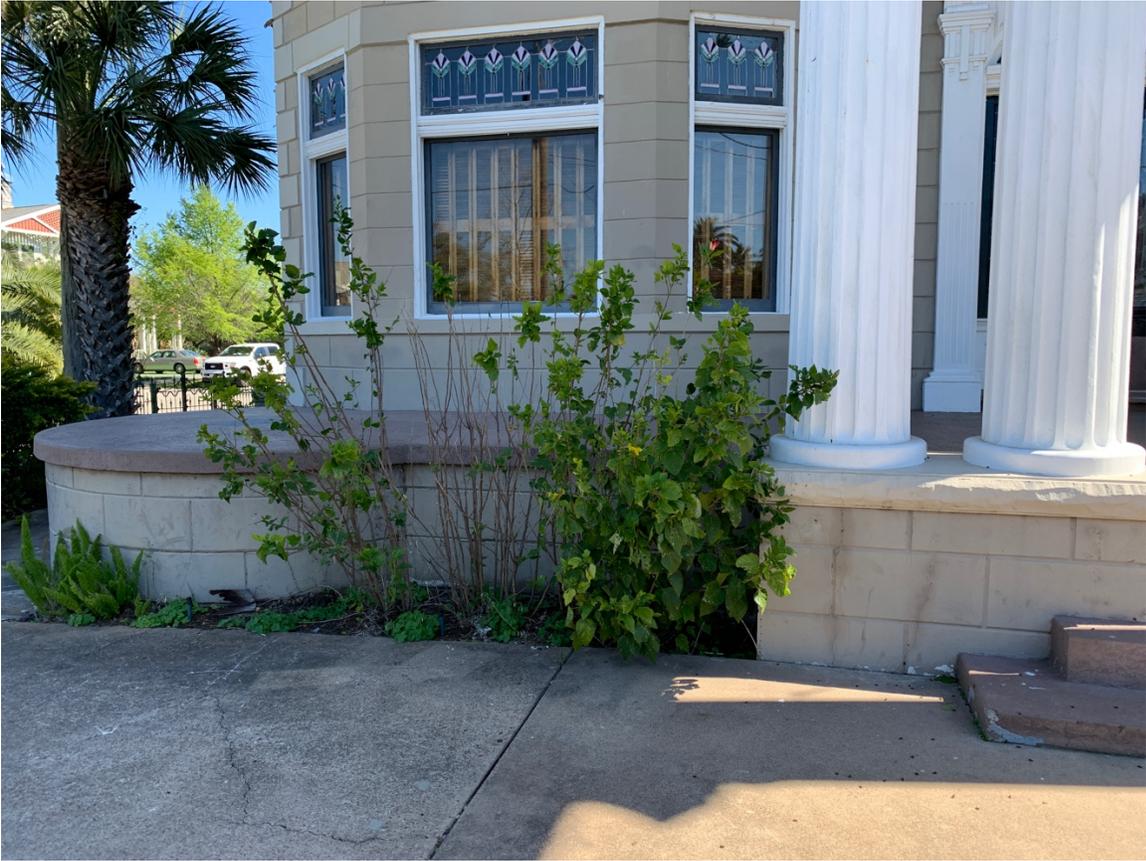
North end of front elevation with non-original round end porch

- Remove two round side porch additions;
- Repair underlying plaster walls;
- Install a black and white, honed marble checkerboard pattern with a black border overlay on the floor of the porch;
- Remove 6’ tall lattice from atop the fence; and
- Complete the existing concrete fence with concrete blocks for a total height of 8’.

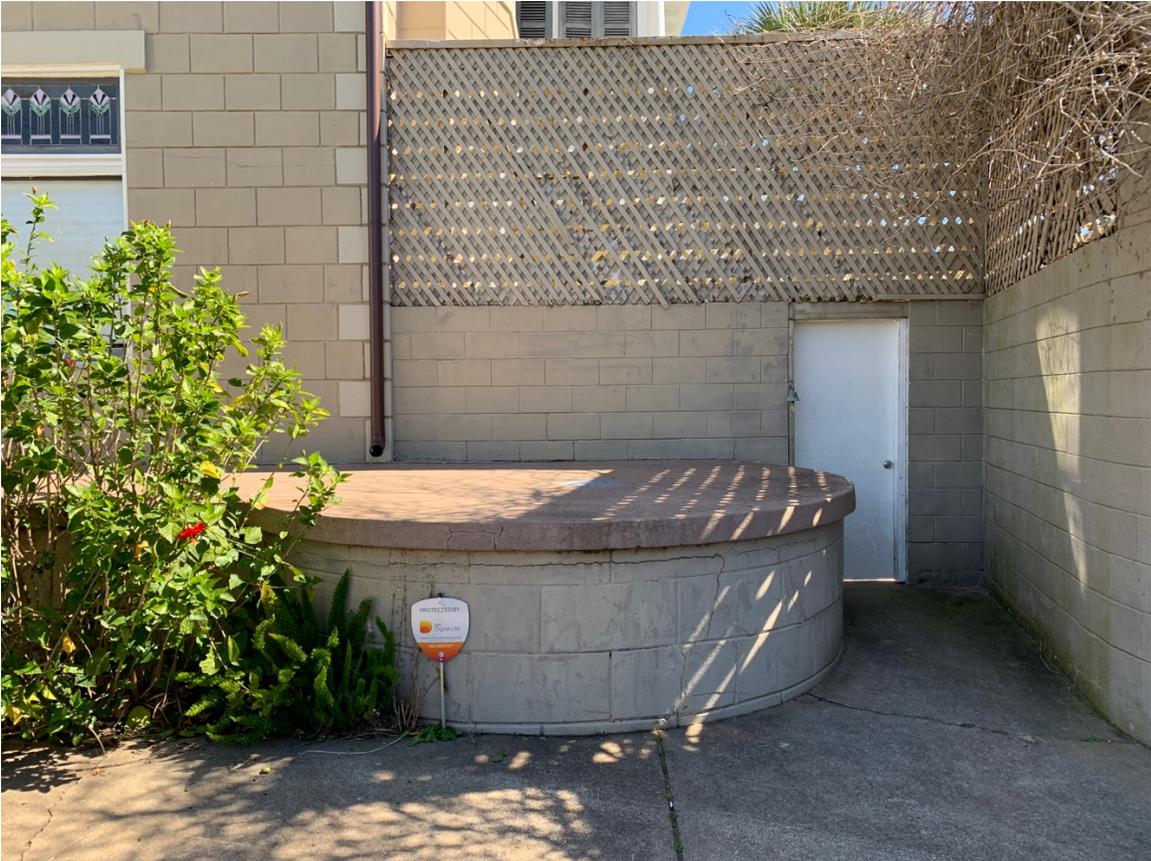
South end of front elevation with non-original round end porch

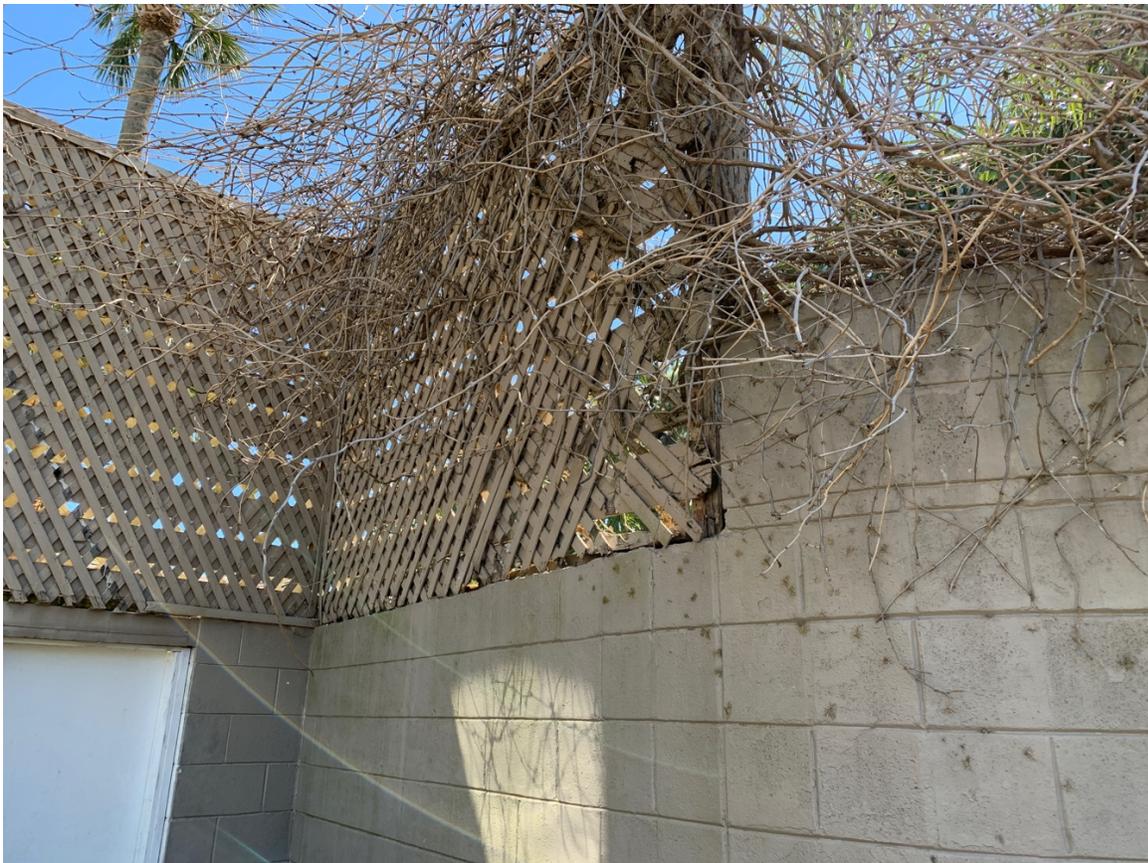
It is requested that the approximately 6' tall by 16' wide lattice atop a portion of the wall be removed and replaced with concrete block to match the remaining wall height. The height of the concrete block addition would be approximately 18", 4'-6" shorter than the lattice panel.

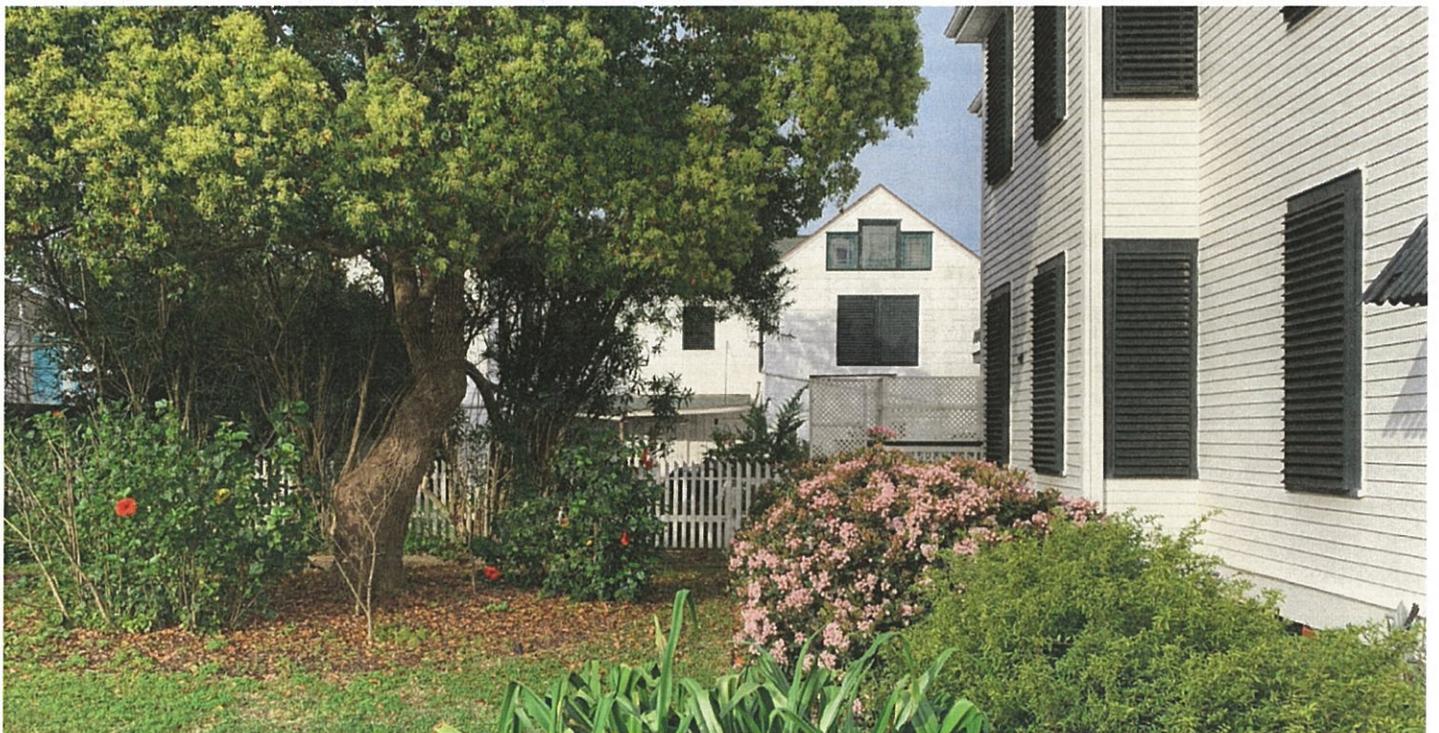
East elevation of the garage structure. The proposed addition will be located between the two existing wings. The façade of the proposed addition will be held back approximately 1'-6" from the face of the two wings. The proposed roof will slope up and stop approximately 8" below the existing second floor windowsill. The addition will have new cement board siding to match the existing mineral board siding.

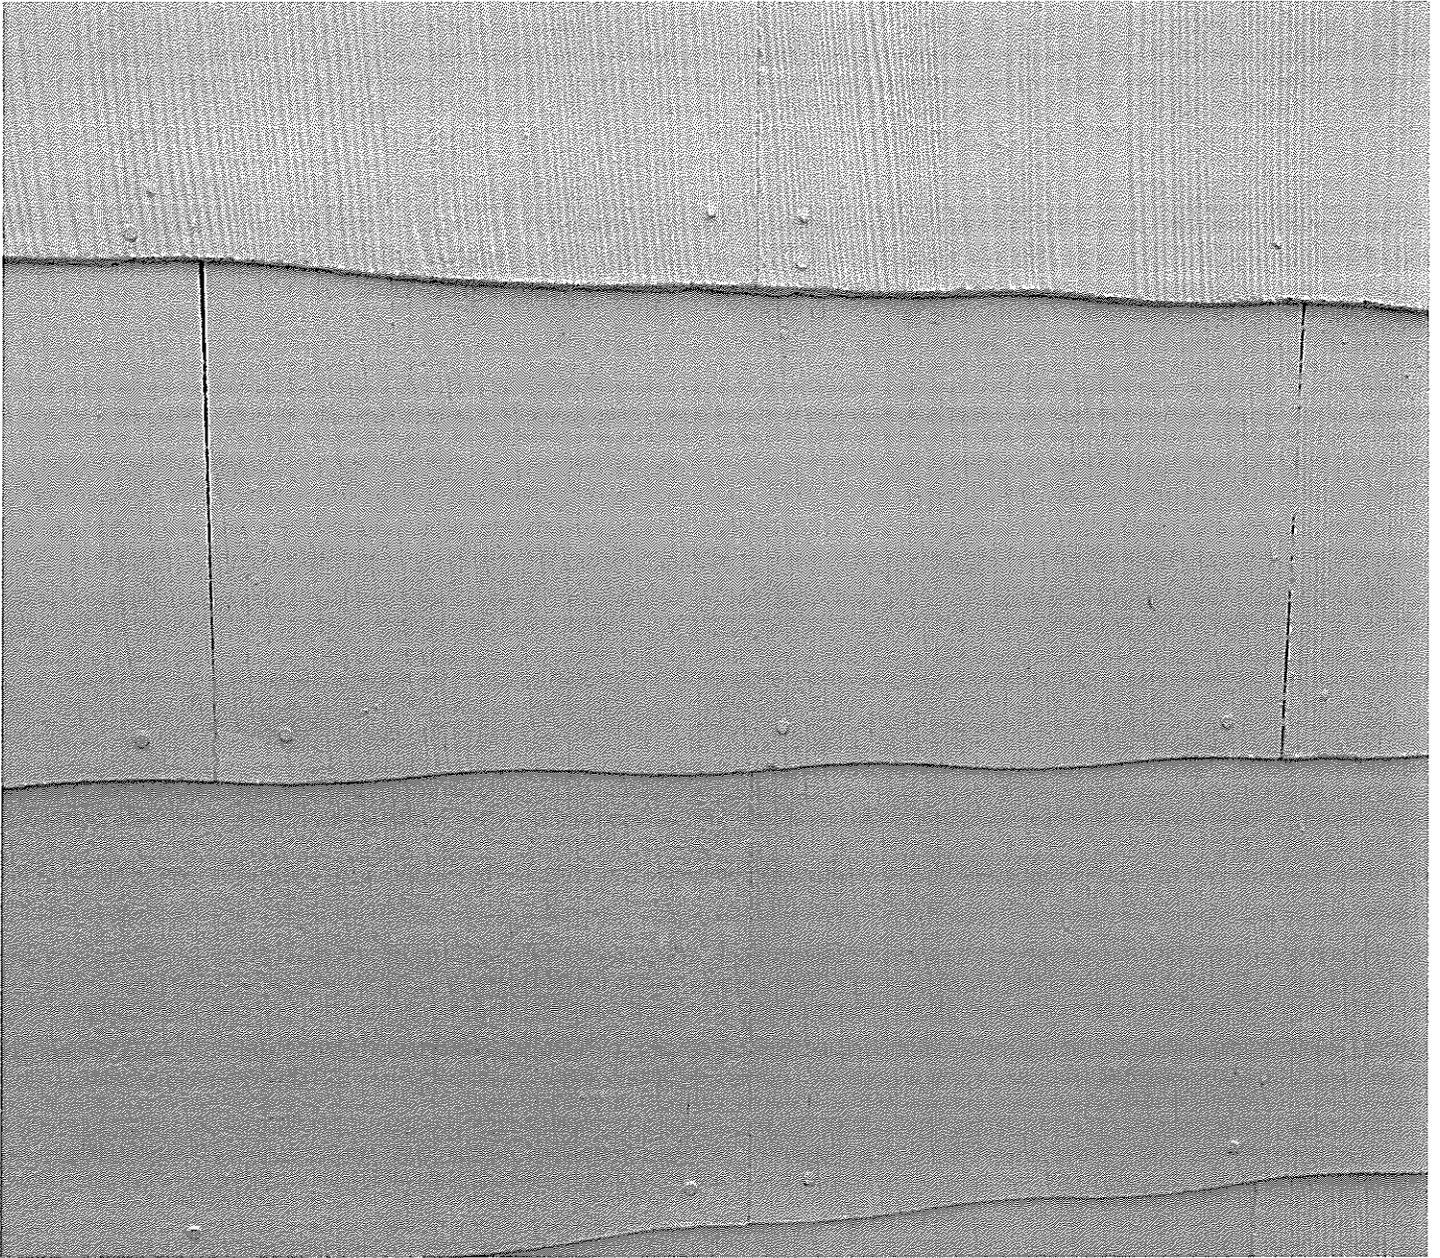
Close up of existing siding material.

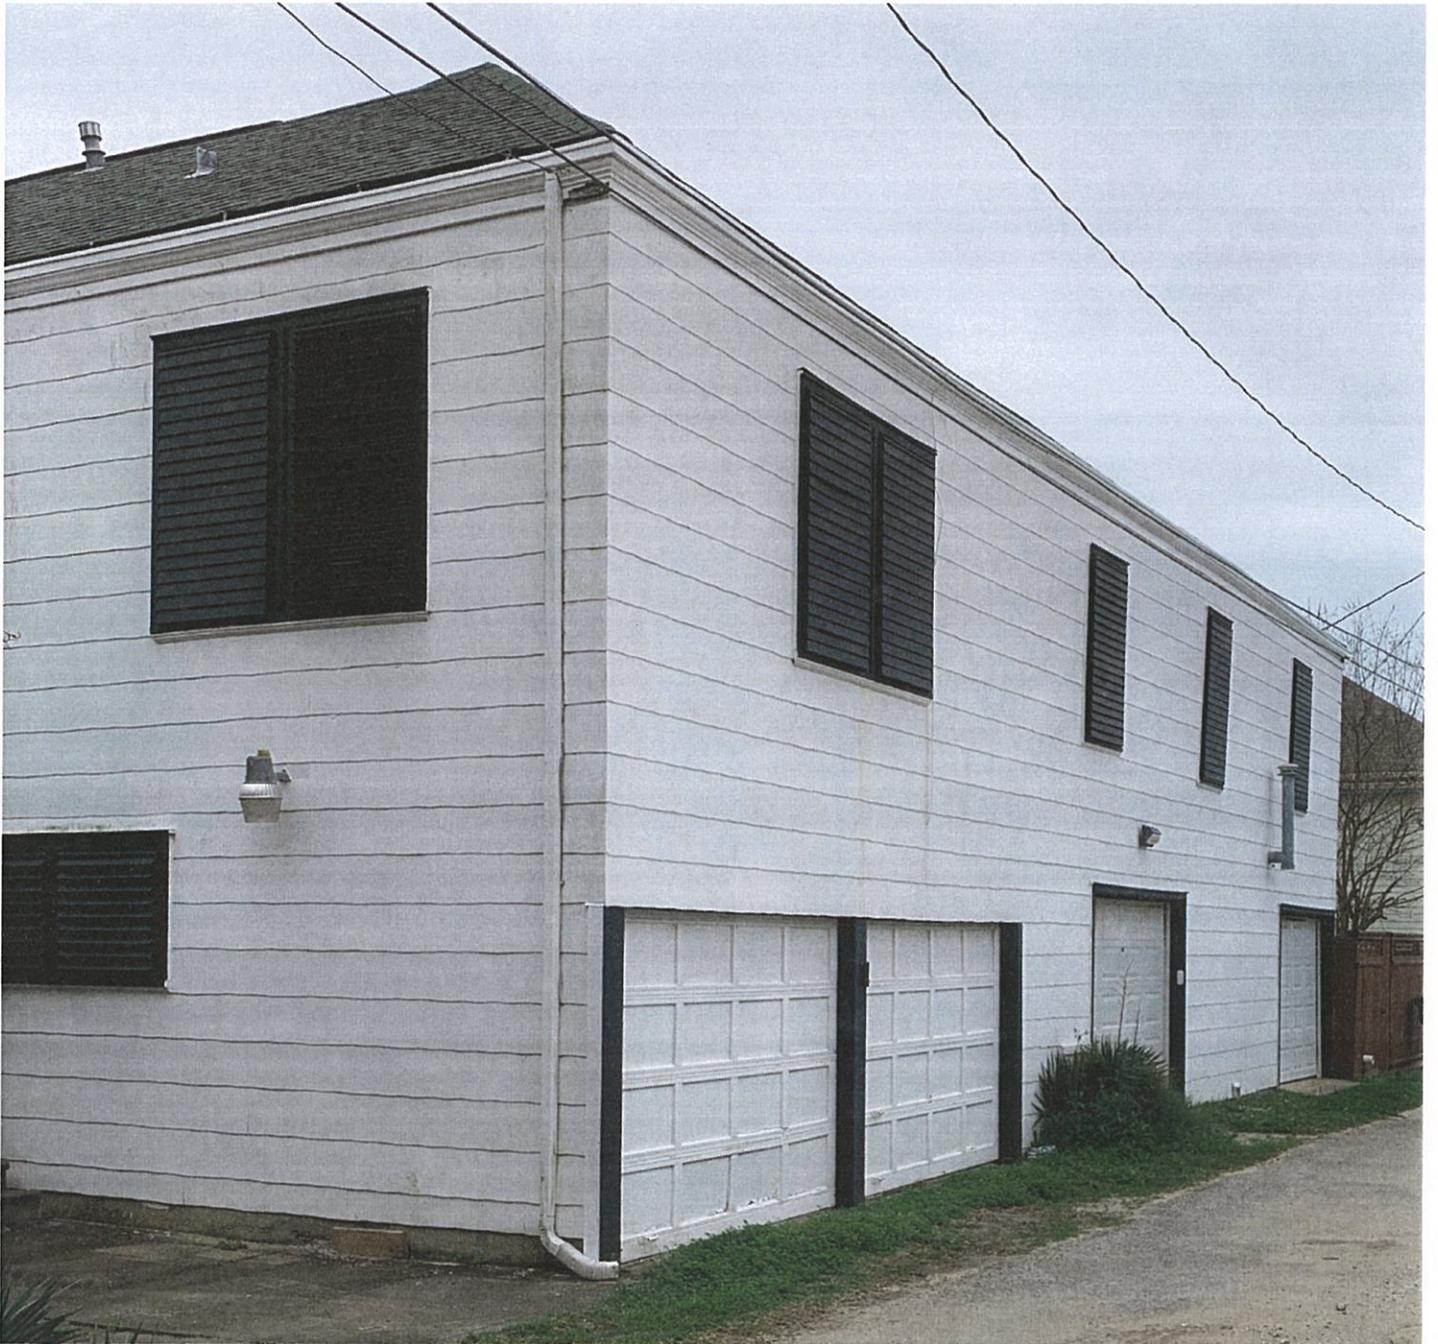
Alley elevation. The two short garage doors to the north will be removed. A single 14 foot wide by 7 foot tall garage door will be installed, and the surrounding wall infilled with salvaged mineral board siding. An additional 9 foot wide garage door will be added between the existing tall doors.

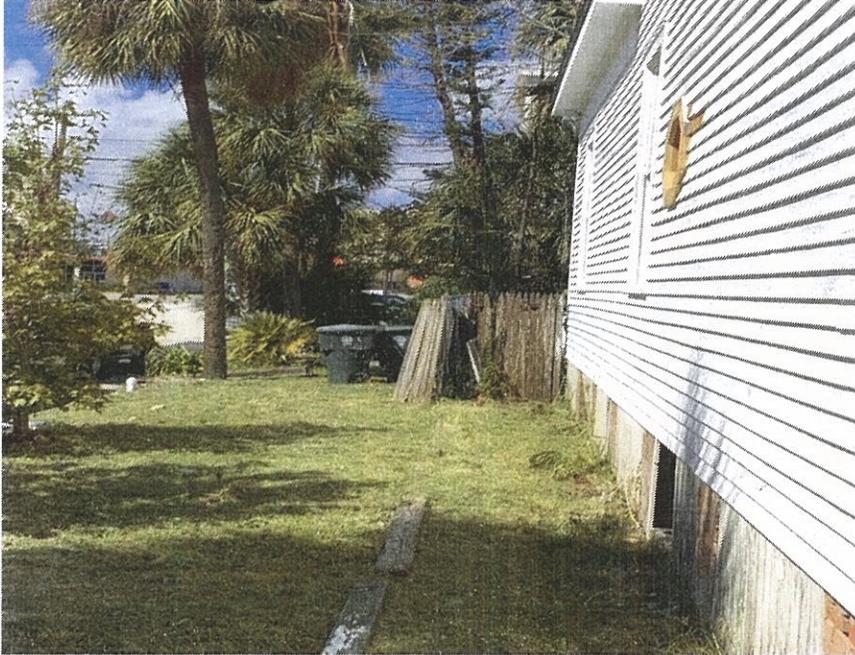
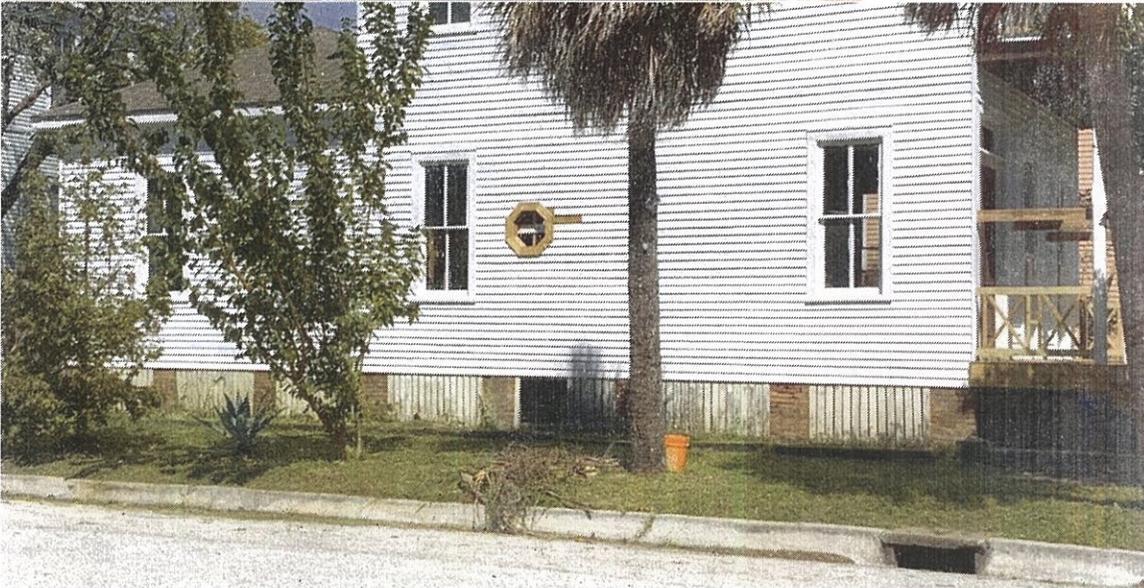
Proposed location- West Side of 1928 Ave K

1928 Ave K is 18'8" from the street. The property line is 16'2" from the street.

The property locate at 1928 Avenue K is a single-family residence. According to the applicant, placing an HVAC unit on the east side of the structure would block a walkway that provides access to a side entryway, and placing the HVAC unit in the backyard would be disruptive to occupants of the master bedroom and/or living room as well as neighbors in an adjacent property. The applicant is also proposing a picket fence to screen the HVAC unit and its platform.

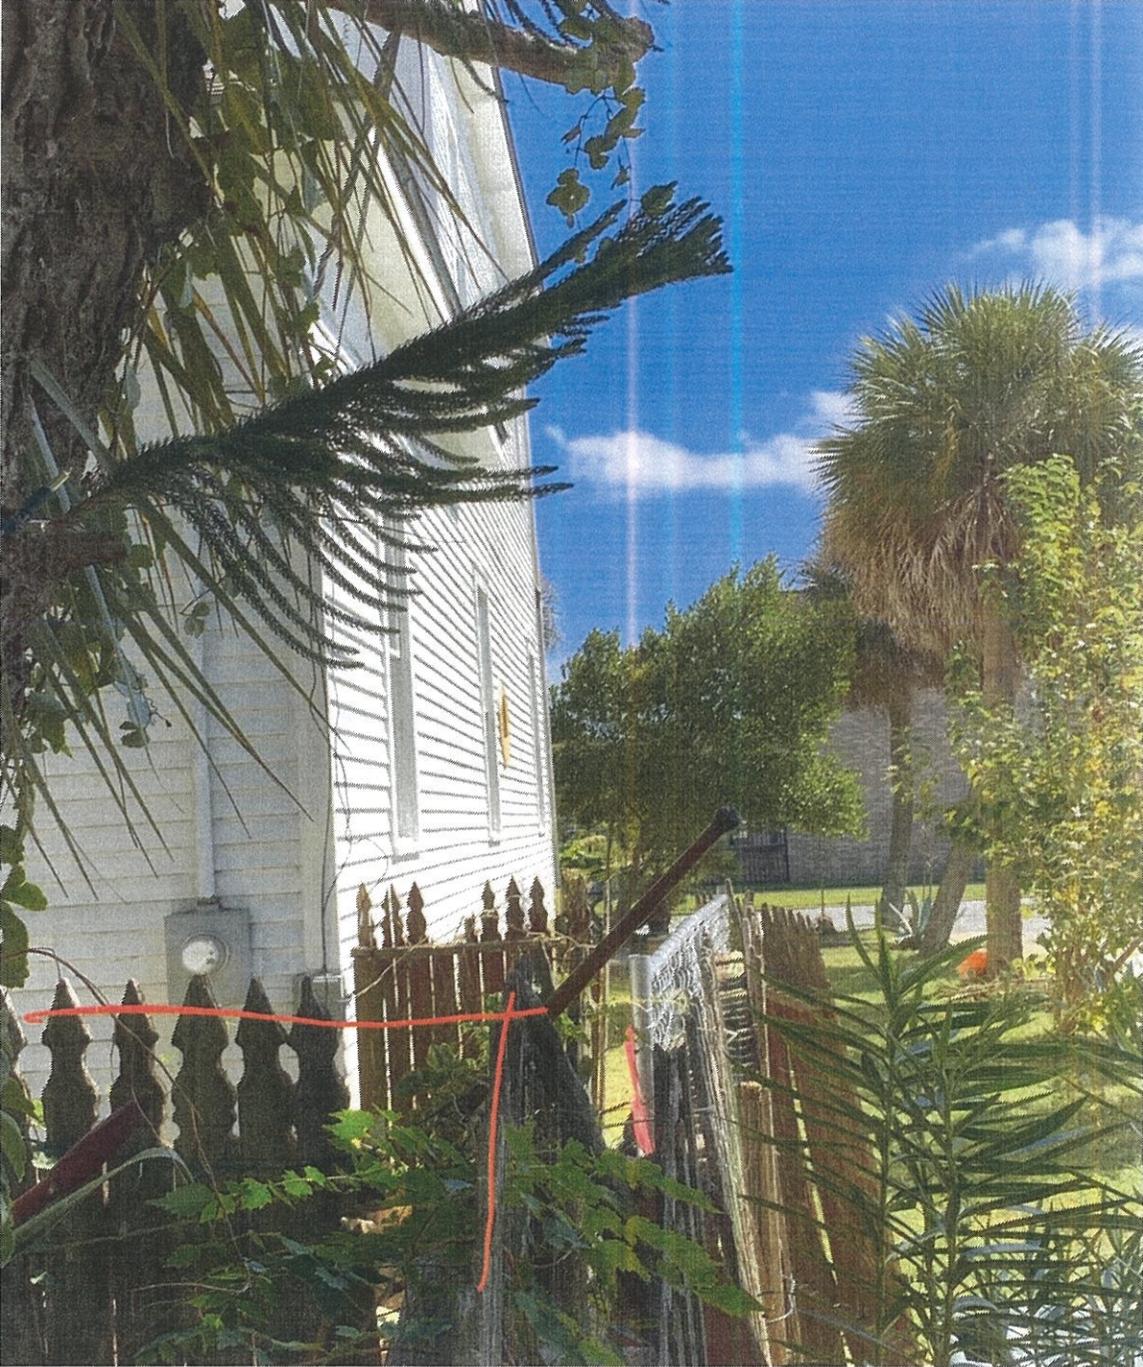
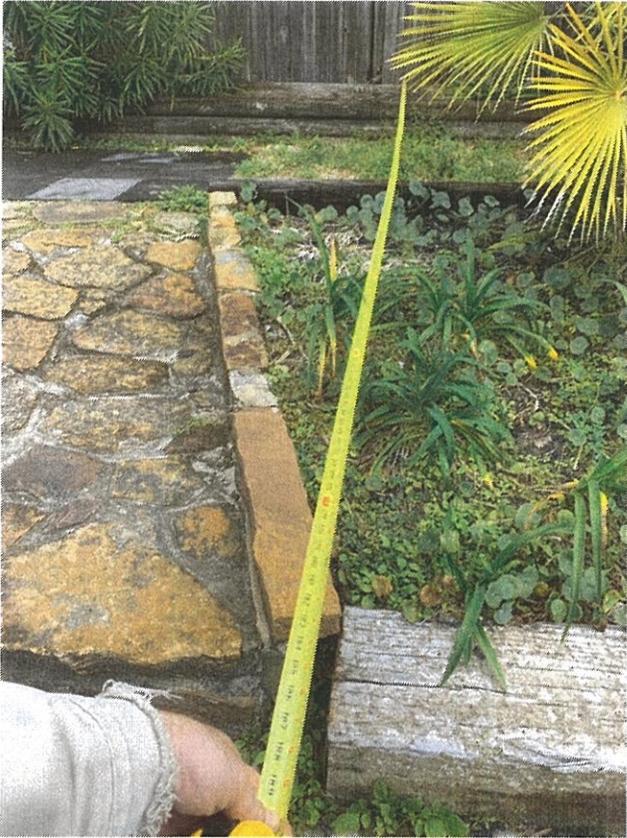
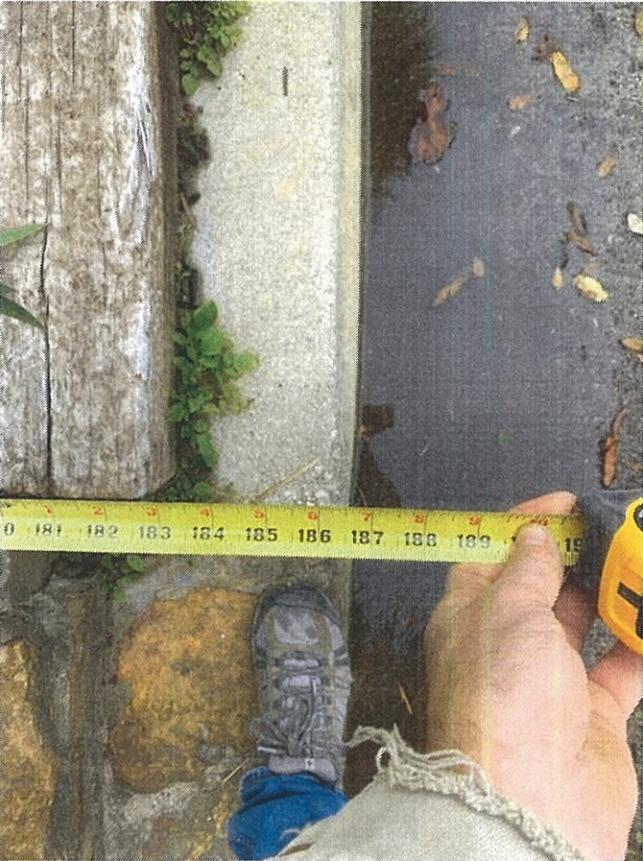
1014 20th street  
Fence is 15'6" from the street

Examples of neighbors that are over the property line.

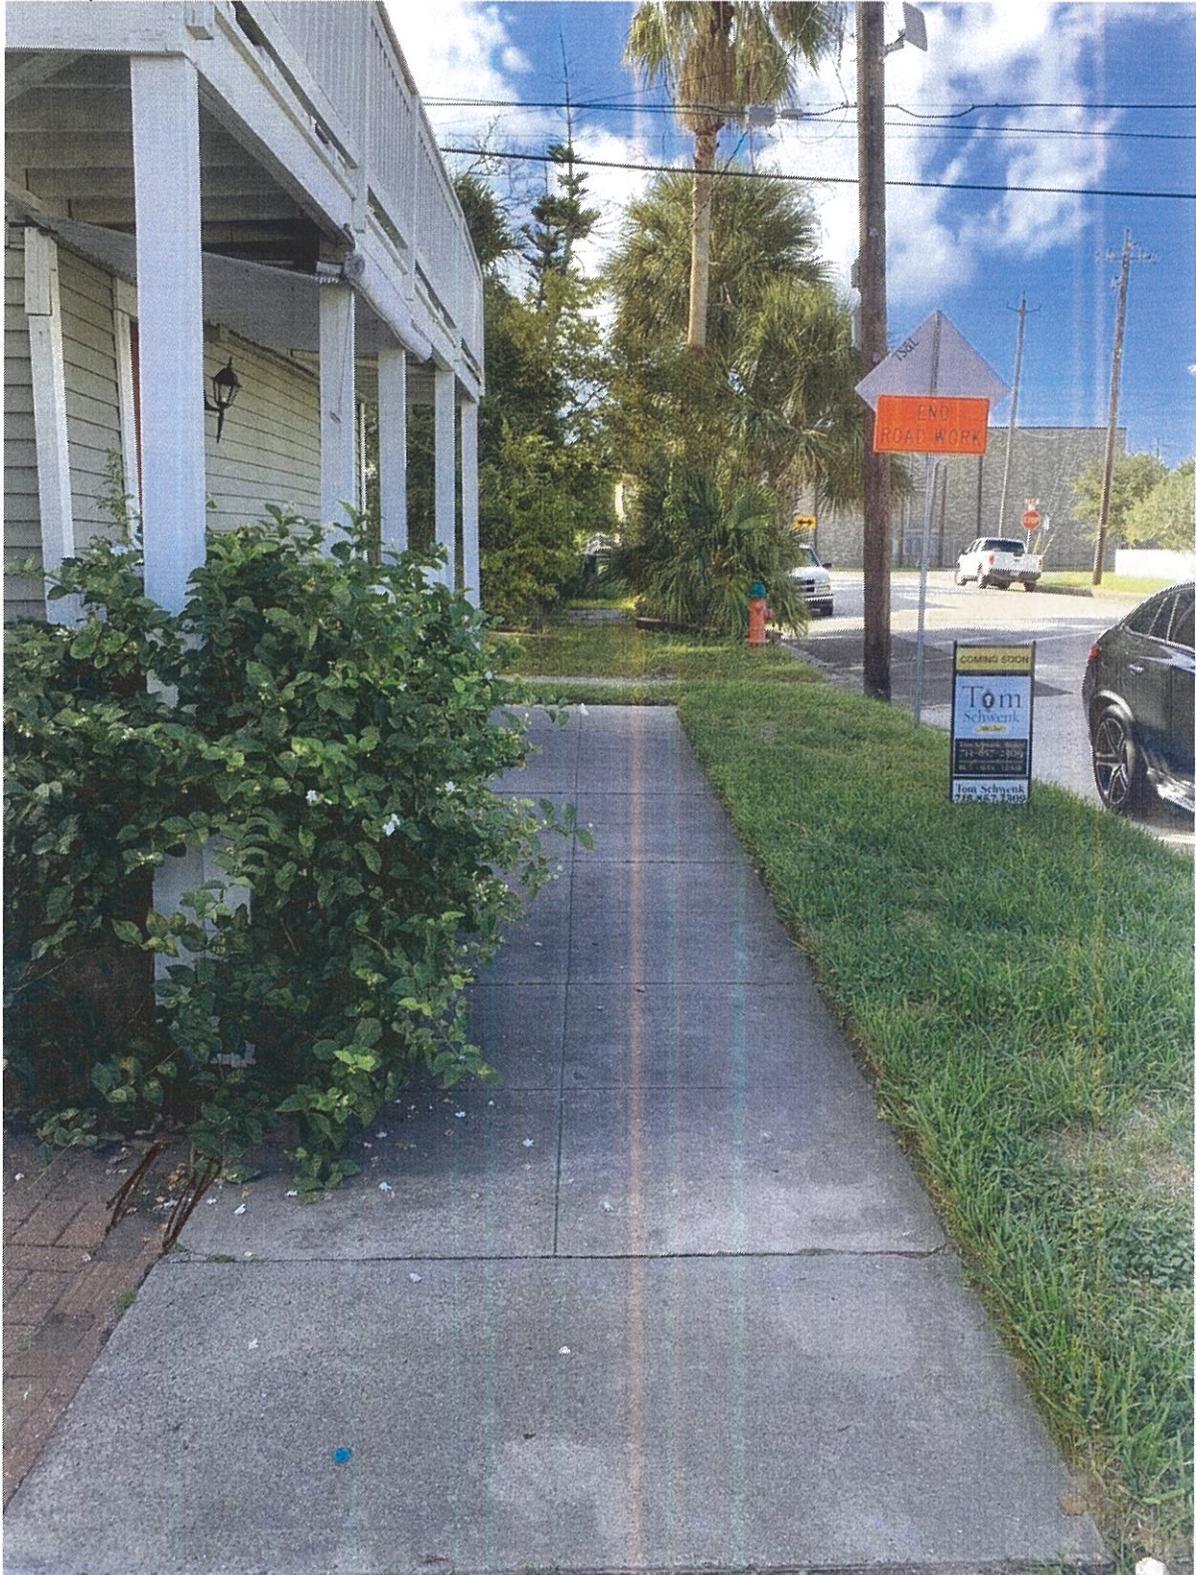
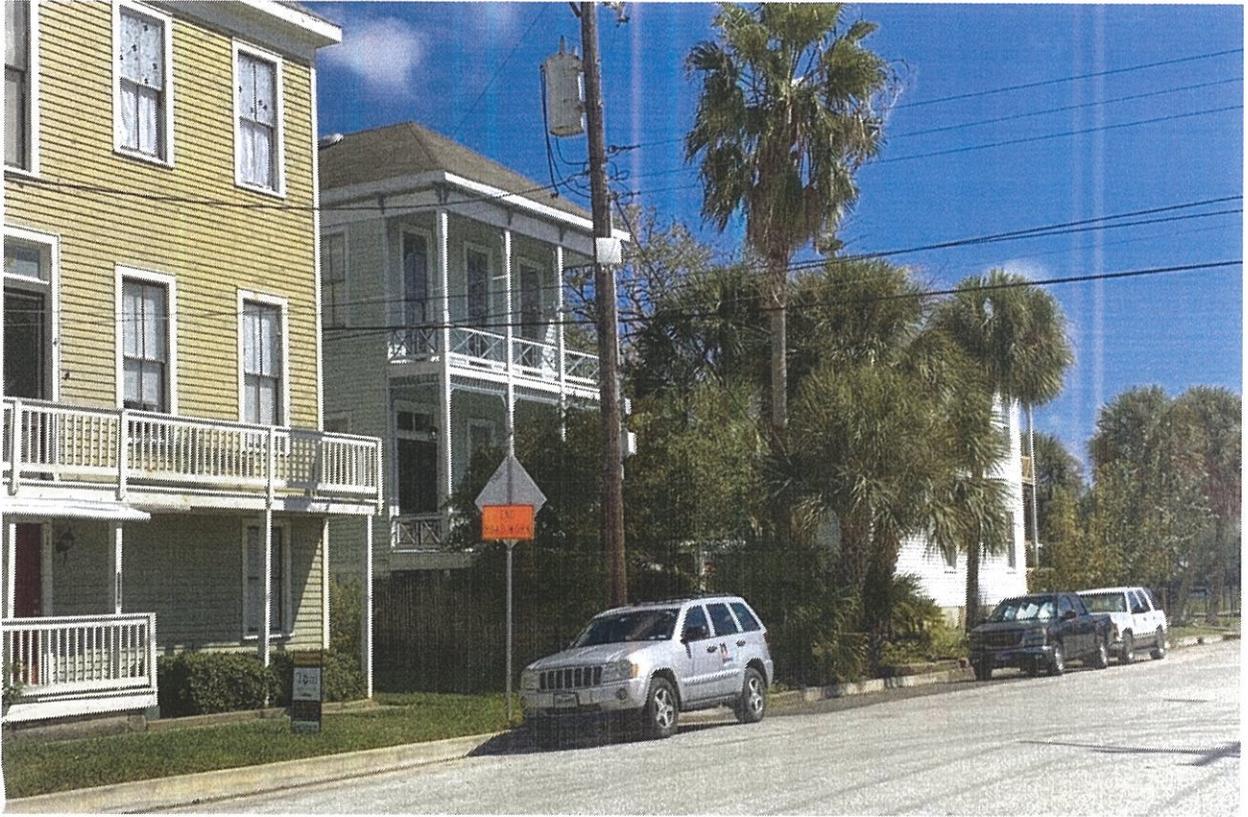
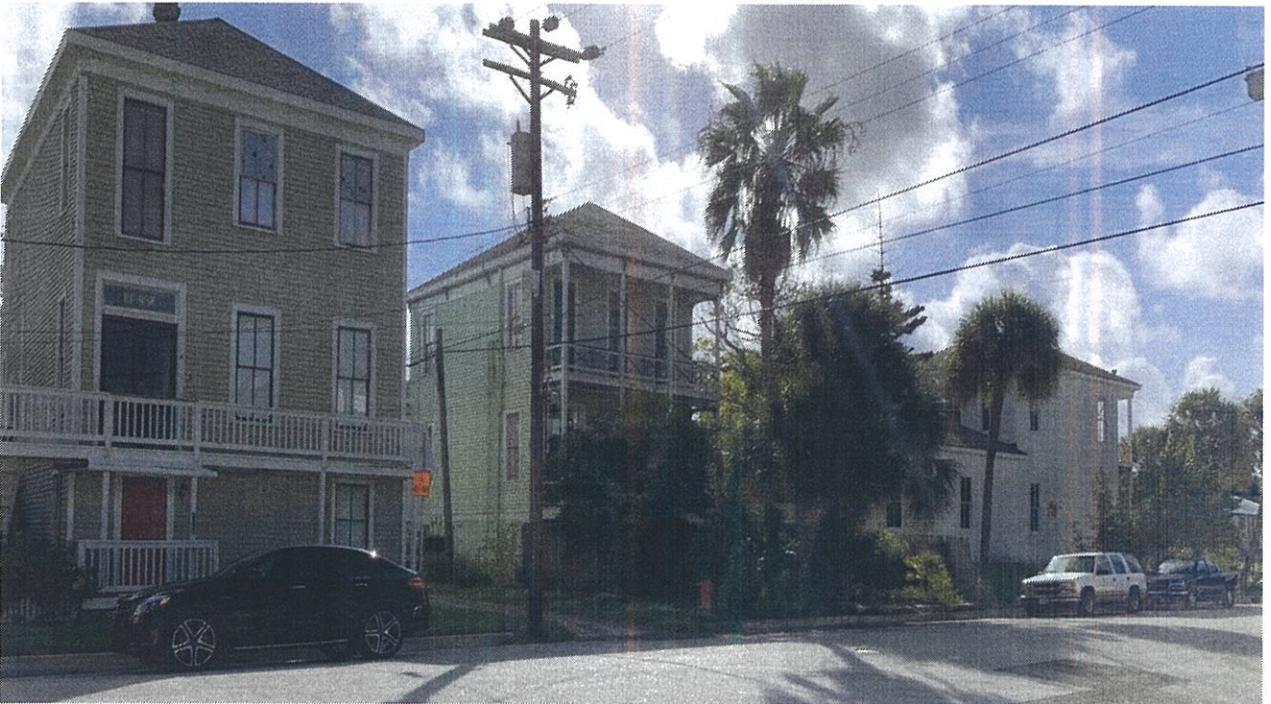
1012 20th street

Front porch is built 14' from the street.
