**AGENDA  
LANDMARK COMMISSION  
REGULAR MEETING  
1:30 p.m. Monday, April 20, 2020  
City Council Chambers, 2<sup>nd</sup> Floor of City Hall  
823 Rosenberg, Galveston, Texas**

8. Consent Agenda
  - A. 20LC-017 (1518 Rosenberg/25th Street) Request For A Certificate Of Appropriateness For Modifications To The Structure Including Front-Porch Railing. Property Is Legally Described As The Lot 10, Northwest Block 42, Galveston Outlots Special Subdivision, In The City And County Of Galveston, Texas. Applicants: David Hyde And Donald Stewart  
Property Owner: David Hyde

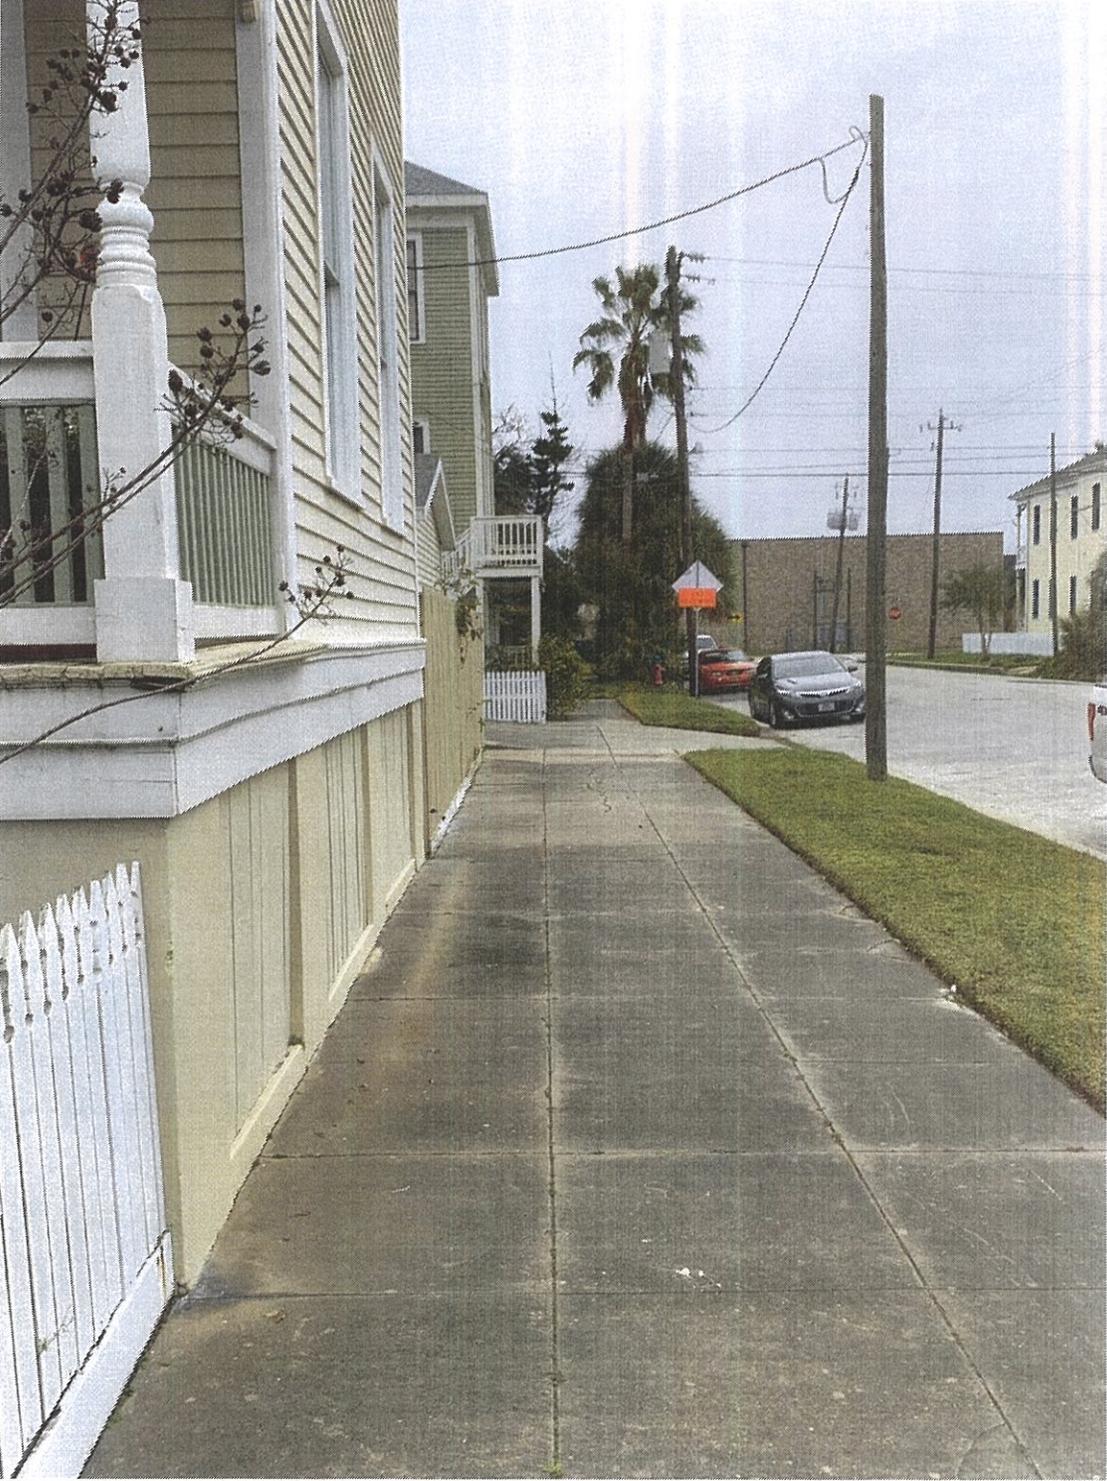
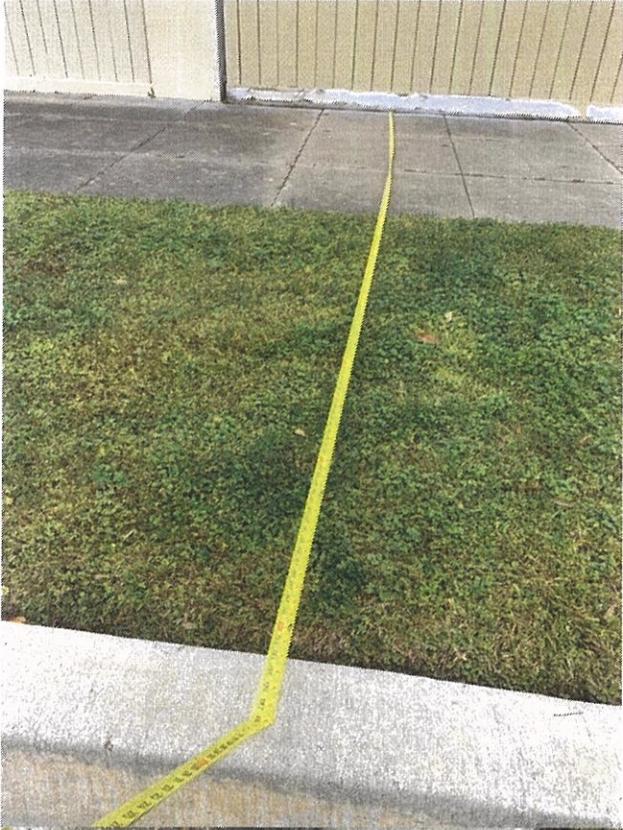
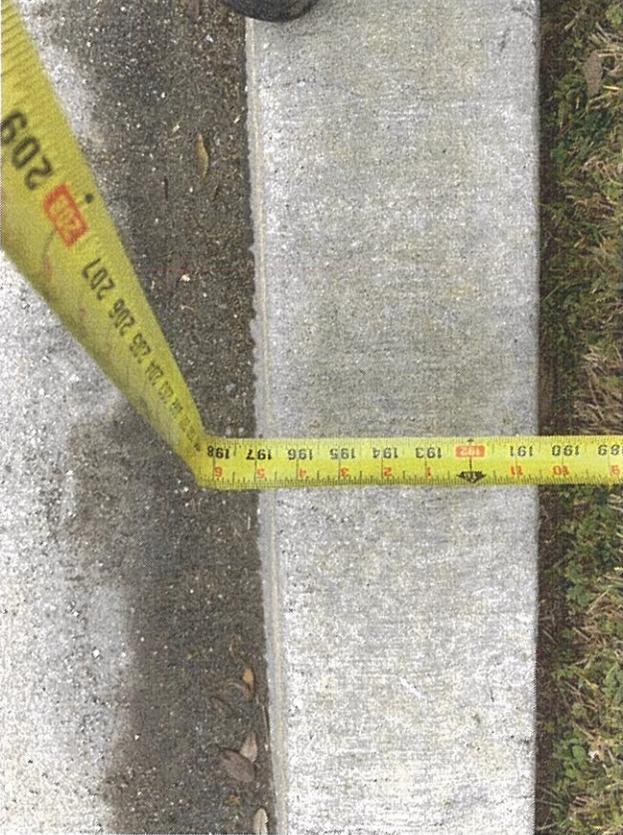
1927 Broadway

The house is located 16' 5" from the street.
