AGENDA
LANDMARK COMMISSION
REGULAR MEETING
4:00 p.m. Monday, June 15, 2020
City Council Chambers, 2nd Floor of City Hall
823 Rosenberg, Galveston, Texas

MINUTES OF THE LANDMARK COMMISSION OF THE CITY OF GALVESTON REGULAR MEETING – June 1, 2020

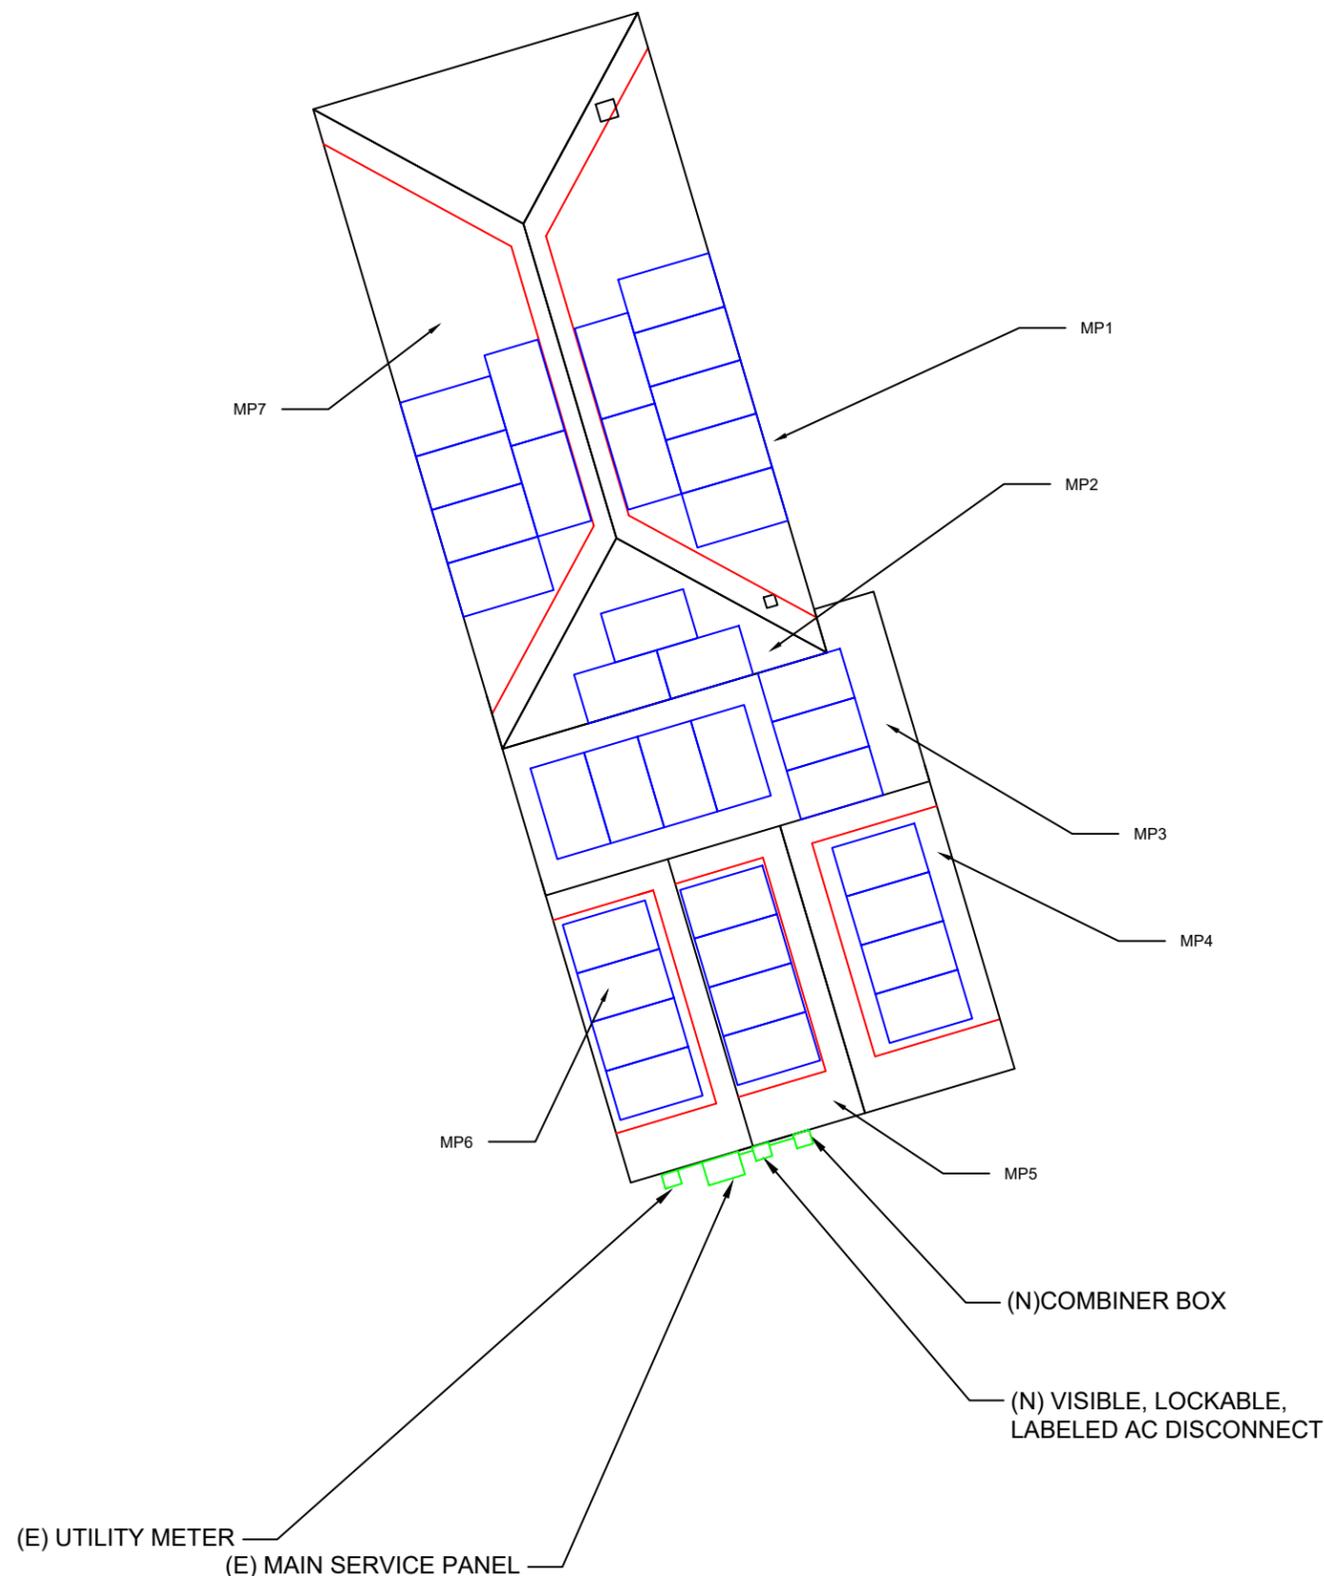
NOTE:
 RACKING AND MODULES ARE COMPLIANT WITH UL 1703 FIRE
 INSTALLATION OF ALL EQUIPMENT SHALL BE ACCORDING TO
 MANUFACTURERS RECOMMENDATIONS.

MOUNTING PLANE	MP1	MP2	MP3	MP4	MP5	MP6	MP7
AZIMUTH	73	163	163	73	253	253	253
TILT (degrees)	35	35	35	35	35	35	35
MODULE COUNT	7	3	7	4	4	4	6

AC DISCONNECT LOCATED ON
 ACCESSIBLE EXTERIOR WALL
 WITHIN 10 FEET OF UTILITY METER

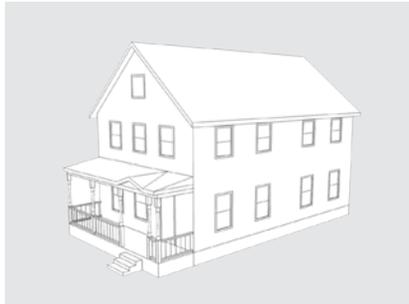
Existing Structure

The two-story structure illustrated at right has a significant south-facing sloped roof area.

- Gable roof end faces the street
- Side of roof faces south

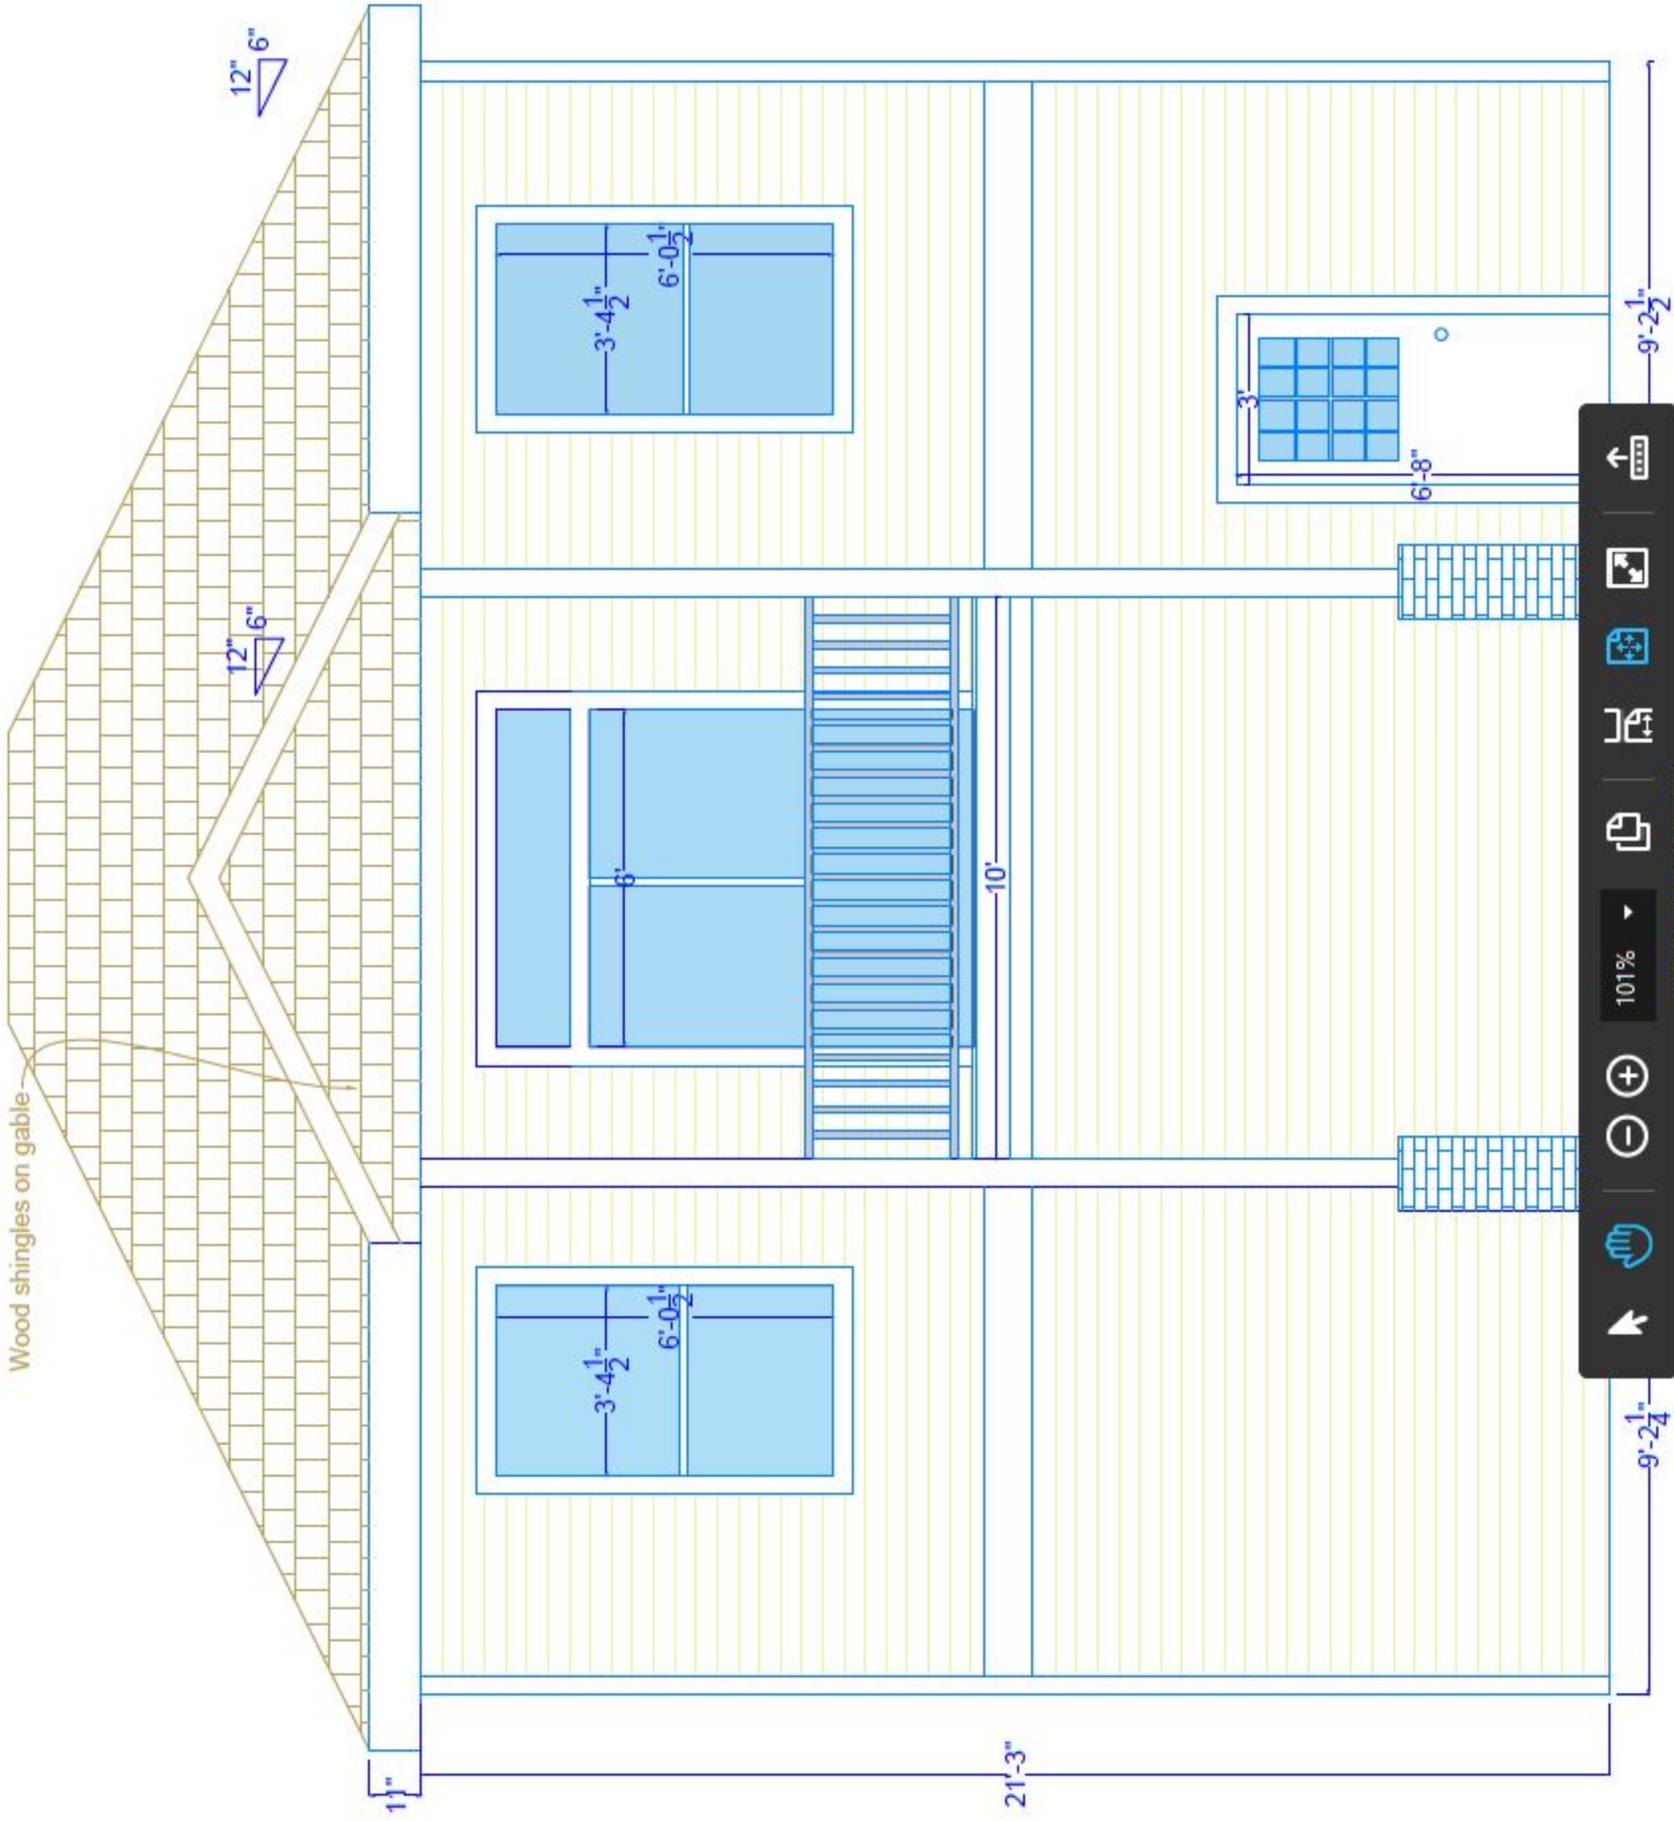
SOUTH ELEVATION

Wood shingles on gable
